Inspection Report

4700 Turley Mill Rd, Farmington, MO 63640, USA

A-Team Consulting and Contracting

Date: 1/2/2025	Time:	Report ID: 2025010202
Property: Address	Customer: NAME	Real Estate Professional:

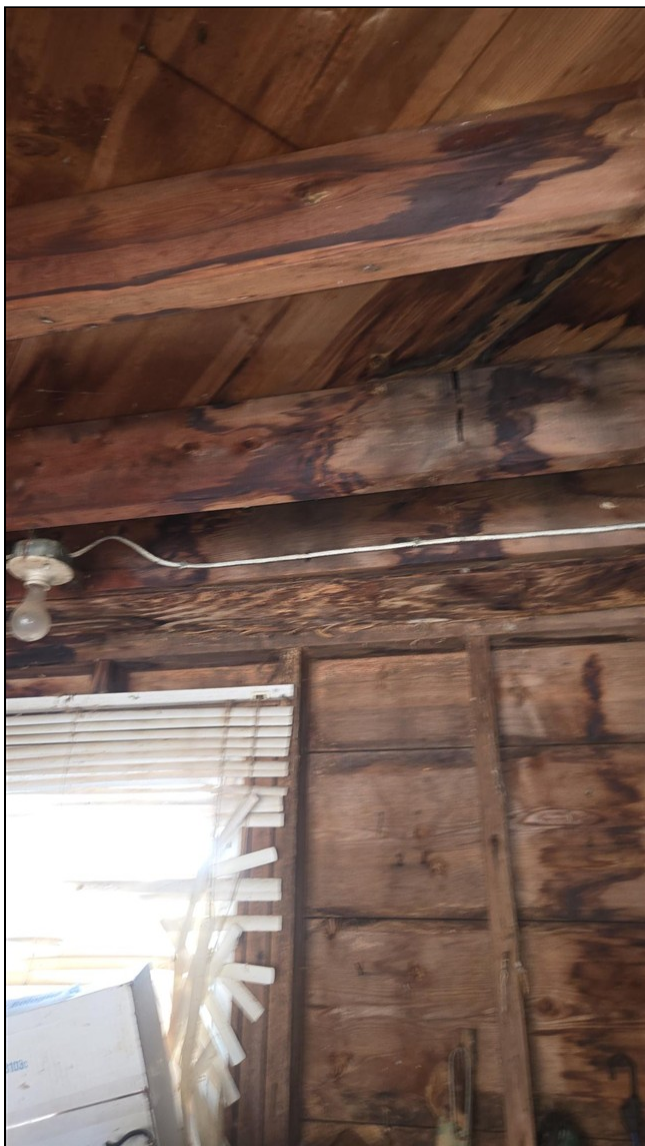
1.0 Item 2(Picture) There appeared to be active leaking and water damage in the area of the tree branches in the garage.

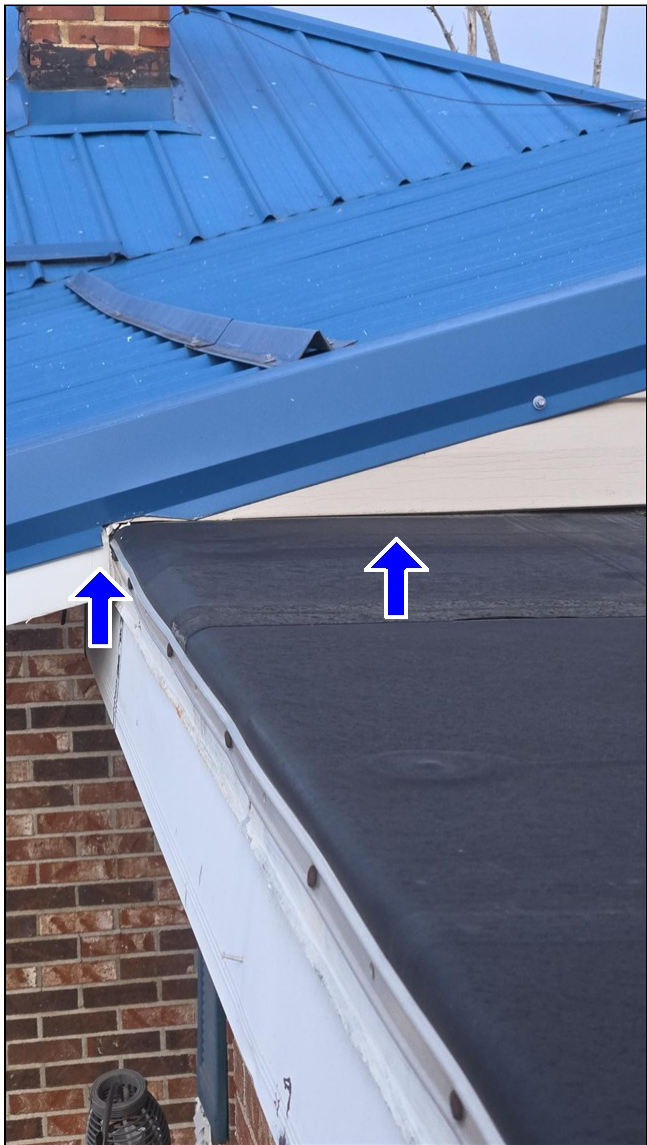
1.1 Item 1(Picture) The flashing on the roof between the flat roof and the house was missing and did not look appropriate. This is an unusual situation and it should be repaired by a qualified roofer. This situation may cause leaks and there may be hidden water damage in this area.

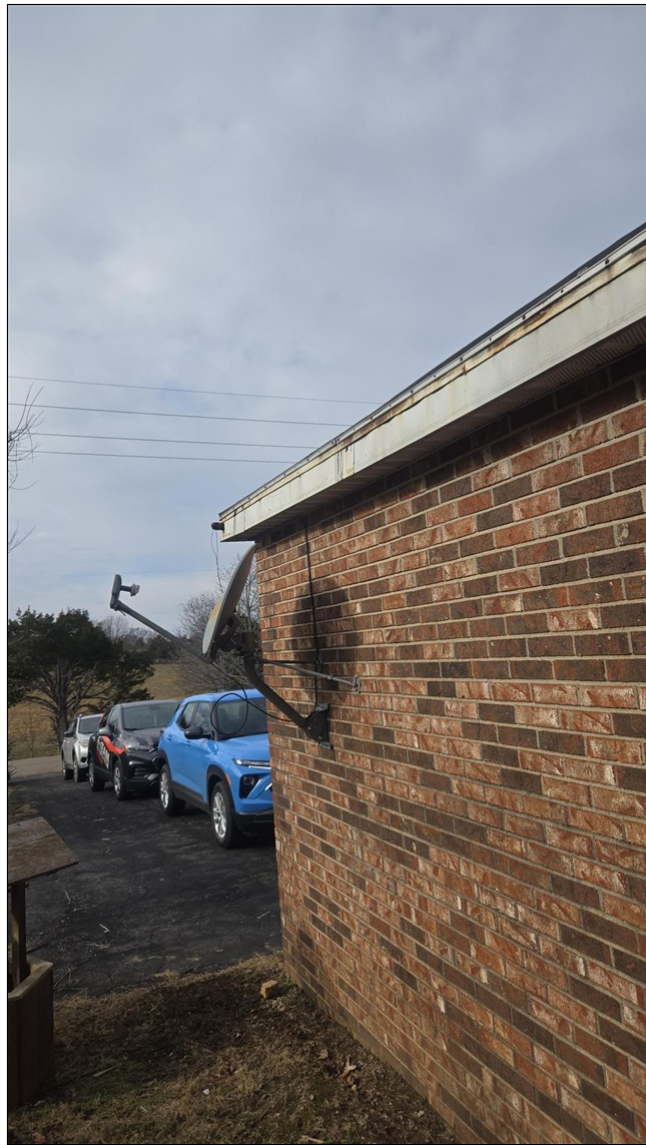
1.3 Item 2(Picture) The gutters were missing. The downspouts were missing. The downspout drains were missing. Some drains did not have an identifiable outlet. Gutters should be provided with down spouts and downspout drains that discharge to daylight at least 10' outside of the perimeter of the house. Water should never be allowed to pool, puddle, or run within 10' of the perimeter of the home. The roof was missing some guttering. All roofs should be provided with gutters, downspouts, and drains.

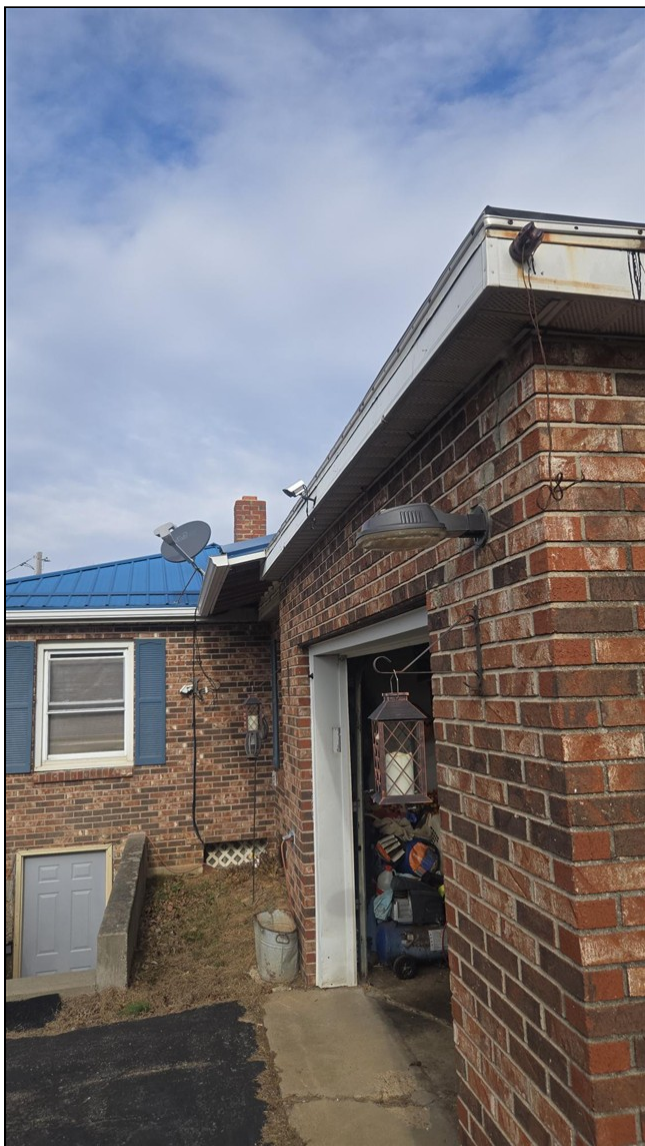
1.3 Item 3(Picture) The gutters were missing. The downspouts were missing. The downspout drains were missing. Some drains did not have an identifiable outlet. Gutters should be provided with down spouts and downspout drains that discharge to daylight at least 10' outside of the perimeter of the house. Water should never be allowed to pool, puddle, or run within 10' of the perimeter of the home. The roof was missing some guttering. All roofs should be provided with gutters, downspouts, and drains.

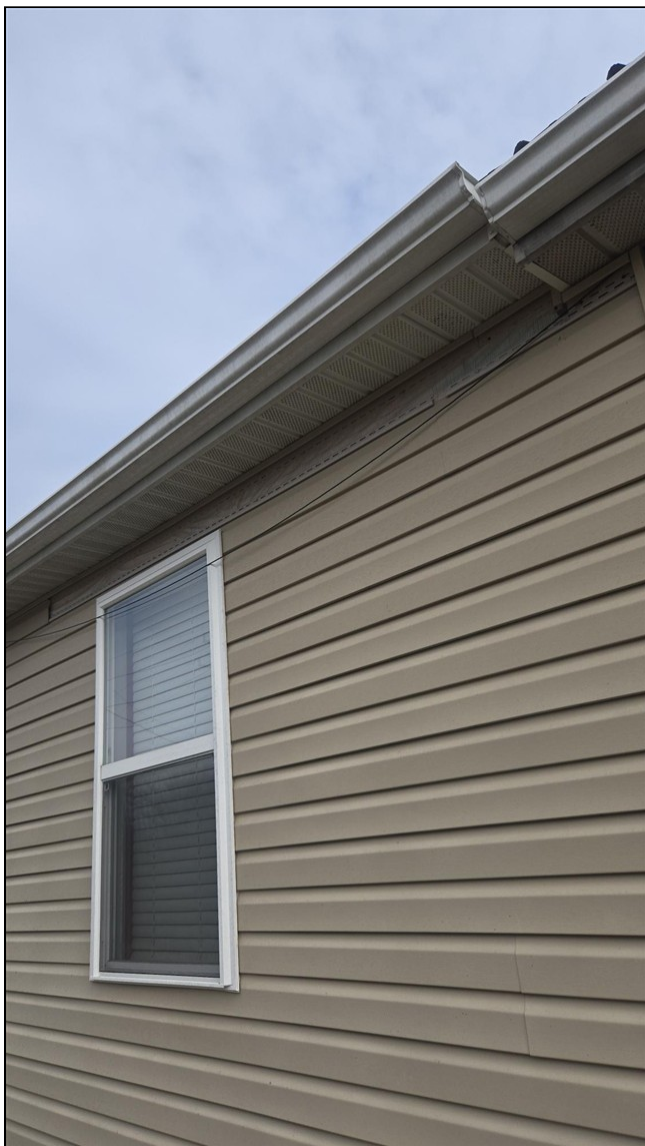
2.0 Item 3(Picture) There was missing siding noticed and the OSB exterior wall sheathing was not protected with a house wrap. The siding should be completely removed. The osb exterior walls should be provided with house wrap and the siding should be reinstalled.

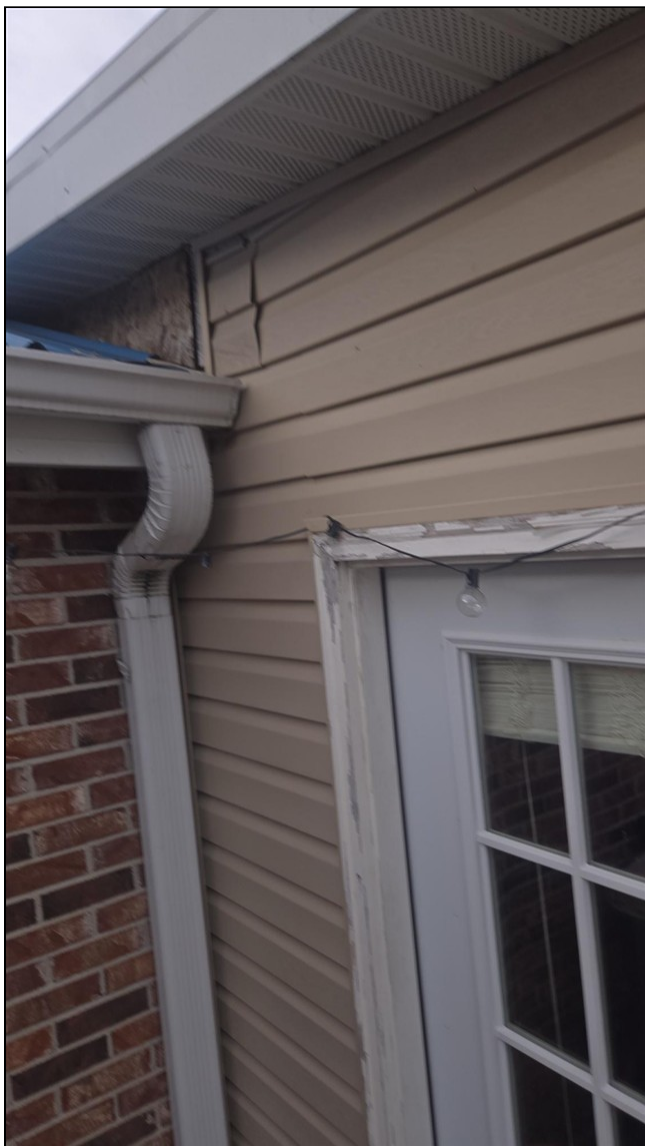
2.0 Item 5(Picture) There was missing siding noticed and the OSB exterior wall sheathing was not protected with a house wrap. The siding should be completely removed. The osb exterior walls should be provided with house wrap and the siding should be reinstalled.

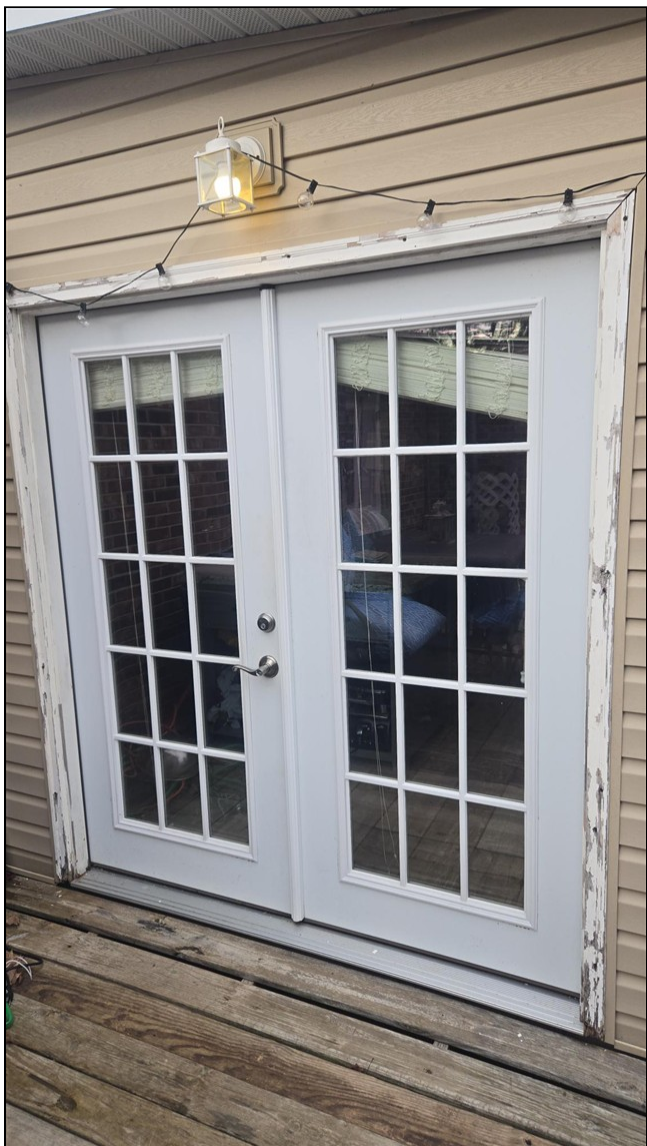
2.1 Item 5(Picture) There was bare wood and rotted wood noticed. There was exposed wood and metal. Exposed materials degrade faster than painted materials. A qualified contractor should repaint, stain, or seal any and all exposed materials. Painting of bare metal/wood is a minimum housing standard requirement.

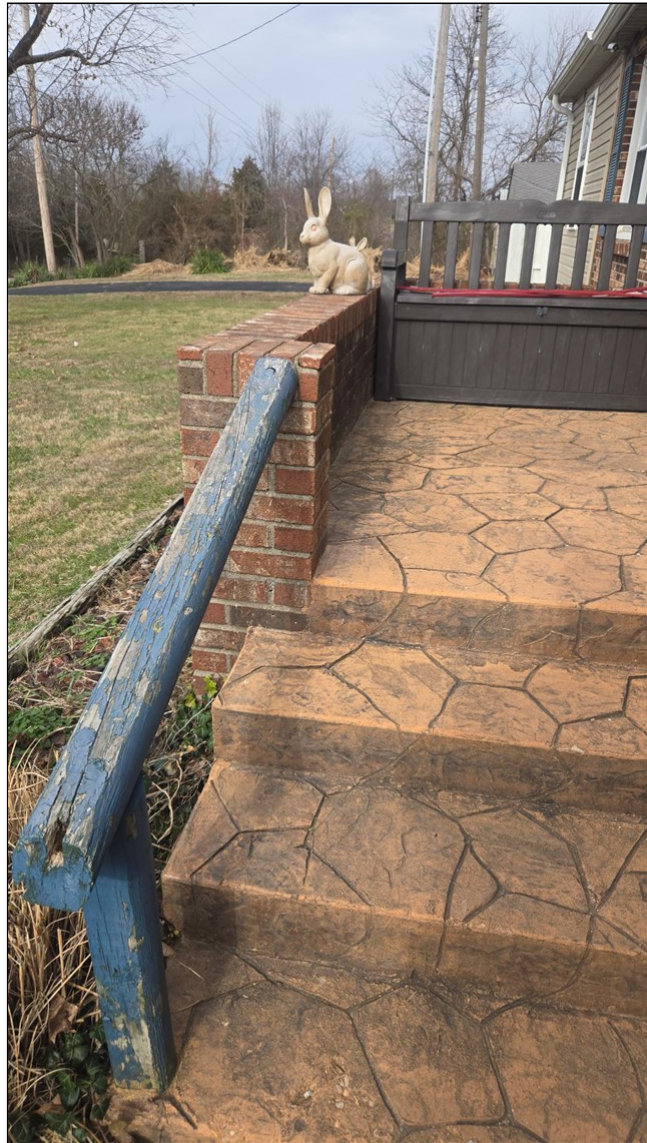
2.3 Item 2(Picture) There was bare wood and rotted wood noticed. There was exposed wood and metal. Exposed materials degrade faster than painted materials. A qualified contractor should repaint, stain, or seal any and all exposed materials. Painting of bare metal/wood is a minimum housing standard requirement.

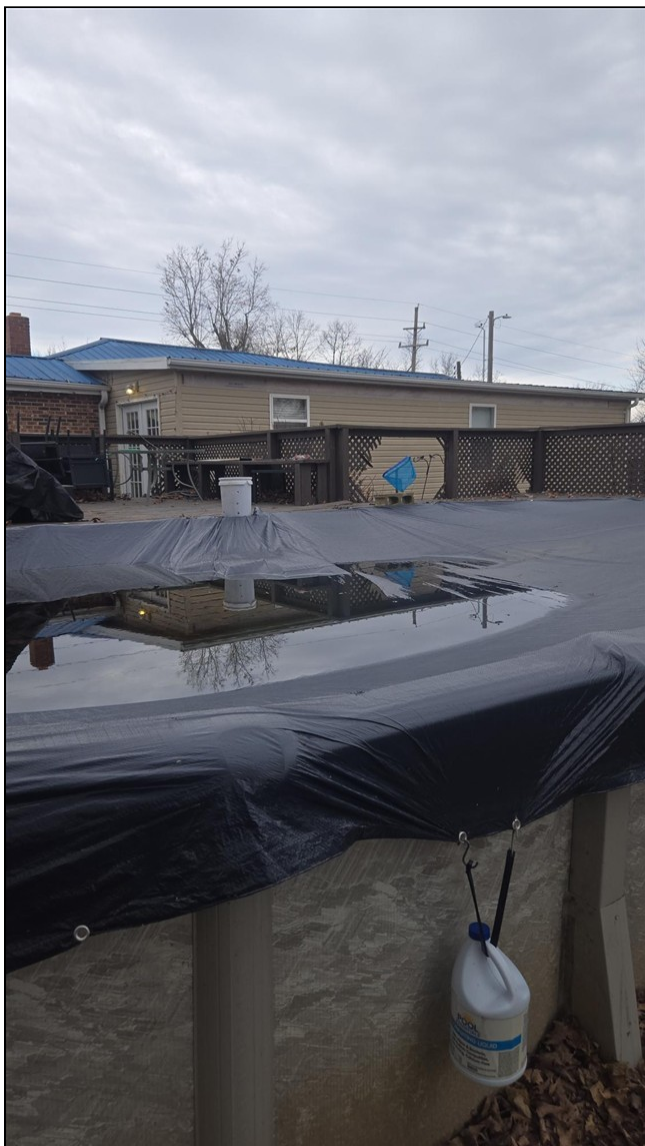
2.6 Item 1(Picture) This swimming pool is not safe and drowning may occur. Swimming Pools should be fully visible from the home. All swimming pools should have self closing and locking gates to prevent unapproved entry. A pool cover alarm should be installed. There should be two ladders to escape the pool. There should be depth markings and “no diving” markings. There should be visible and accessible life saving devices. This pool is a hazard and all safety hazards should be found and fixed by a qualified contractor. The pool was closed for winter and could not be fully inspected.

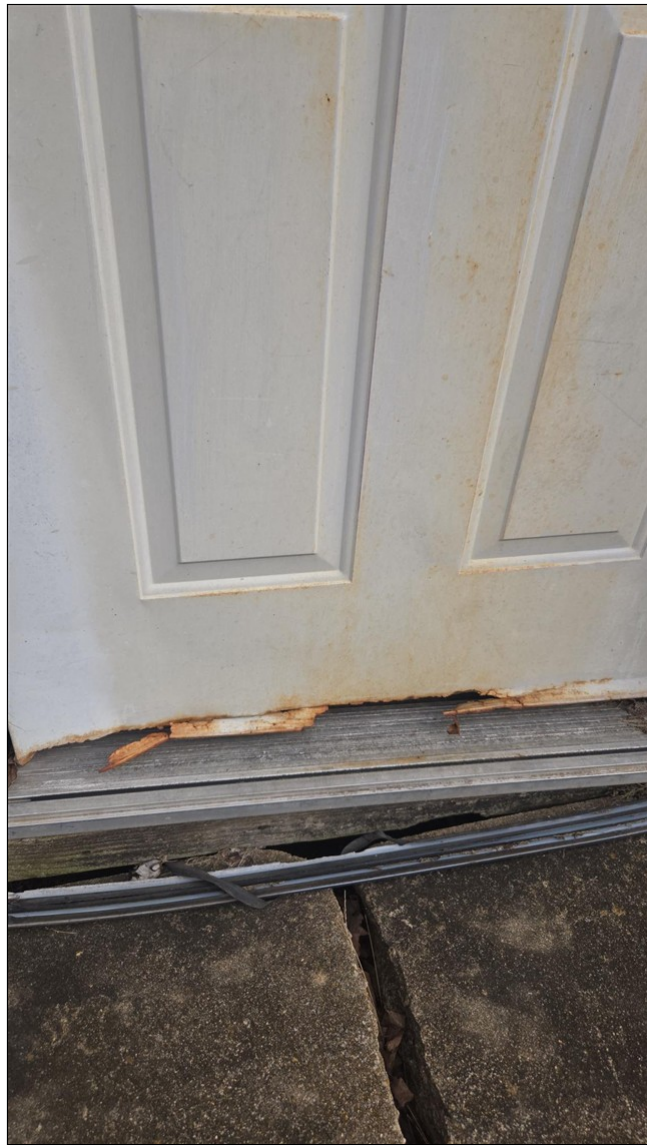
2.7 Item 2(Picture) Rusty door

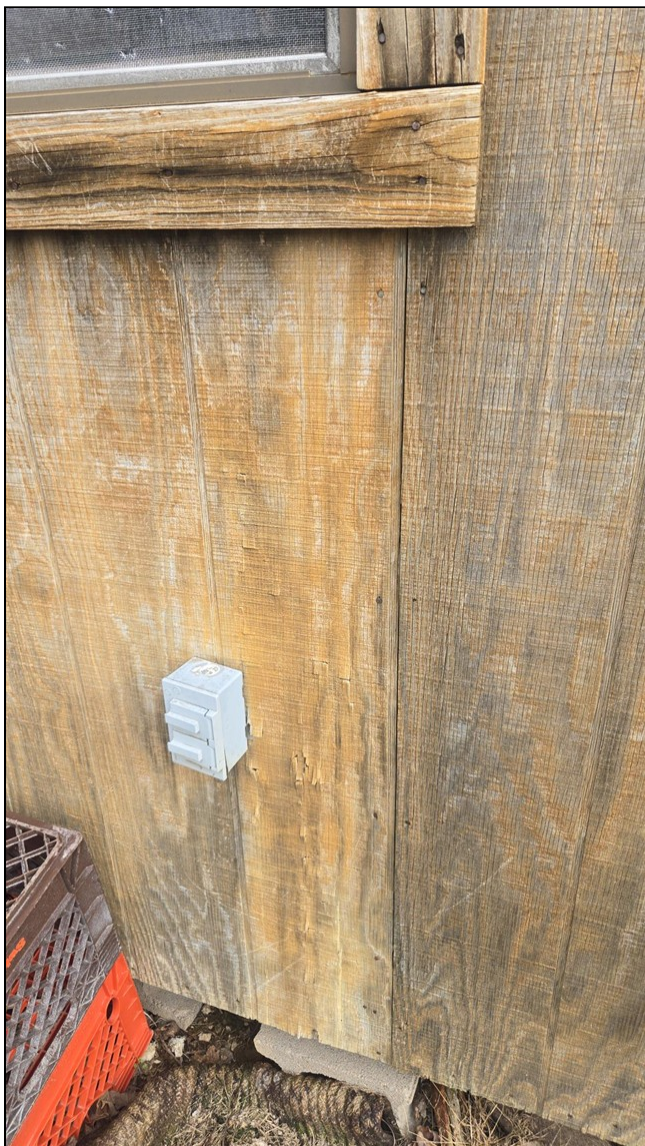
2.7 Item 3(Picture) Bare wood. Not GFCI protected. Outbuilding electrical systems do not meet National Electrical code guidelines. A licensed electrical contractor should bring all of the buildings and the pool area up to modern standards.

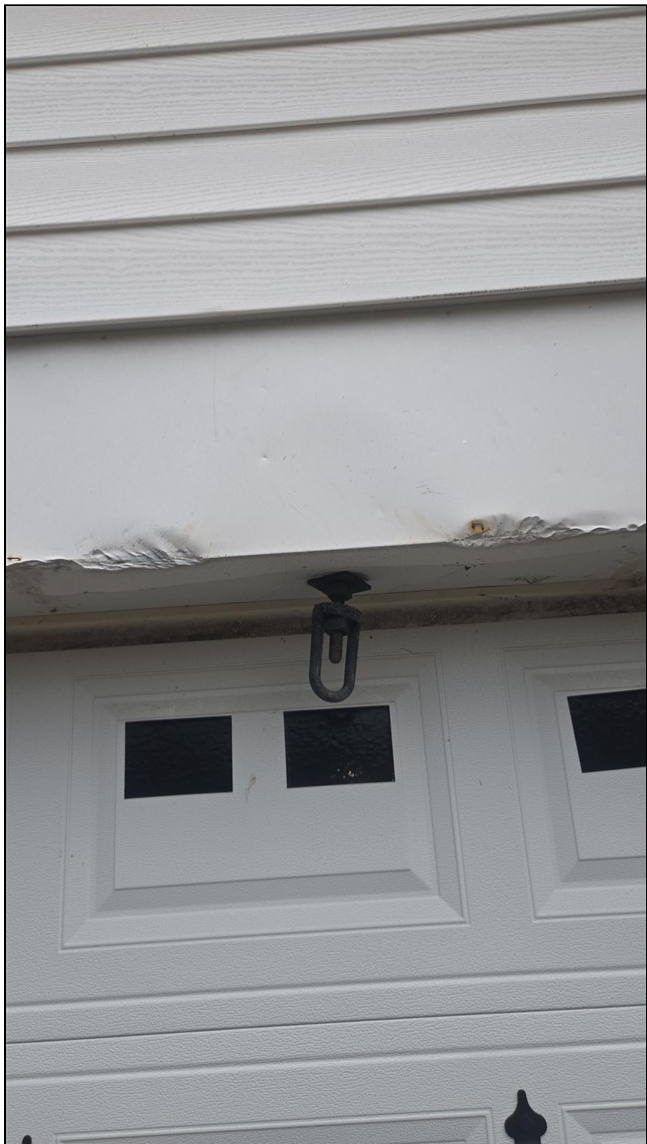
2.7 Item 9(Picture) Damaged outbuilding fascia.

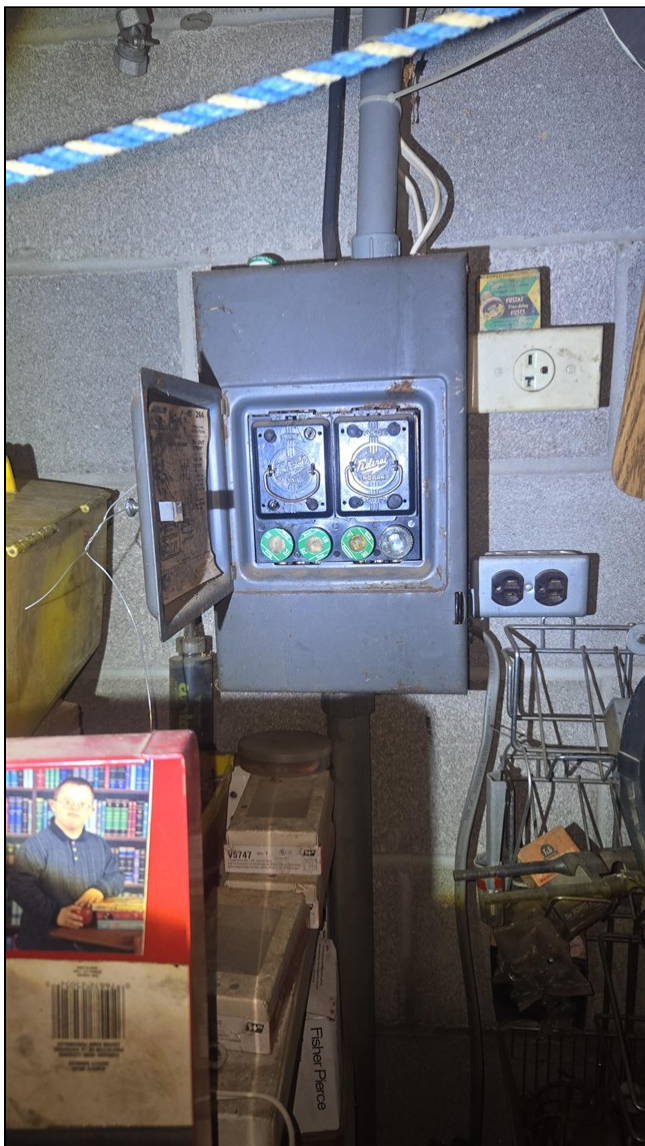
2.7 Item 11(Picture) Outbuilding electrical / fuse box - A qualified electrical contractor should find and fix any and all NEC defects.

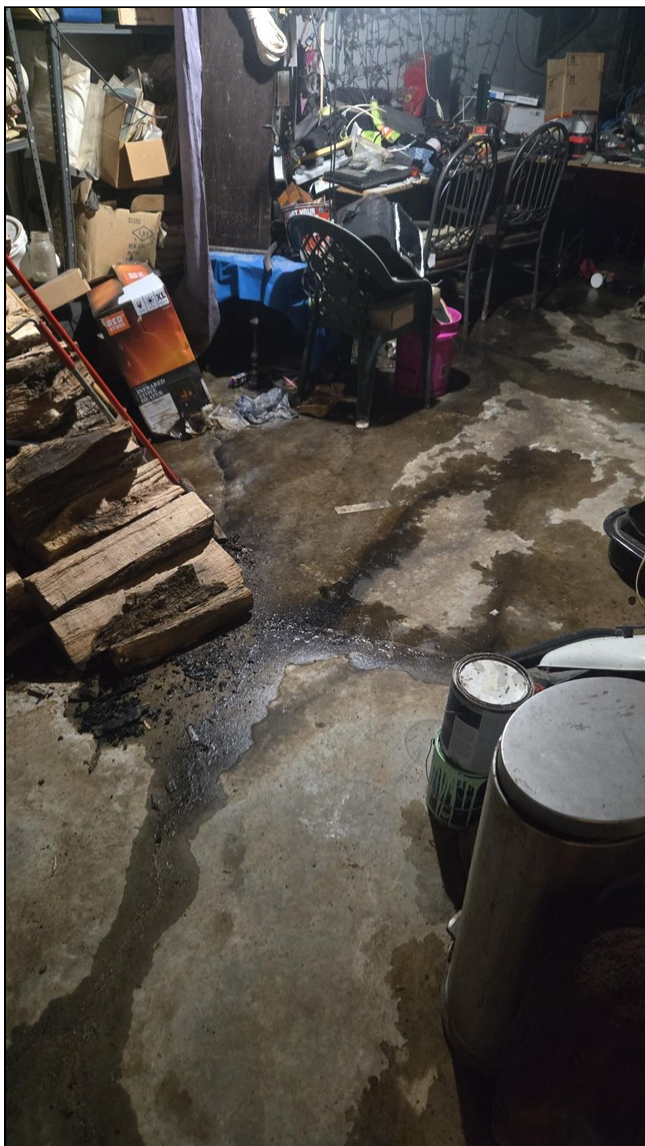
3.0 Item 3(Picture) The basement was wet at the time of the inspection. This appeared to be from hydrostatic pressure and may be due to a combination of circumstances. Based on the floor staining and the seller's description of the septic tank lid as metal, I suspect that most of this water is from a failed septic tank that is leaking near the foundation of the home and putting hydrostatic pressure on the concrete. Additional factors that may be contributing to this condition include improper downspout drainage and surface drainage around the home. I recommend that the septic tank is completely replaced and that the downspouts are installed into separate downspout drains that drain to daylight near the road ditch. Hydrostatic pressure may cause catastrophic damage to the foundation and this situation should be repaired as soon as practical.

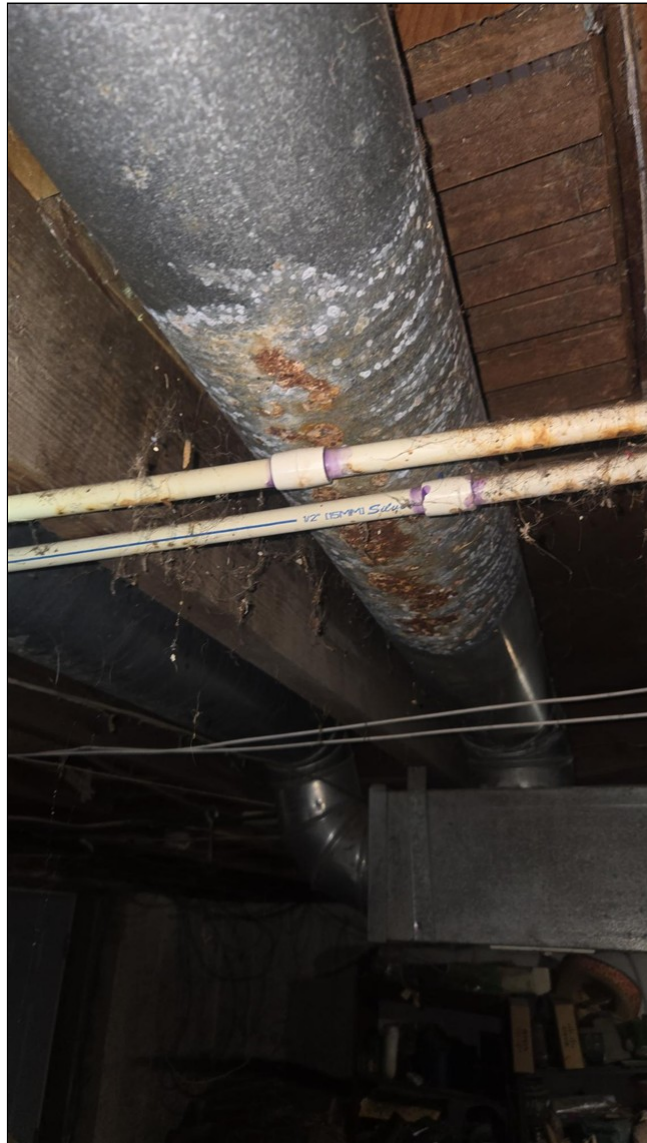
4.3 Item 2(Picture) The ducts were sweating. Ducts sweat whenever moisture vapor condenses on the duct due to temperature and humidity. Installing a return air vent in this area and/or adding insulation may help limit the condensation. A qualified HVAC contractor should repair the sweating ducts.

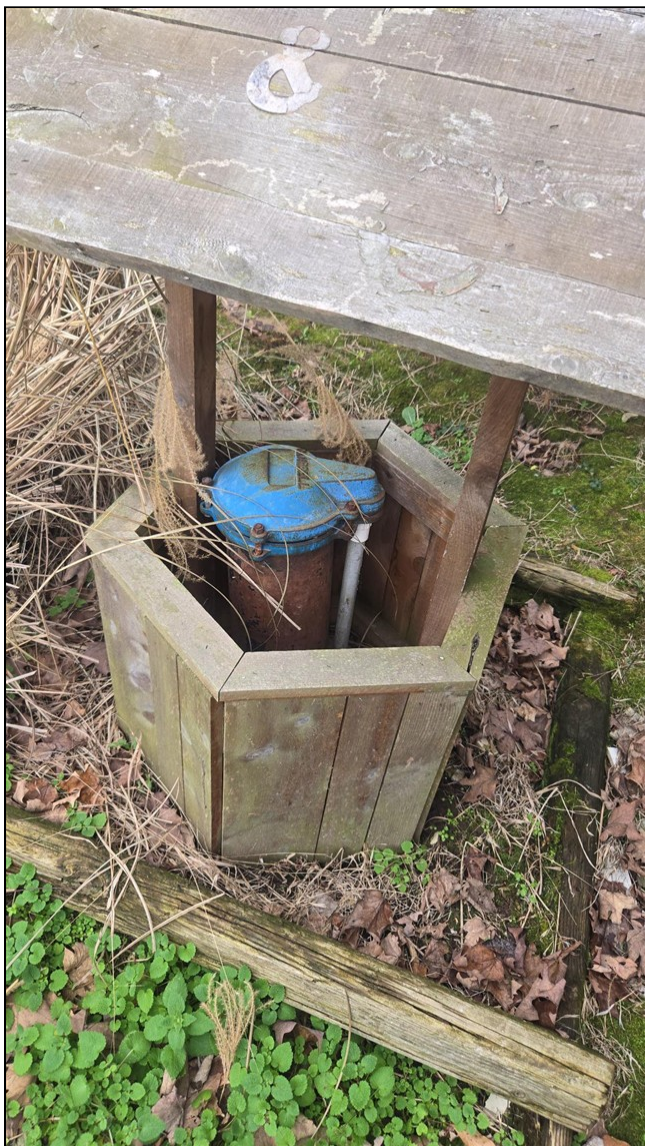
5.1 Item 5(Picture) The well should be inspected and a MO Bacteriological water sample should be taken and test results should be reviewed by the Buyer prior to closing.

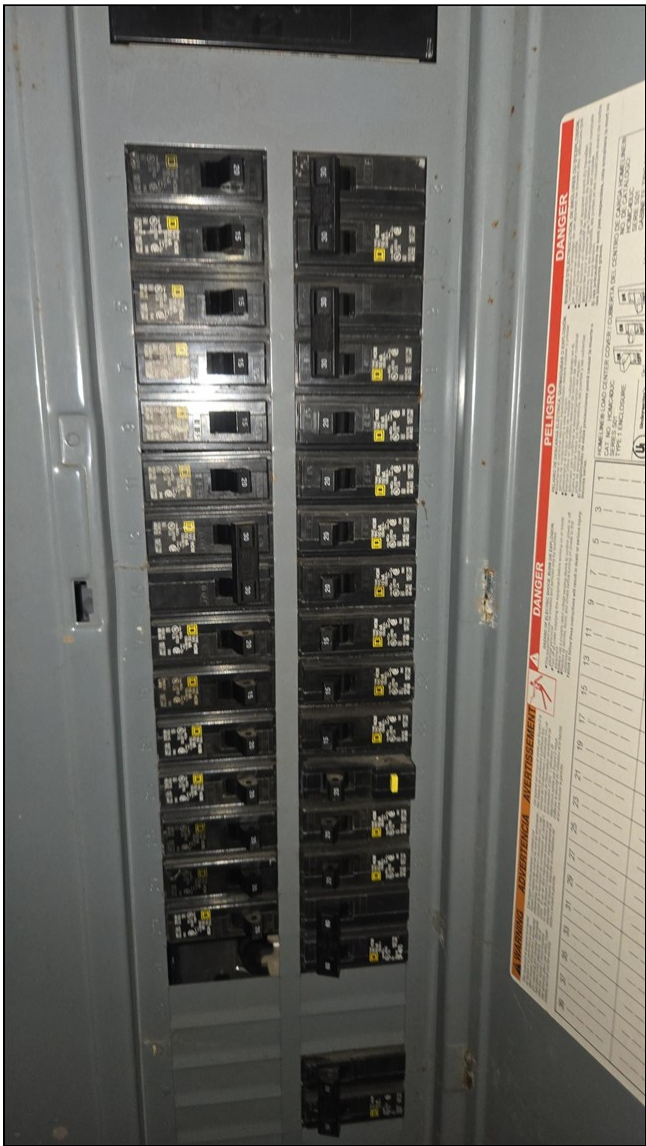
6.1 Item 5(Picture) A qualified electrical contractor should find and fix any and all National Electrical Code deficiencies.

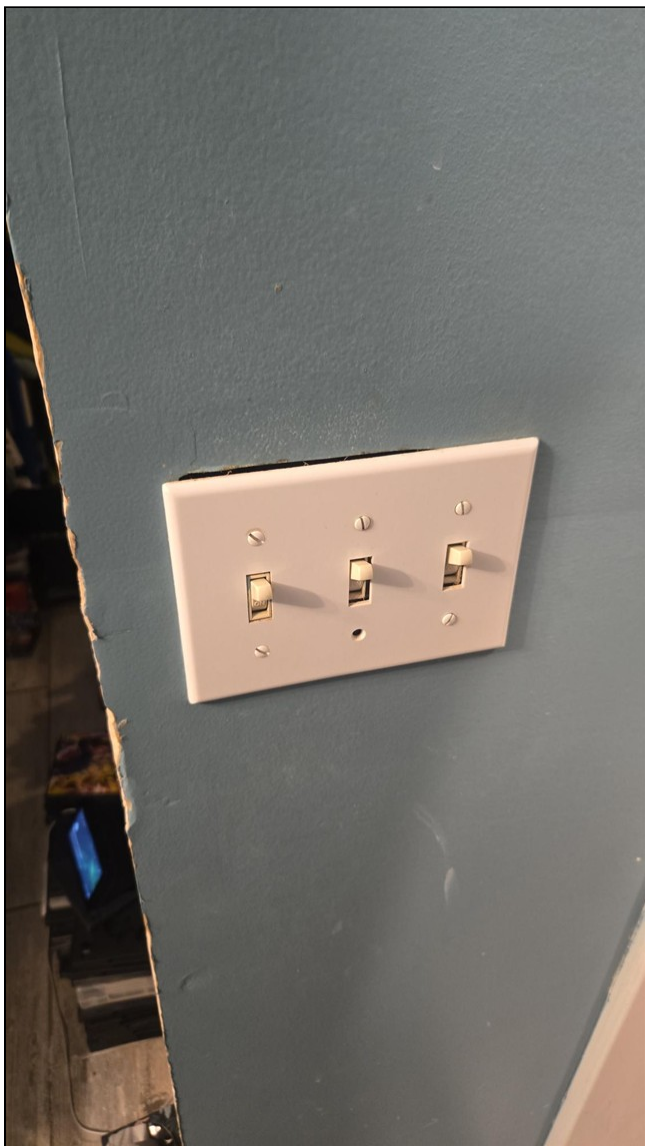
6.3 Item 5(Picture) A qualified electrical contractor should find and fix any and all National Electrical Code deficiencies. Missing screws, cracked covers, covers loose or protruding from the wall.

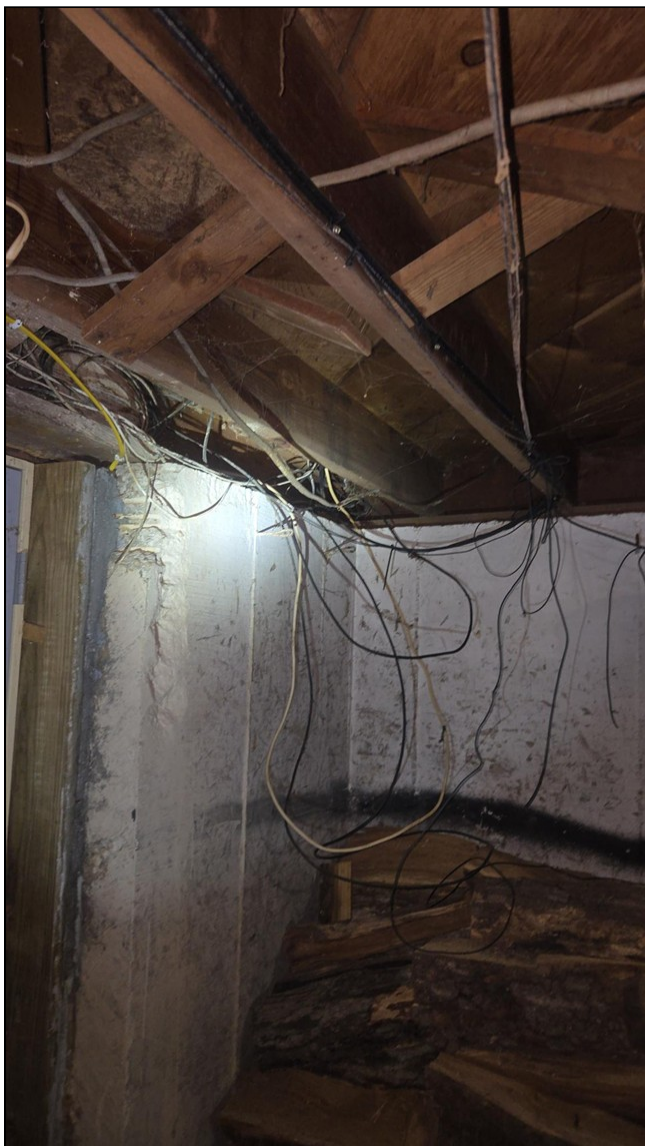
6.3 Item 7(Picture) A qualified electrical contractor should find and fix any and all National Electrical Code deficiencies. Loose wires

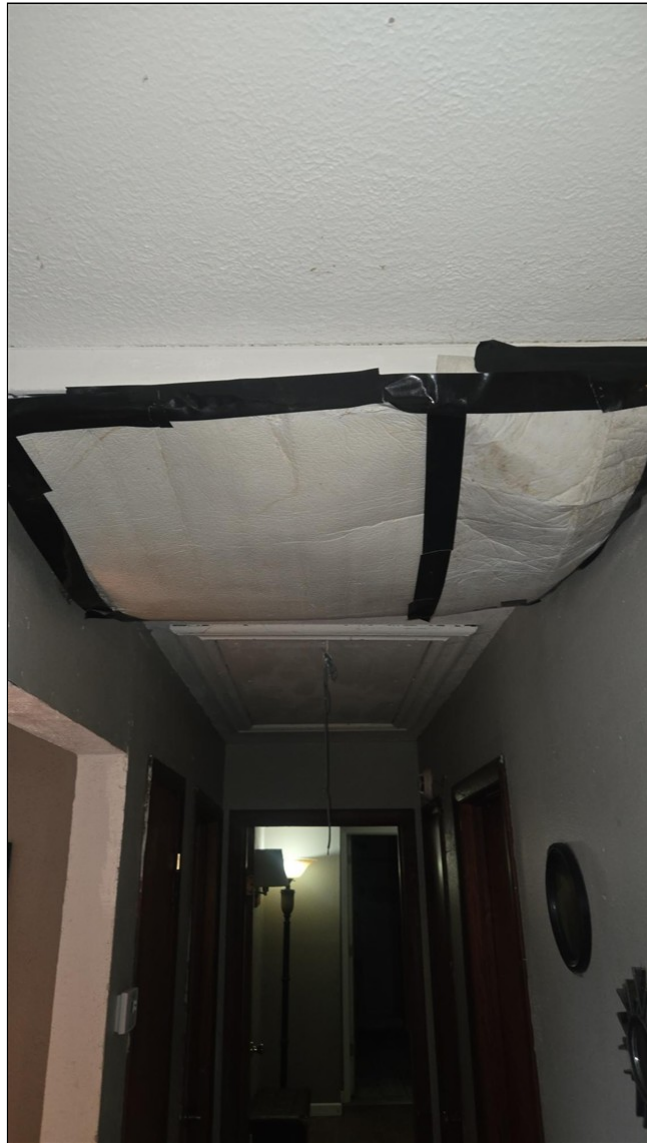
7.0 Item 2(Picture) The attic fan should be deleted and an attic access should be established here. InterNACHI recommends that attic fans are deleted, because overall they are less energy efficient than HVAC.

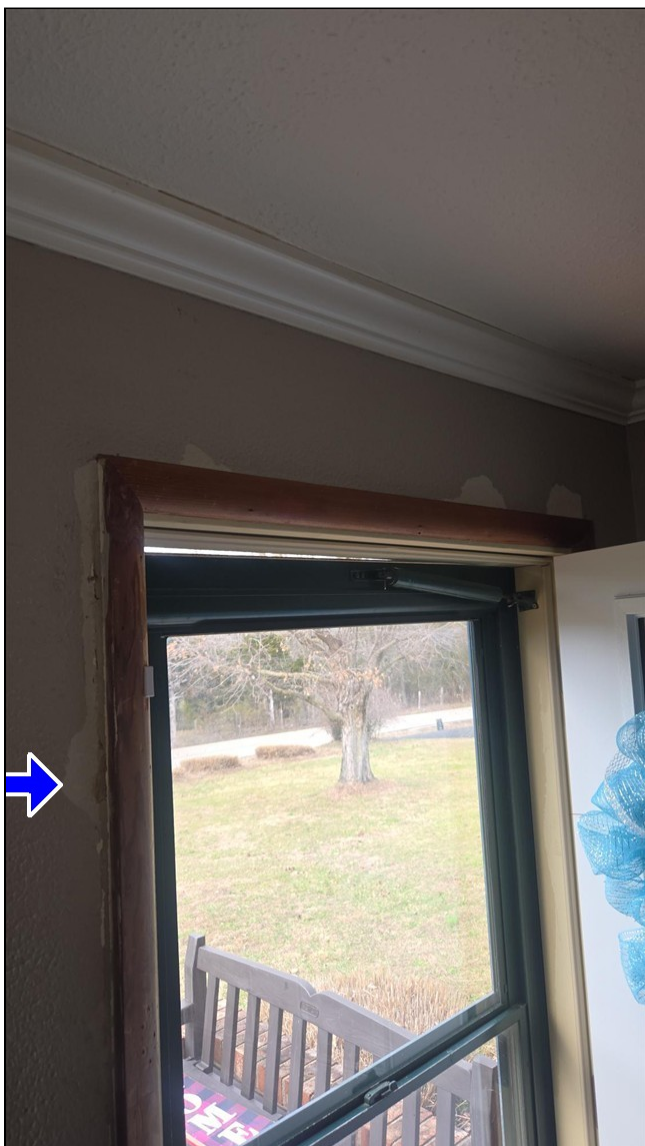
7.1 Item 1(Picture) There were some scuffs, scrapes, cracks, and inconsistent texture noticed throughout the house.

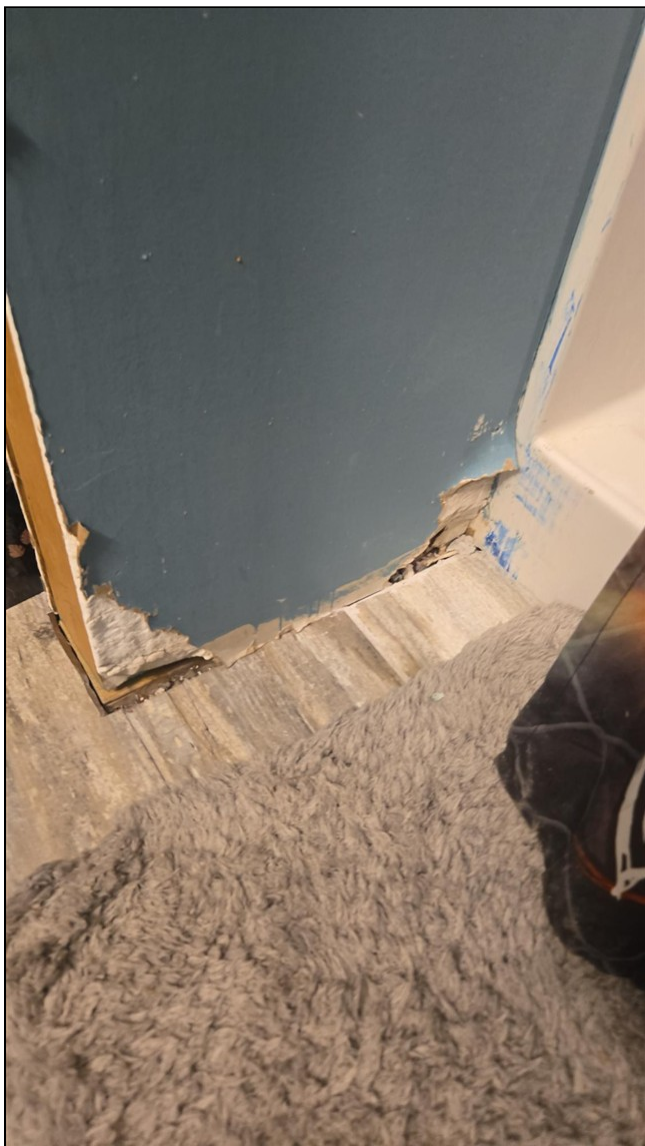
7.1 Item 3(Picture) There were drywall repairs required.

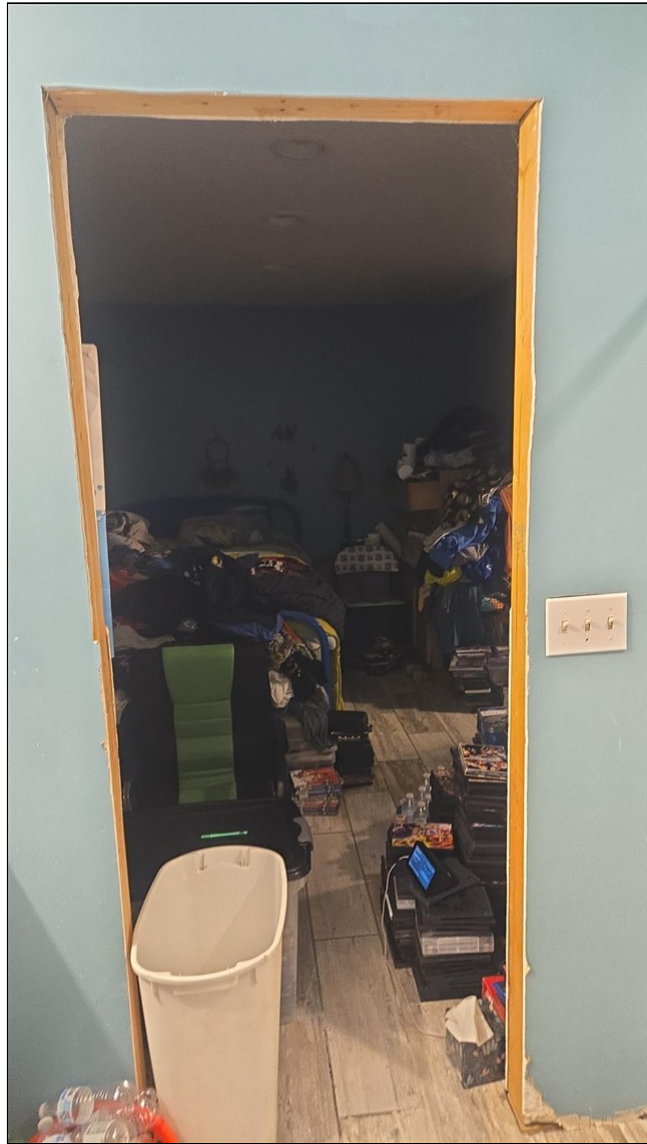
7.5 Item 6(Picture) Cracked door

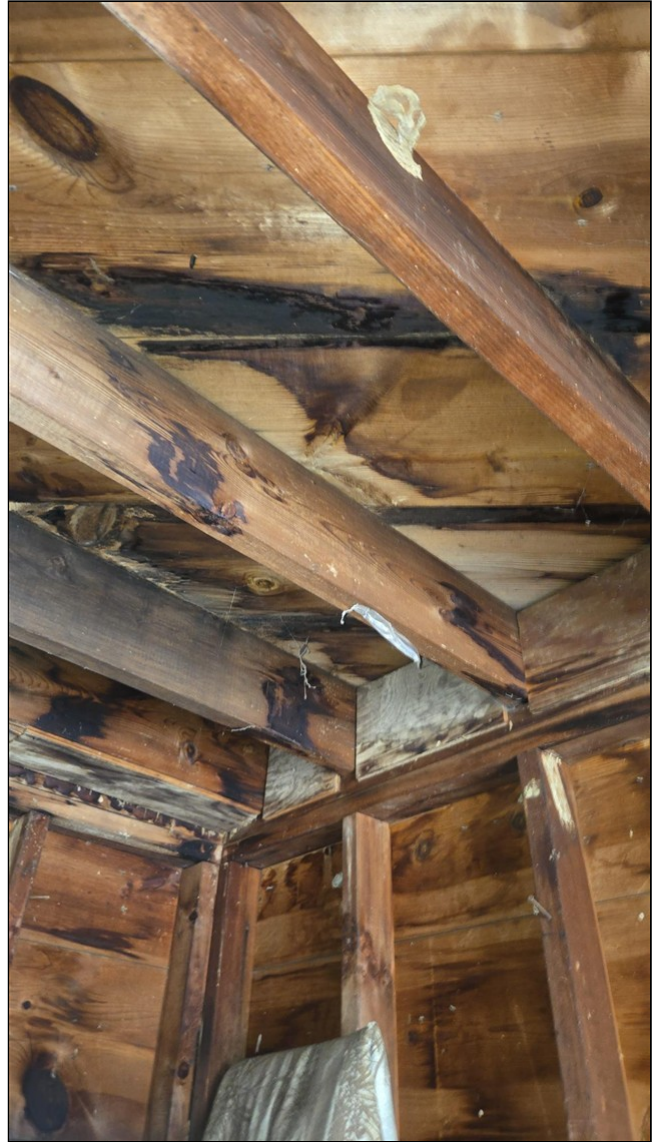
1.0 Item 2(Picture) There appeared to be active leaking and water damage in the area of the tree branches in the garage.

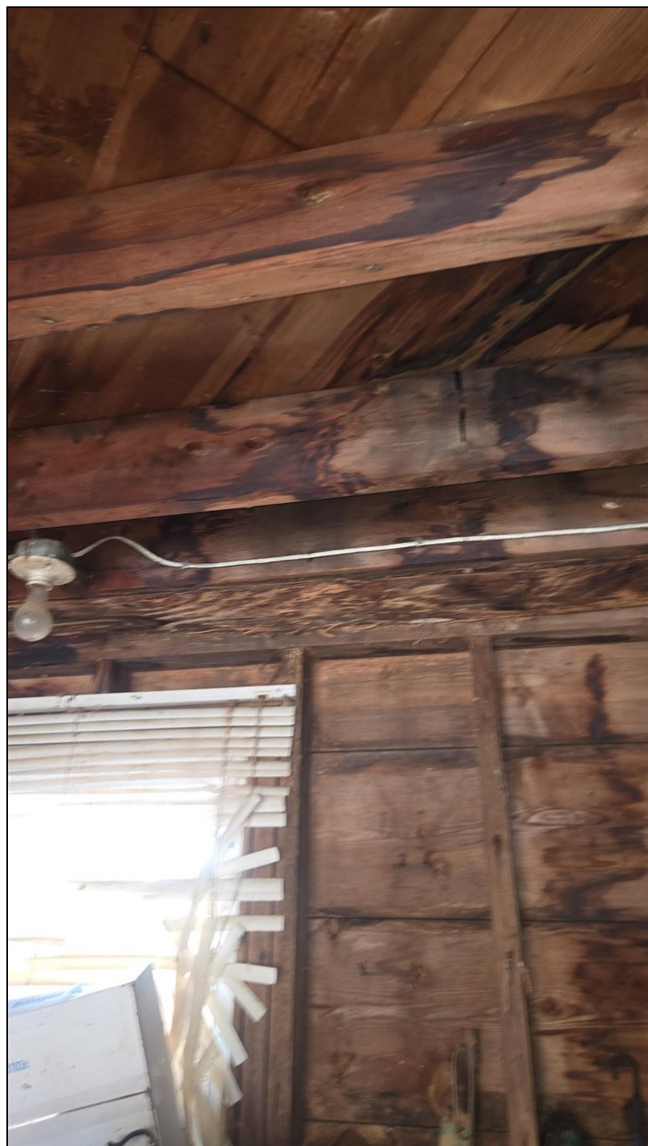
1.0 Item 3(Picture) There appeared to be active leaking and water damage in the area of the tree branches in the garage. There was some rotted wood noticed in the garage. A qualified roofing contractor should repair the roof.

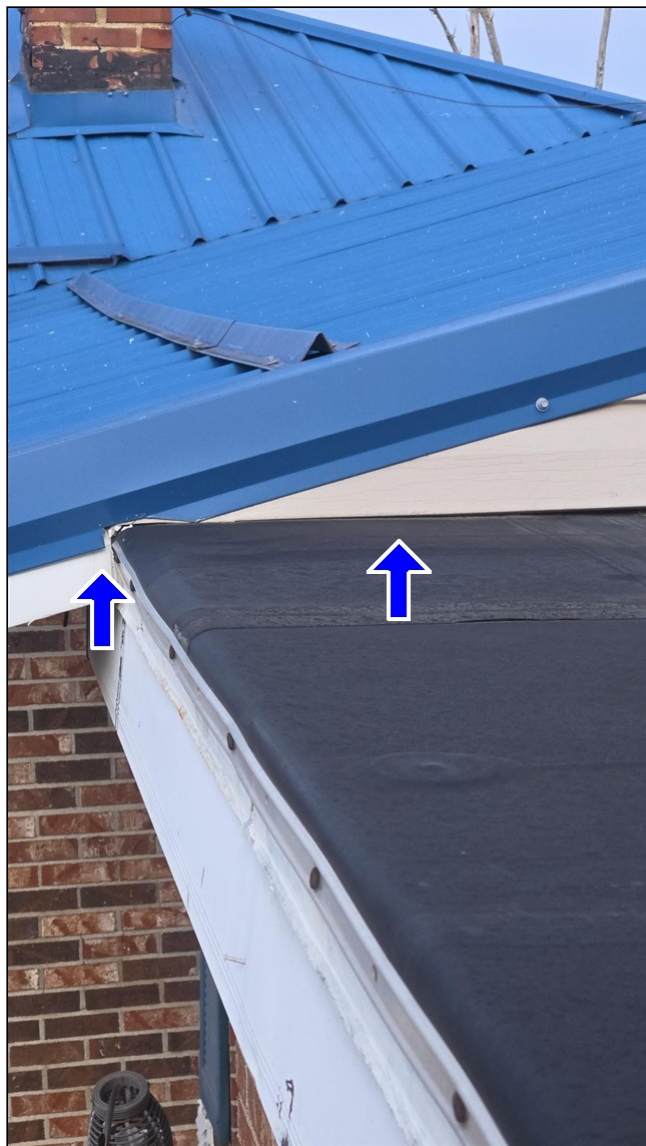
1.1 Item 1(Picture) The flashing on the roof between the flat roof and the house was missing and did not look appropriate. This is an unusual situation and it should be repaired by a qualified roofer. This situation may cause leaks and there may be hidden water damage in this area.

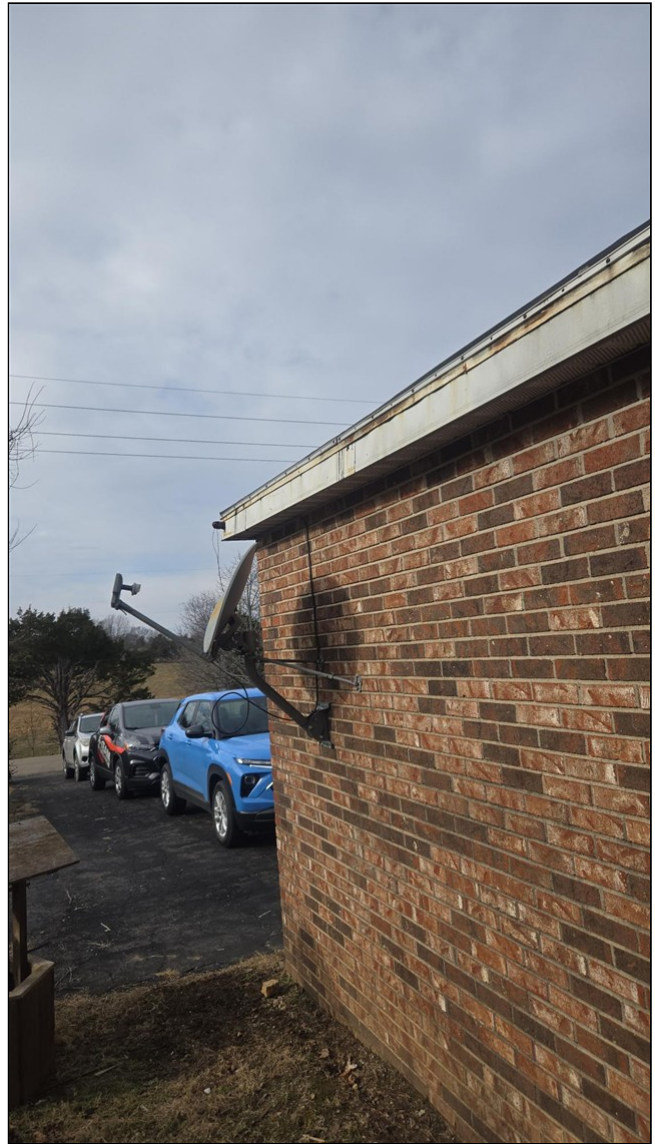
1.3 Item 2(Picture) The gutters were missing. The downspouts were missing. The downspout drains were missing. Some drains did not have an identifiable outlet. Gutters should be provided with down spouts and downspout drains that discharge to daylight at least 10' outside of the perimeter of the house. Water should never be allowed to pool, puddle, or run within 10' of the perimeter of the home. The roof was missing some guttering. All roofs should be provided with gutters, downspouts, and drains.

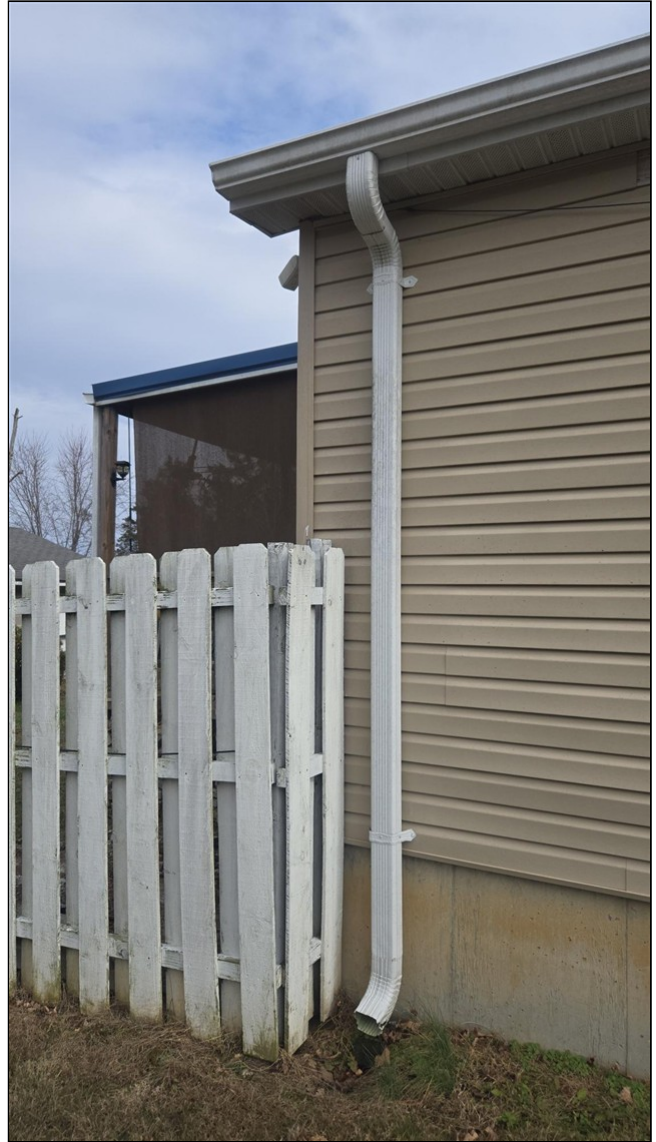
1.3 Item 4(Picture) This basement was actively wet. Improving the surface drainage and downspout drains around the house will increase the likelihood of a dry basement. The basement was dry at the time of the inspection. InterNACHI estimates that over 80% of wet basement issues are from water that is within 10' of the perimeter of the house.
