Inspection Report

4700 Turley Mill Rd, Farmington, MO 63640, USA

A-Team Consulting and Contracting

Date: 1/2/2025	Time:	Report ID: 2025010202
Property: Address	Customer: NAME	Real Estate Professional:

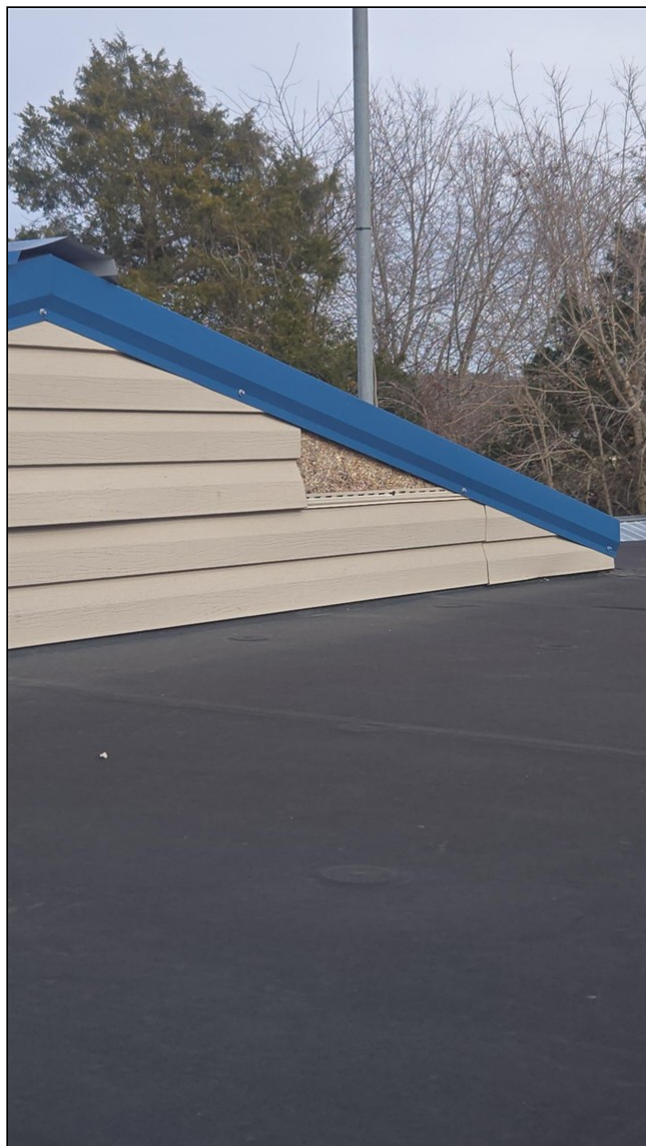
2.0 Item 1(Picture) There was missing siding noticed and the OSB exterior wall sheathing was not protected with a house wrap. The siding should be completely removed. The osb exterior walls should be provided with house wrap and the siding should be reinstalled.

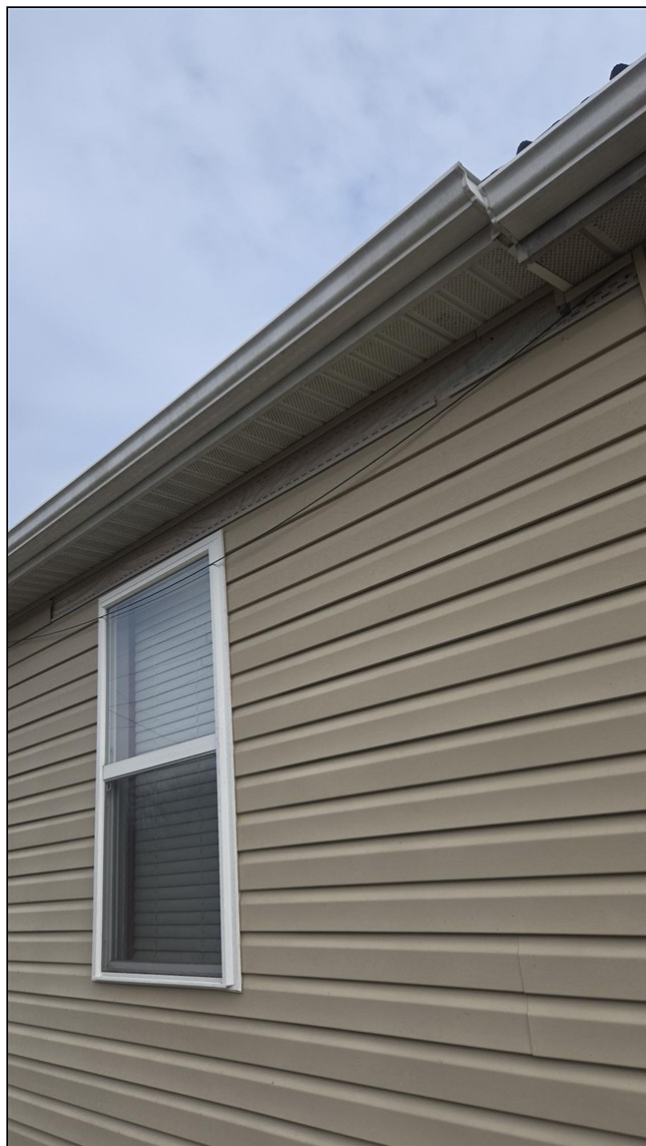
2.0 Item 3(Picture) There was missing siding noticed and the OSB exterior wall sheathing was not protected with a house wrap. The siding should be completely removed. The osb exterior walls should be provided with house wrap and the siding should be reinstalled.

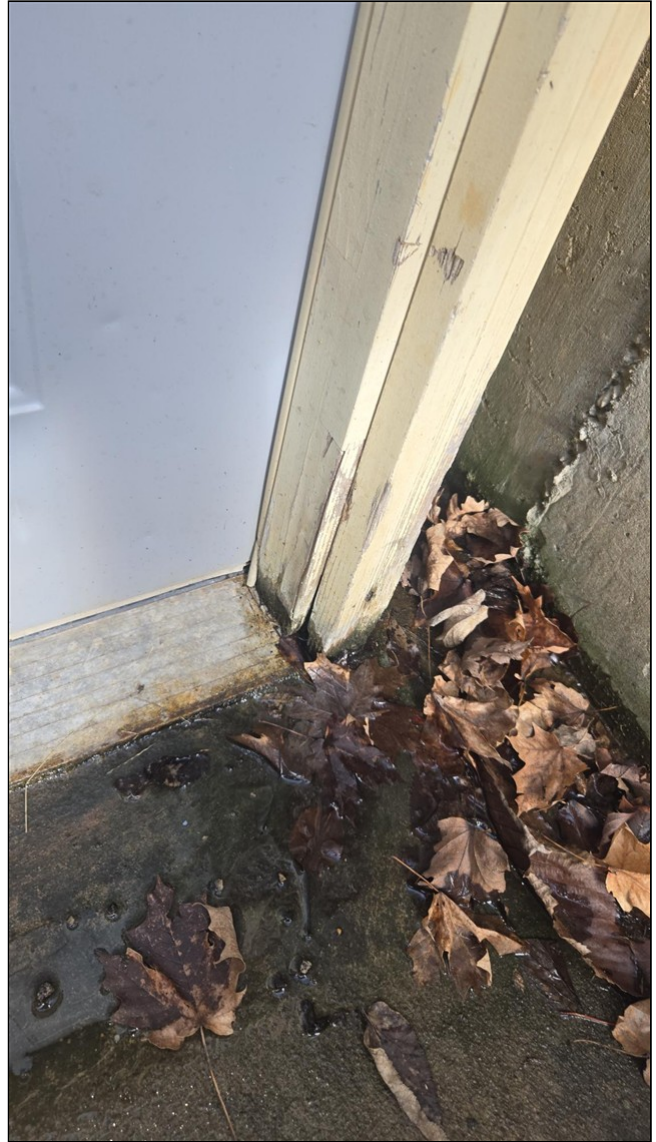
2.1 Item 2(Picture) There was bare wood and rotted wood noticed. There was exposed wood and metal. Exposed materials degrade faster than painted materials. A qualified contractor should repaint, stain, or seal any and all exposed materials. Painting of bare metal/wood is a minimum housing standard requirement.

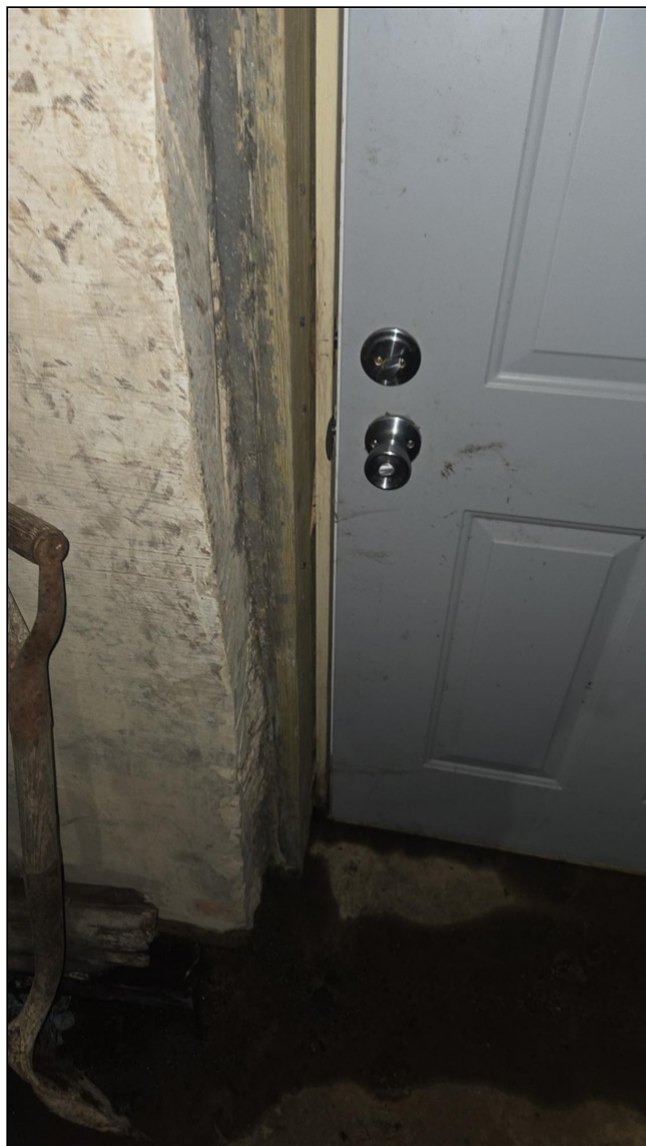
2.1 Item 3(Picture) Bolt doesn't lock on basement door. The basement door required repair.

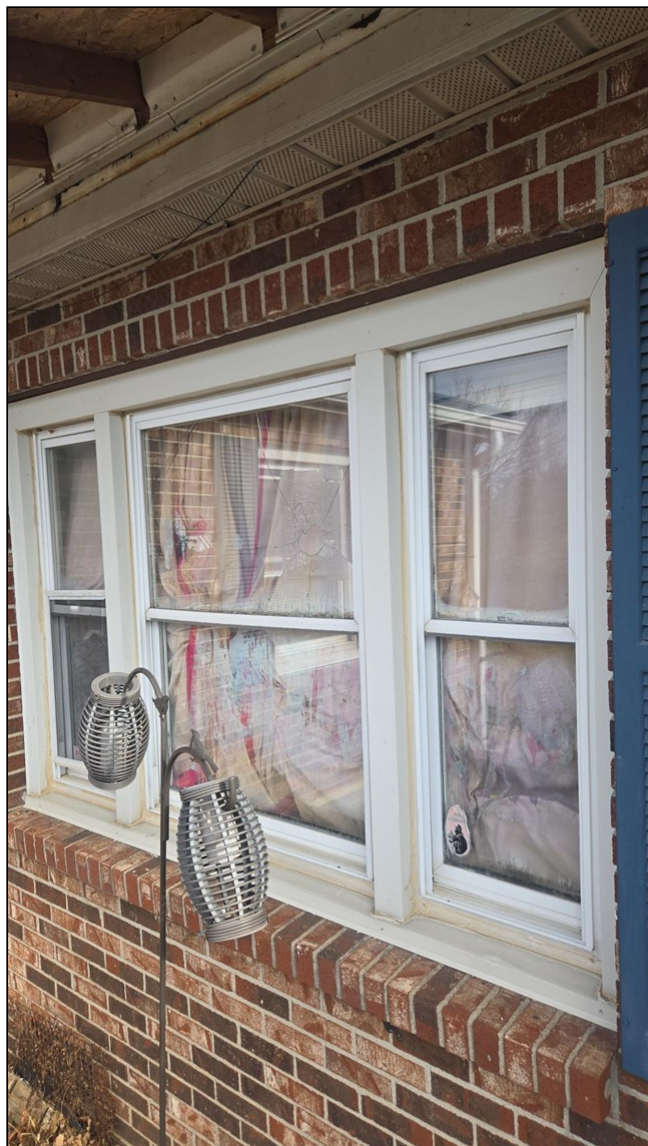
2.2 Item 1(Picture) Broken window - There was at least one broken window; any and all broken windows should be found and replaced by a qualified contractor. Minimum housing standards require all windows to be whole; exterior windows should open, close, latch, and lock. A qualified contractor should find and fix any and all broken or damaged windows.

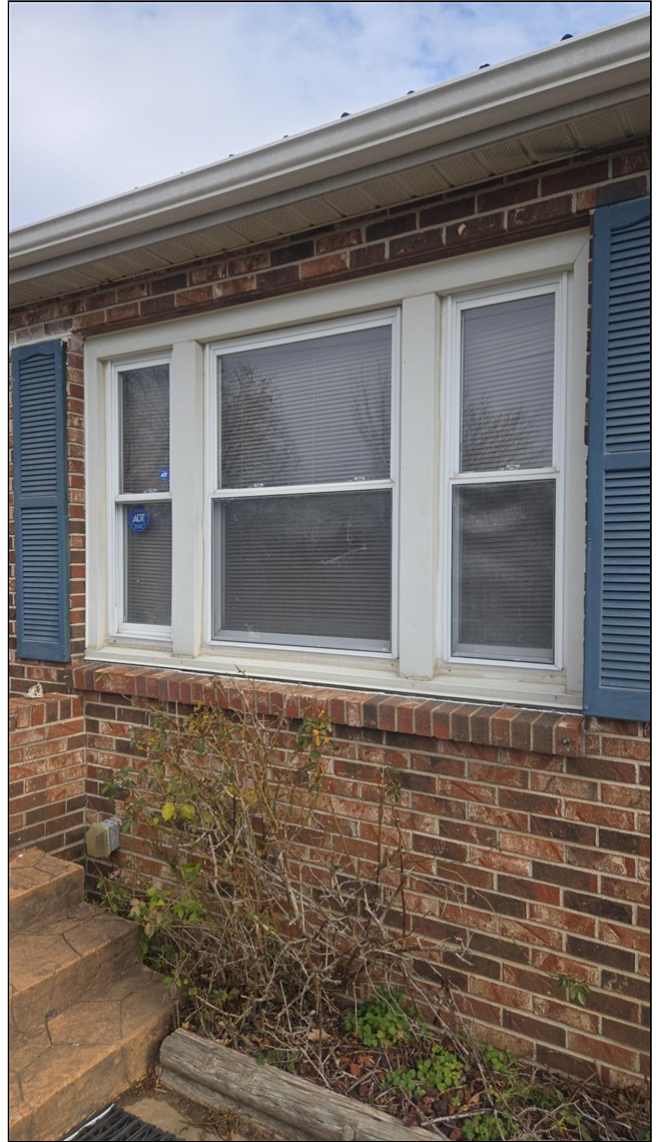
2.2 Item 4(Picture) Broken thermal seals - Dirty windows may appear to be windows with broken thermal panes. Broken thermal seals present as sometimes milky residue between the panes of glass and or condensation in between the thermal panes. Broken thermal seals allow moisture vapor to enter the window between the thermal panes and make the window less efficient from a thermal energy perspective. The windows should be cleaned; any and all broken thermal seals should be found and fixed by a qualified contractor.

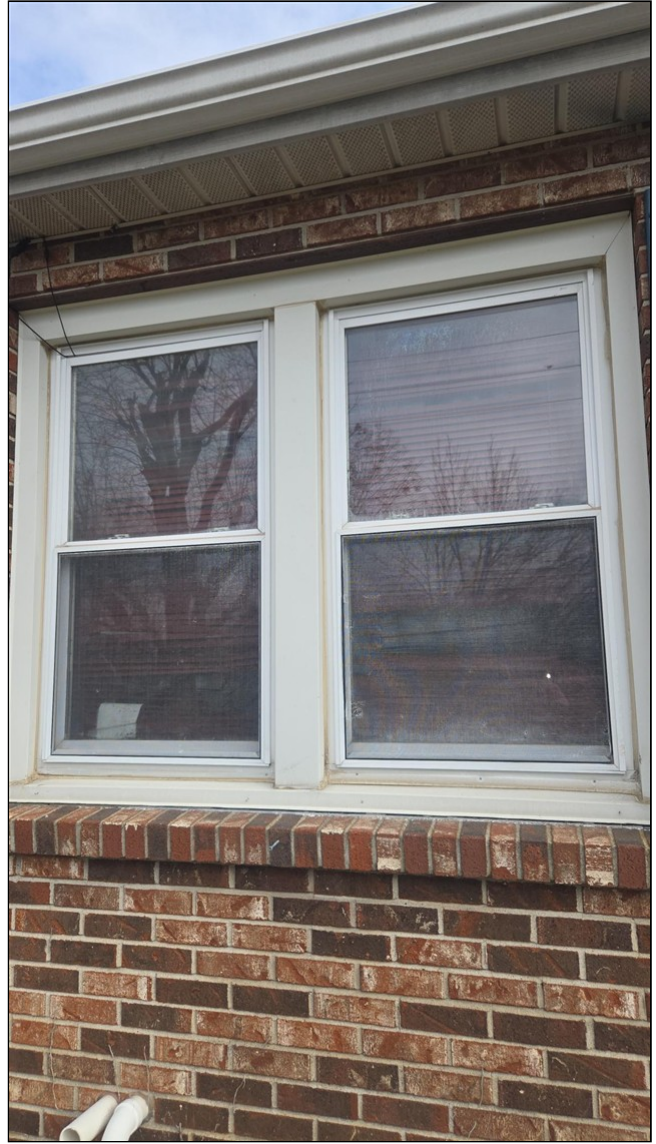
2.2 Item 6(Picture) Dirty windows may appear to be windows with broken thermal panes. Broken thermal seals present as sometimes milky residue between the panes of glass and or condensation in between the thermal panes. Broken thermal seals allow moisture vapor to enter the window between the thermal panes and make the window less efficient from a thermal energy perspective. The windows should be cleaned; any and all broken thermal seals should be found and fixed by a qualified contractor.

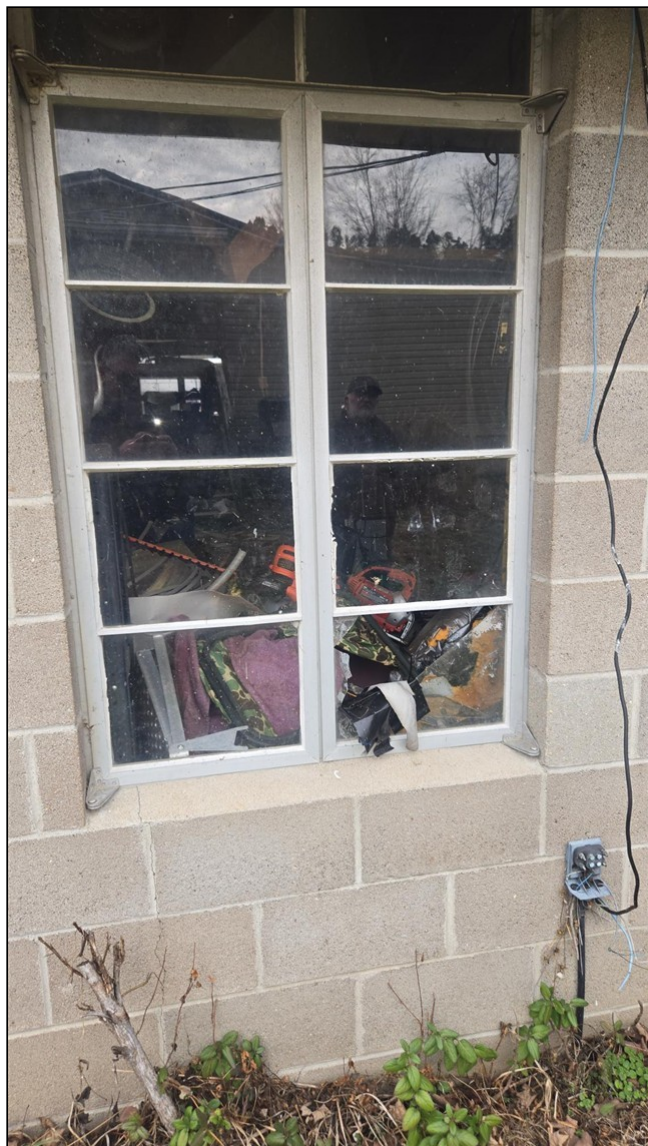
2.2 Item 7(Picture) Broken window on outbuilding.

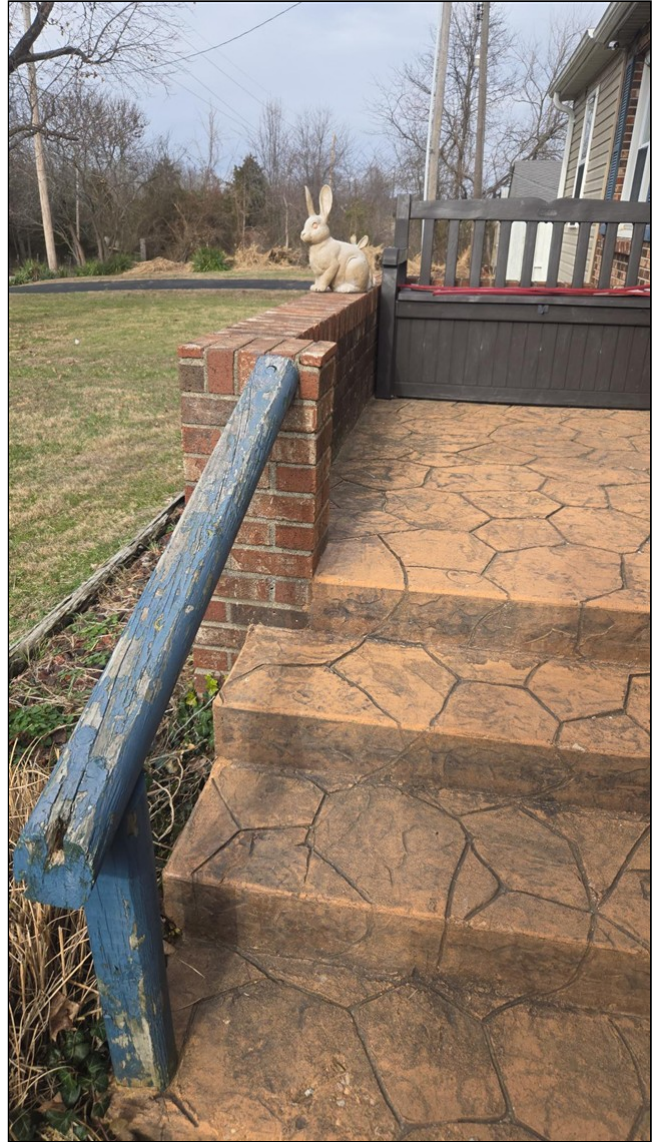
2.3 Item 2(Picture) There was bare wood and rotted wood noticed. There was exposed wood and metal. Exposed materials degrade faster than painted materials. A qualified contractor should repaint, stain, or seal any and all exposed materials. Painting of bare metal/wood is a minimum housing standard requirement.

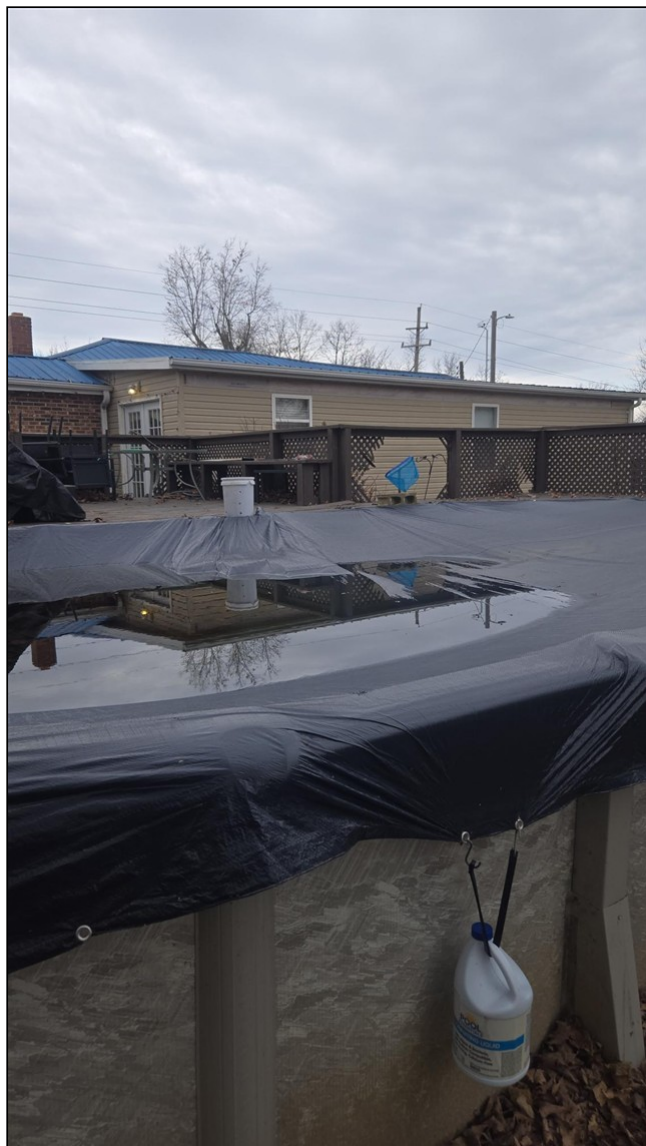
2.6 Item 1(Picture) This swimming pool is not safe and drowning may occur. Swimming Pools should be fully visible from the home. All swimming pools should have self closing and locking gates to prevent unapproved entry. A pool cover alarm should be installed. There should be two ladders to escape the pool. There should be depth markings and “no diving” markings. There should be visible and accessible life saving devices. This pool is a hazard and all safety hazards should be found and fixed by a qualified contractor. The pool was closed for winter and could not be fully inspected.

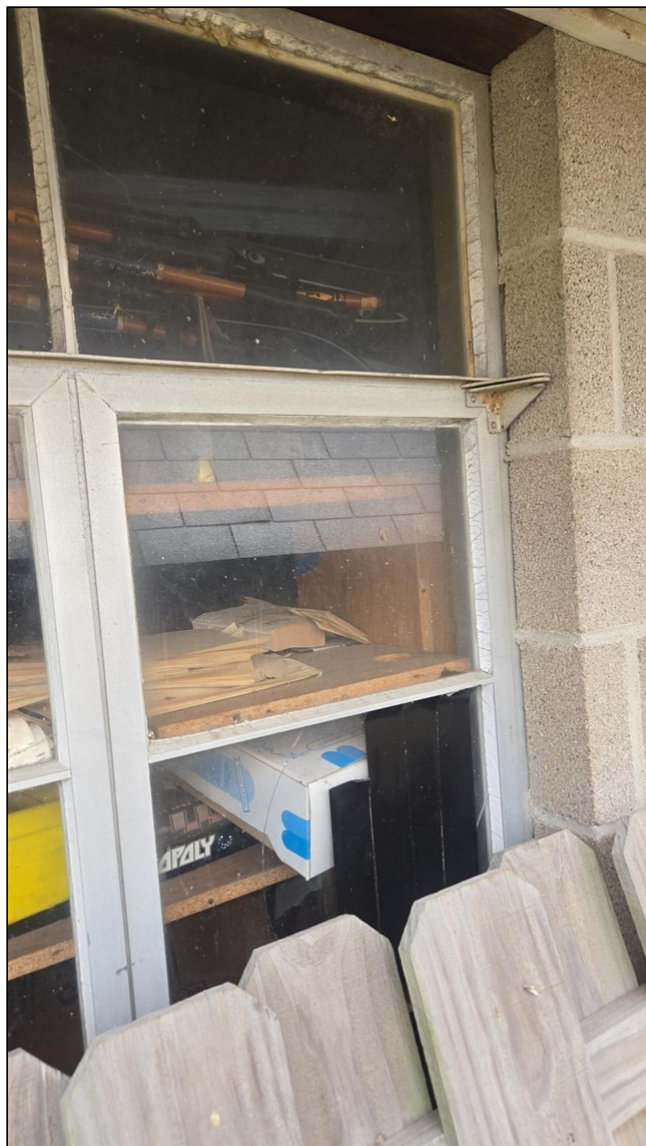
2.7 Item 5(Picture) Broken outbuilding window.

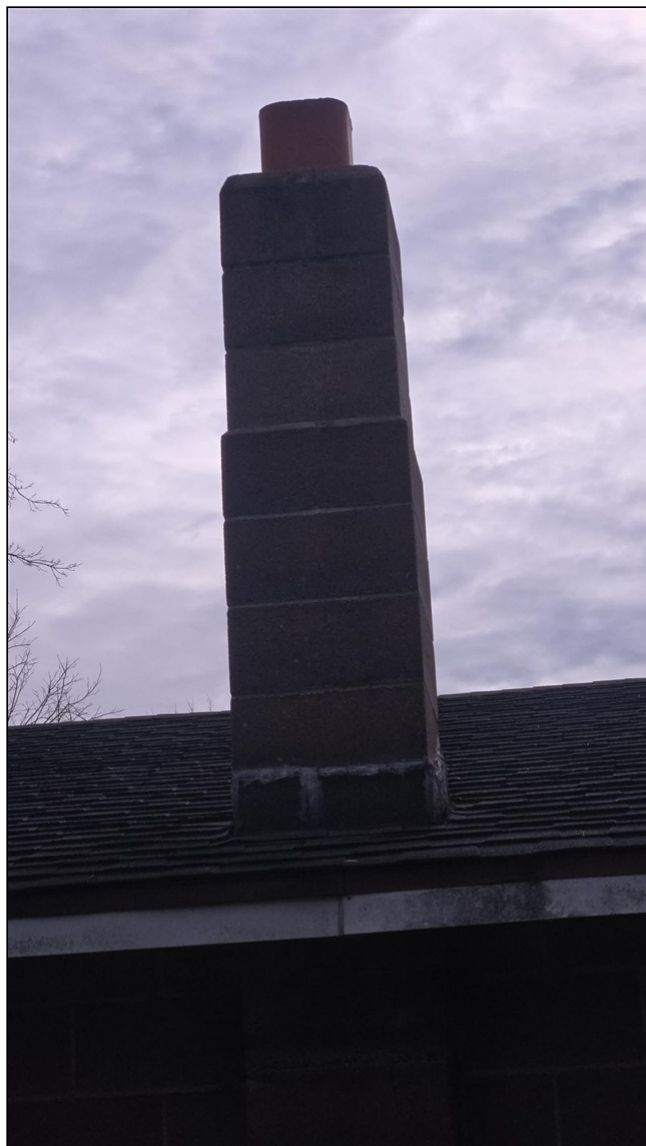
2.7 Item 7(Picture) The outbuilding flue should be swept and repaired by a licensed chimney sweep.

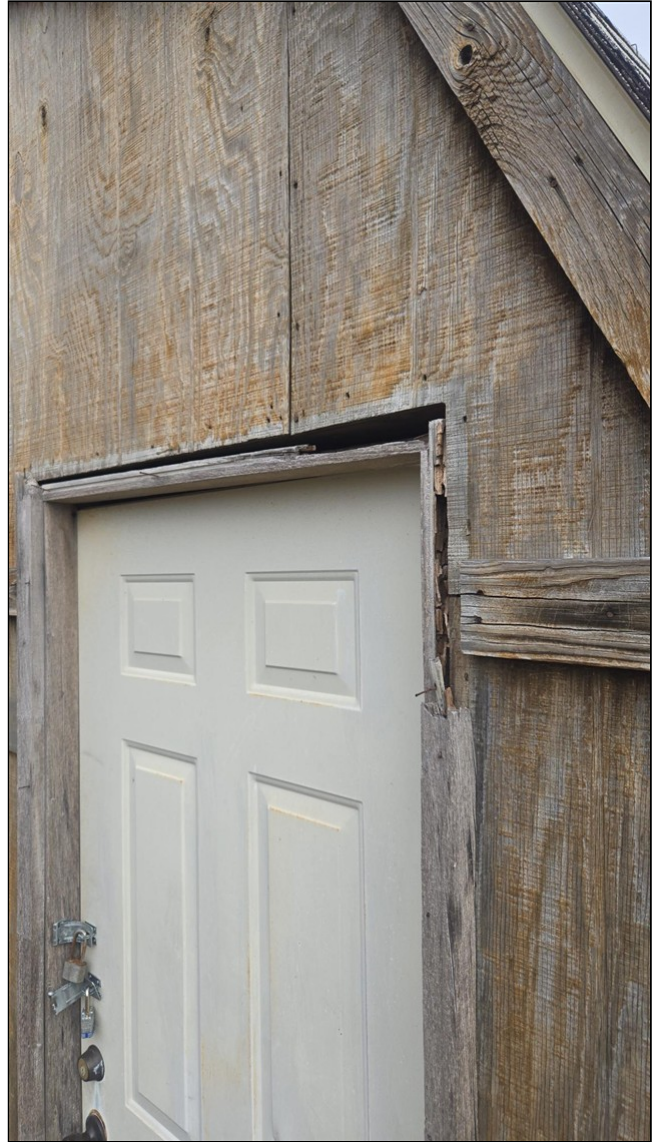
2.7 Item 10(Picture) Rotted wood outbuilding.

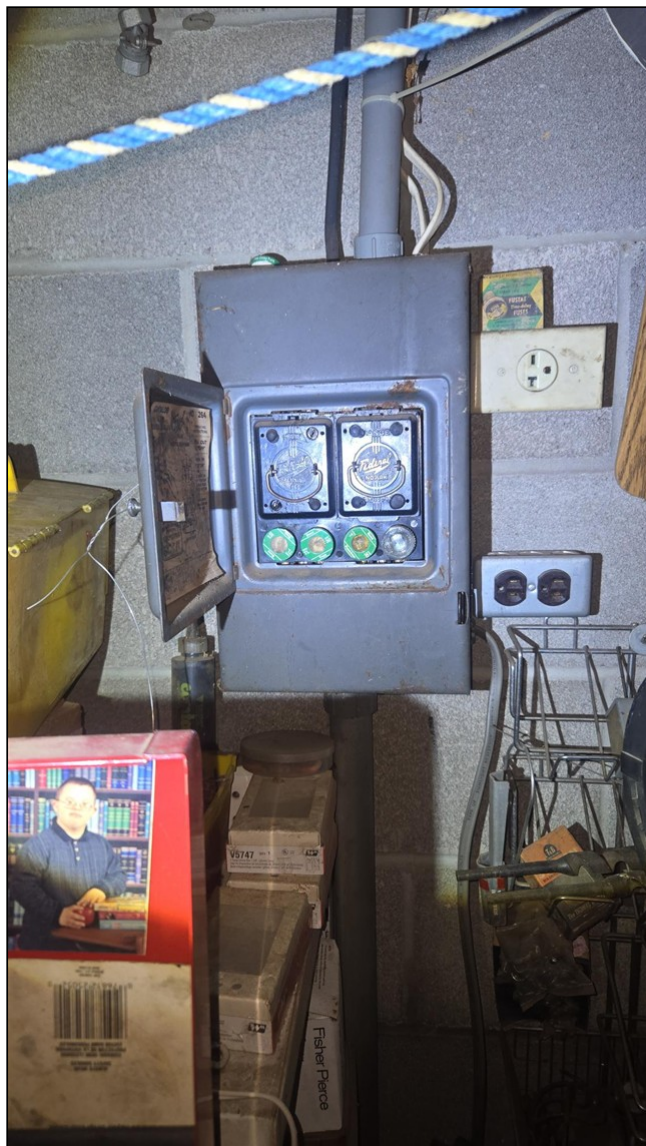
2.7 Item 11(Picture) Outbuilding electrical / fuse box - A qualified electrical contractor should find and fix any and all NEC defects.

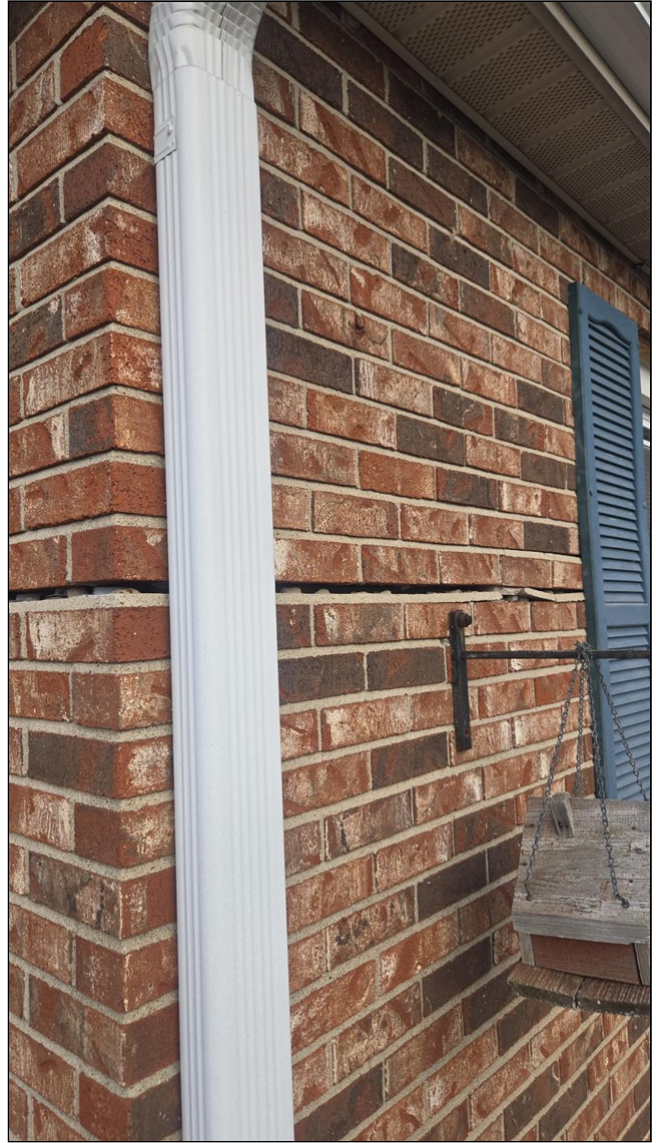
3.0 Item 2(Picture) The exterior brick veneer had subsided because of excessively wet conditions near the foundation of the veneer and removal of foundational support near the basement walk-out door. This is a structural issue for the veneer only and could be repaired in several ways. Scoping repairs is beyond the scope of the inspection. The brick veneer should be repaired to prevent water damage to the exterior wall envelope.

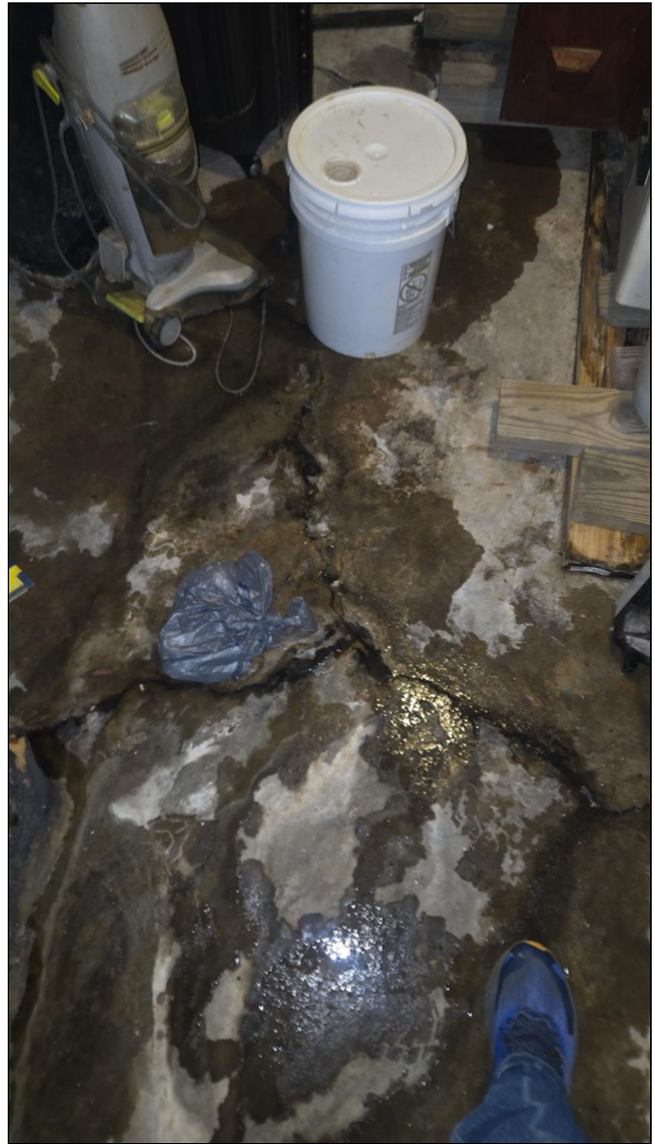
3.0 Item 4(Picture) The basement was wet at the time of the inspection. This appeared to be from hydrostatic pressure and may be due to a combination of circumstances. Based on the floor staining and the seller's description of the septic tank lid as metal, I suspect that most of this water is from a failed septic tank that is leaking near the foundation of the home and putting hydrostatic pressure on the concrete. Additional factors that may be contributing to this condition include improper downspout drainage and surface drainage around the home. I recommend that the septic tank is completely replaced and that the downspouts are installed into separate downspout drains that drain to daylight near the road ditch. Hydrostatic pressure may cause catastrophic damage to the foundation and this situation should be repaired as soon as practical.

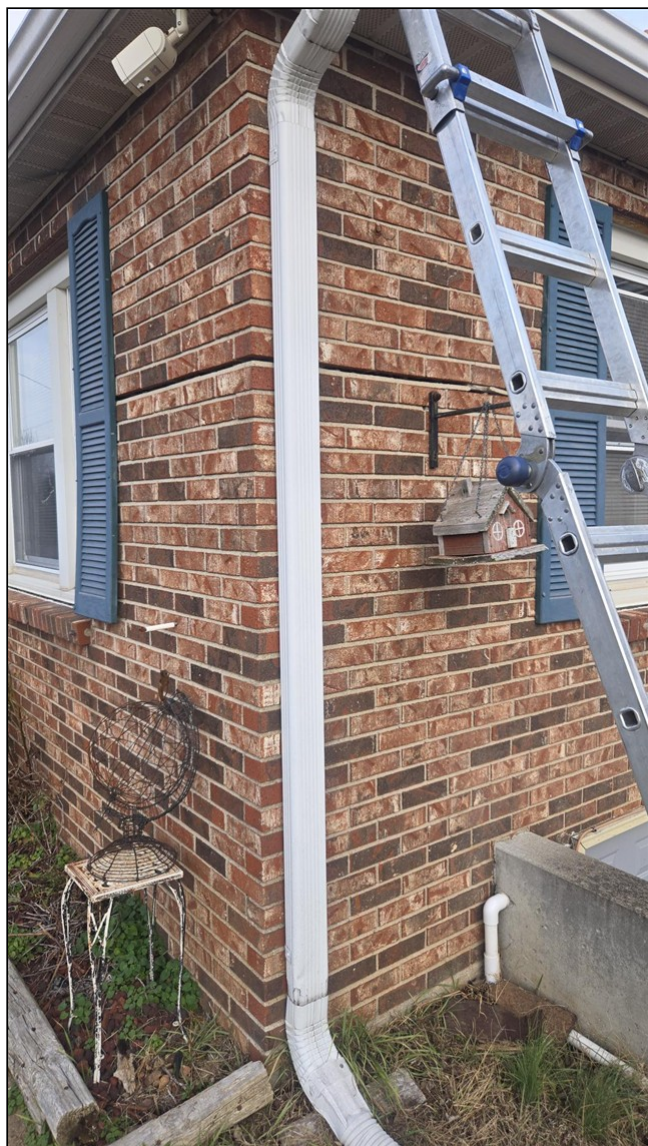
3.1 Item 1(Picture) The brick veneer required immediate repairs.

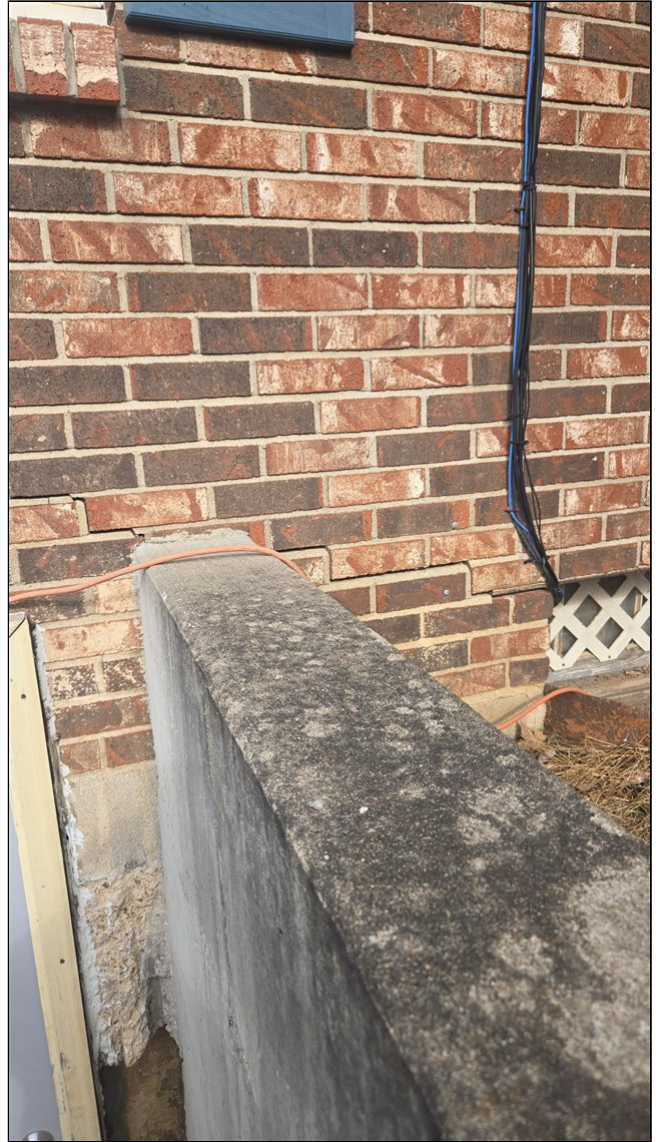
3.1 Item 4(Picture) The brick veneer required immediate repairs.

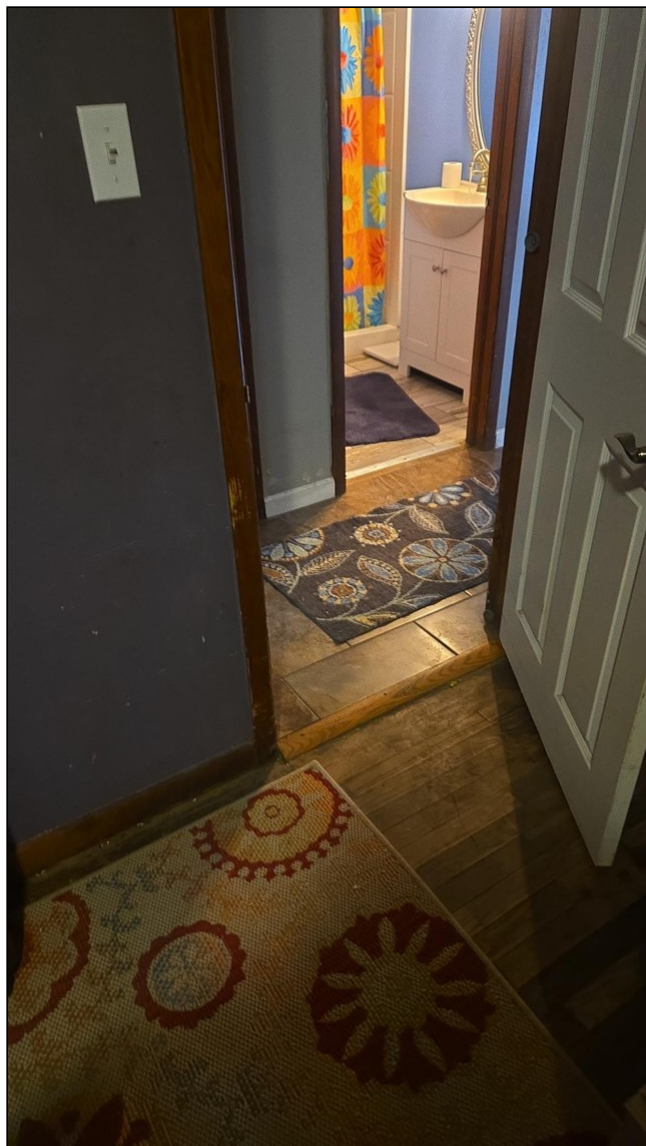
3.3 Item 1(Picture) Some areas of the home were inaccessible at the time of the inspection. We were unable to inspect the crawlspace or attic area. There was noticeable deflection in the floors in some areas and I expect that there are some floor joists that require repairs.

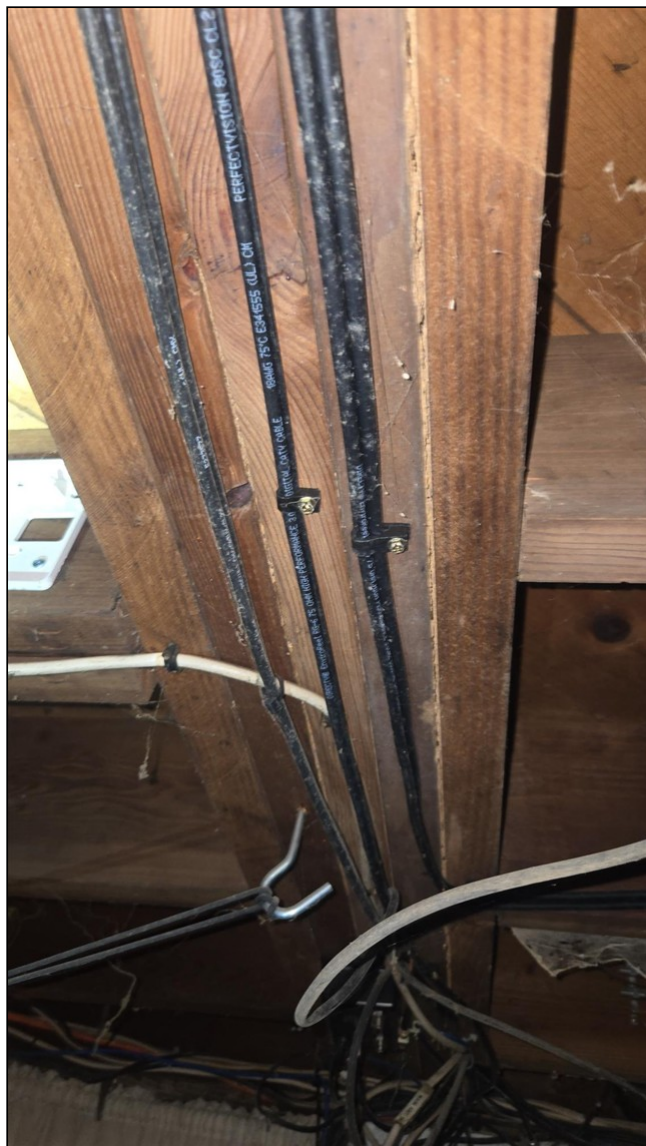
3.3 Item 3(Picture) Main beam termite damage noticed. The main beam should be replaced.

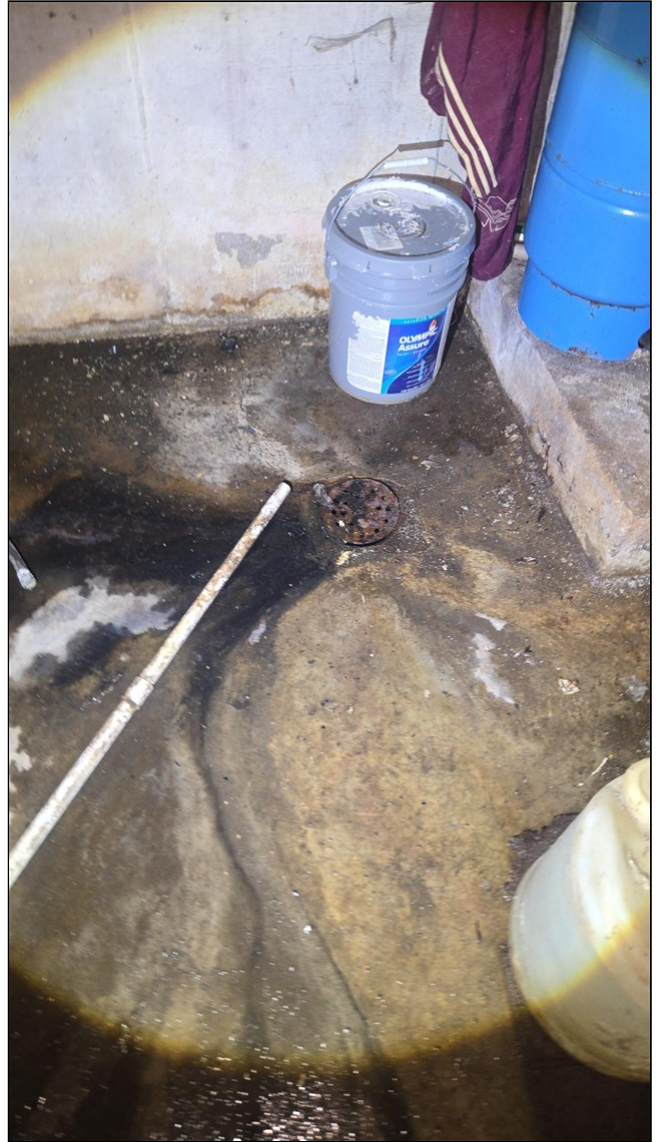
5.0 Item 4(Picture) I recommend that a sewer lateral locator service is hired to trace all sewer line and floor drains that leave the basement prior to making any septic system inspections or repairs. I recommended to call "The Pipe Guard" Allen Carter to locate all these lines. 314-278-7237

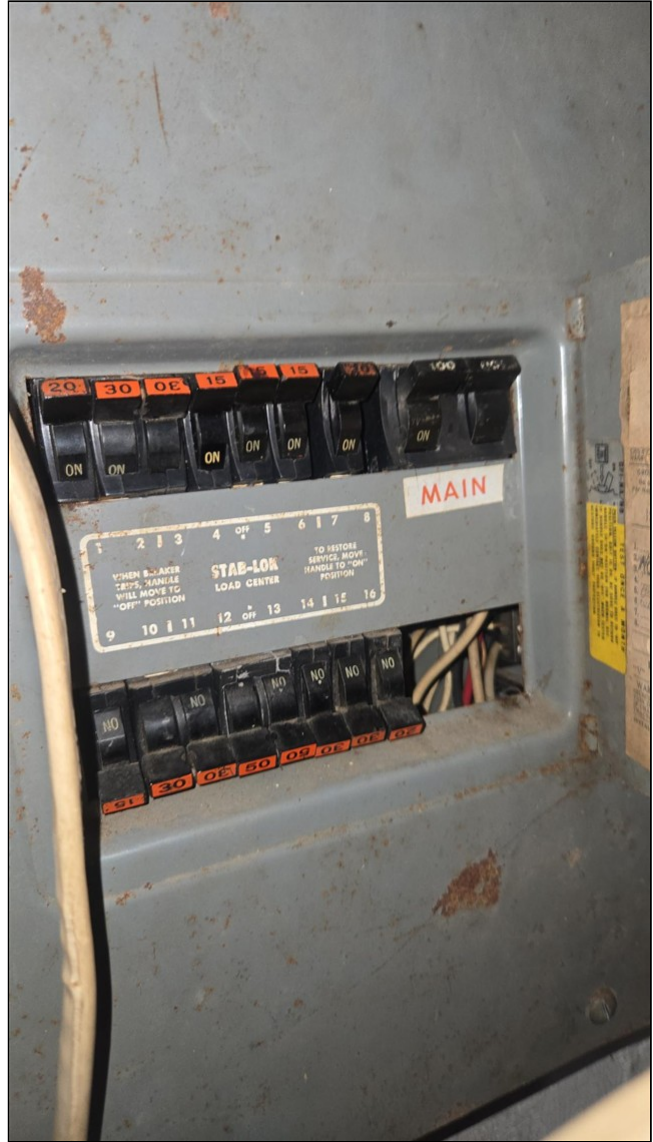
6.1 Item 2(Picture) Open breaker spaces could allow accidental contact with energized parts. A qualified electrical contractor should find and fix any and all National Electrical Code deficiencies.

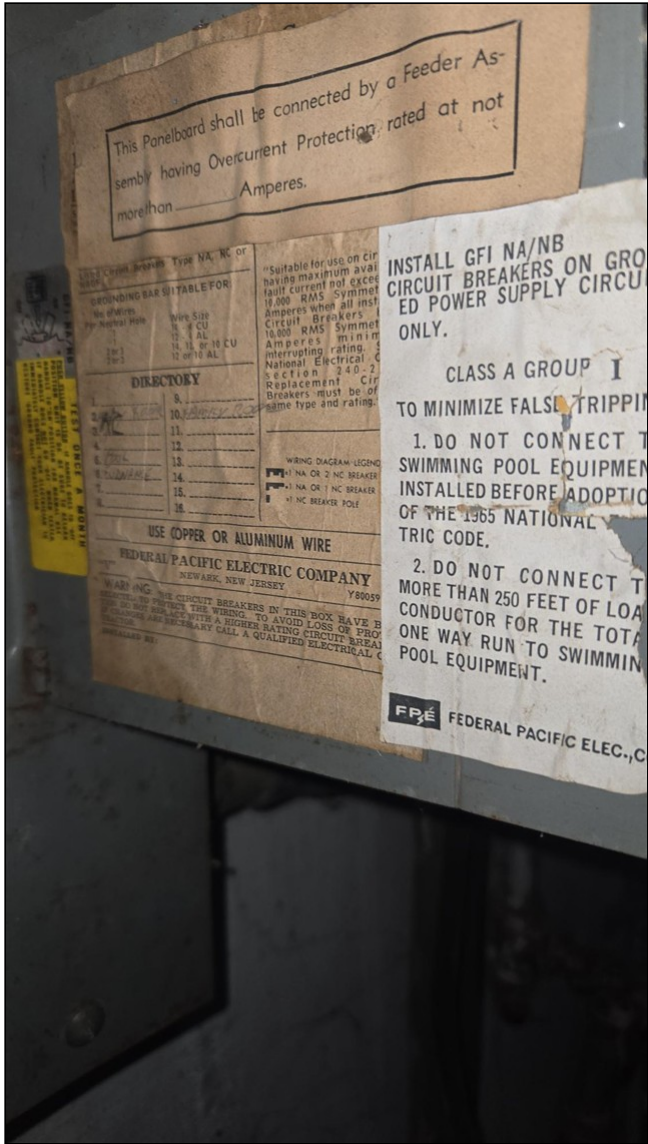
6.1 Item 3(Picture) Breakers not labeled. A qualified electrical contractor should find and fix any and all National Electrical Code deficiencies.

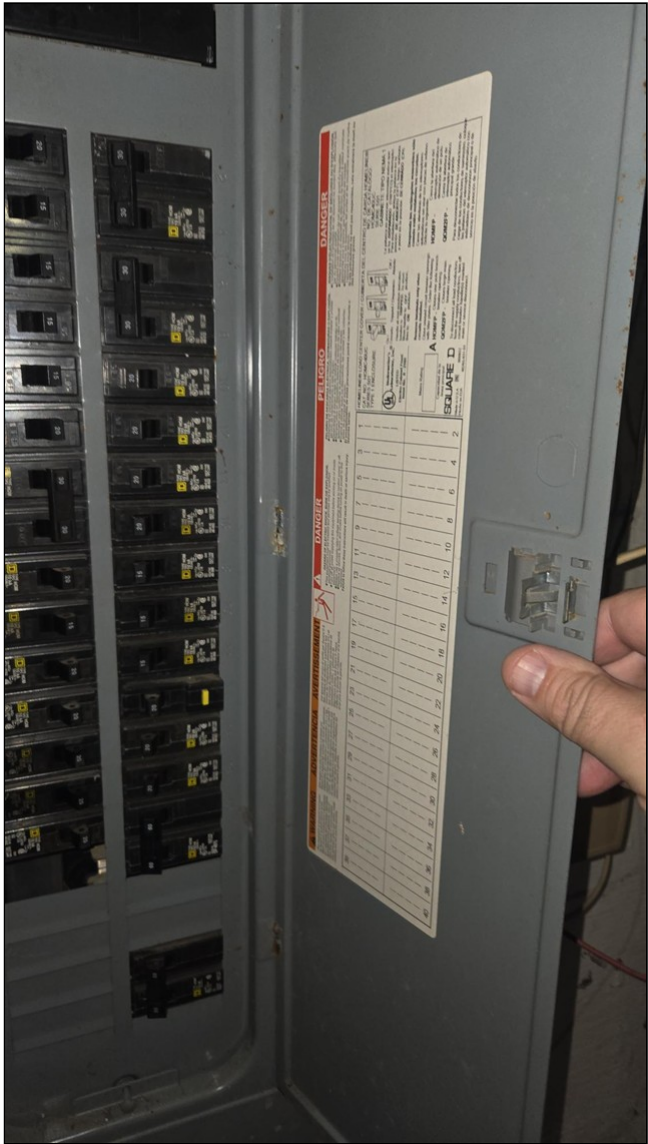
6.1 Item 4(Picture) Breakers not labeled. A qualified electrical contractor should find and fix any and all National Electrical Code deficiencies.

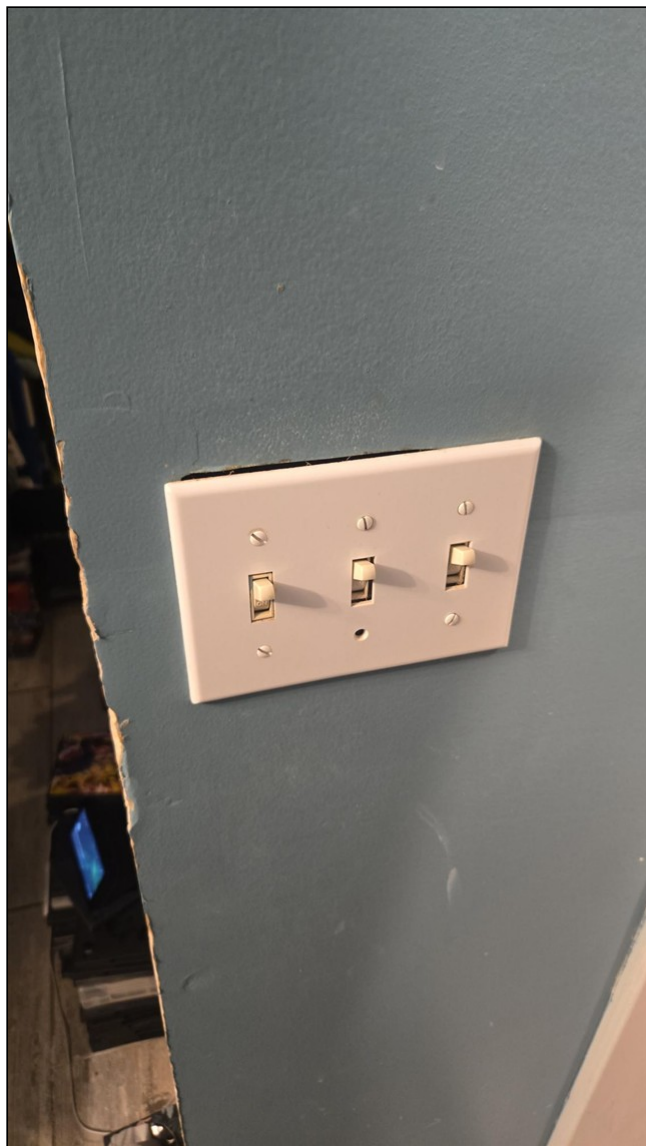
6.3 Item 5(Picture) A qualified electrical contractor should find and fix any and all National Electrical Code deficiencies. Missing screws, cracked covers, covers loose or protruding from the wall.

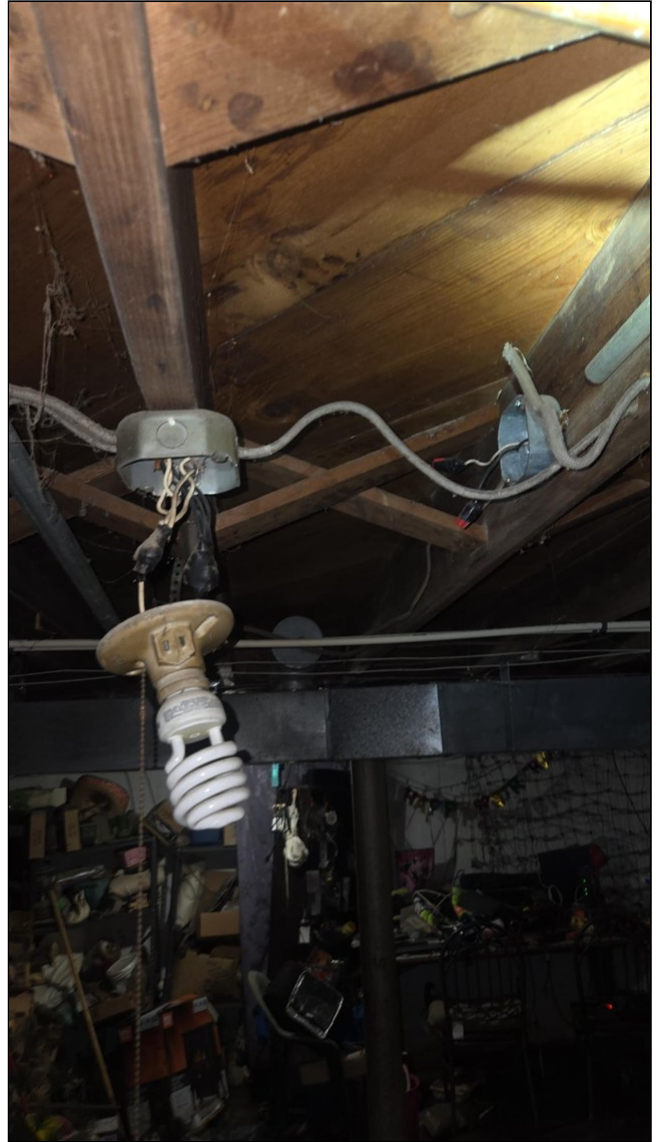
6.3 Item 8(Picture) A qualified electrical contractor should find and fix any and all National Electrical Code deficiencies.

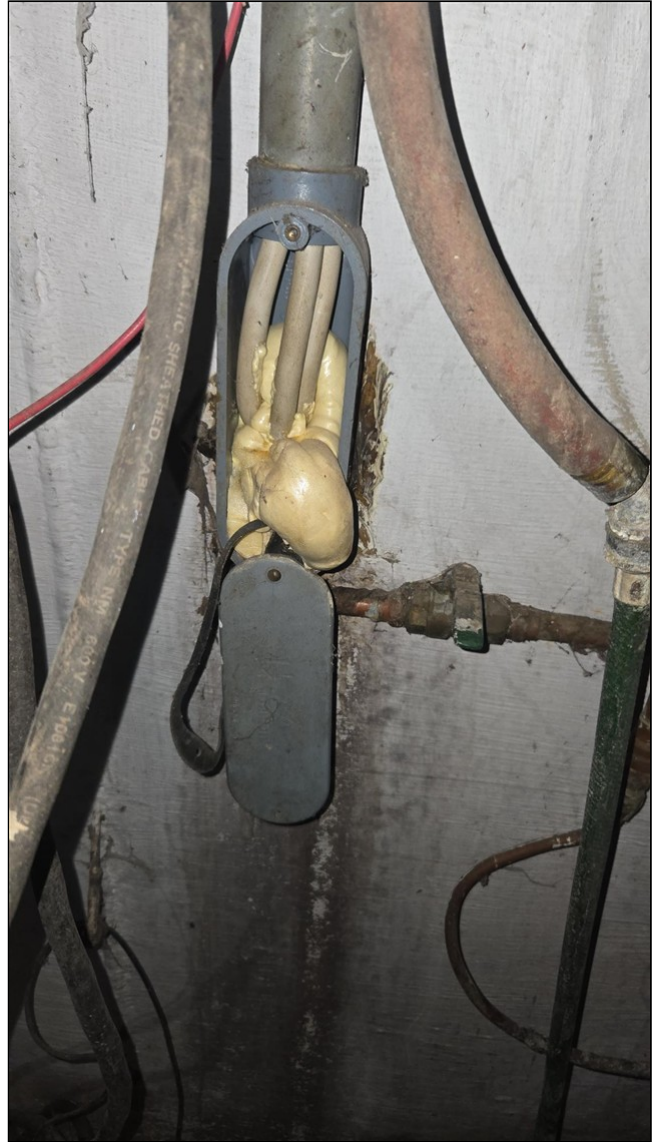
6.3 Item 10(Picture) A qualified electrical contractor should find and fix any and all National Electrical Code deficiencies.

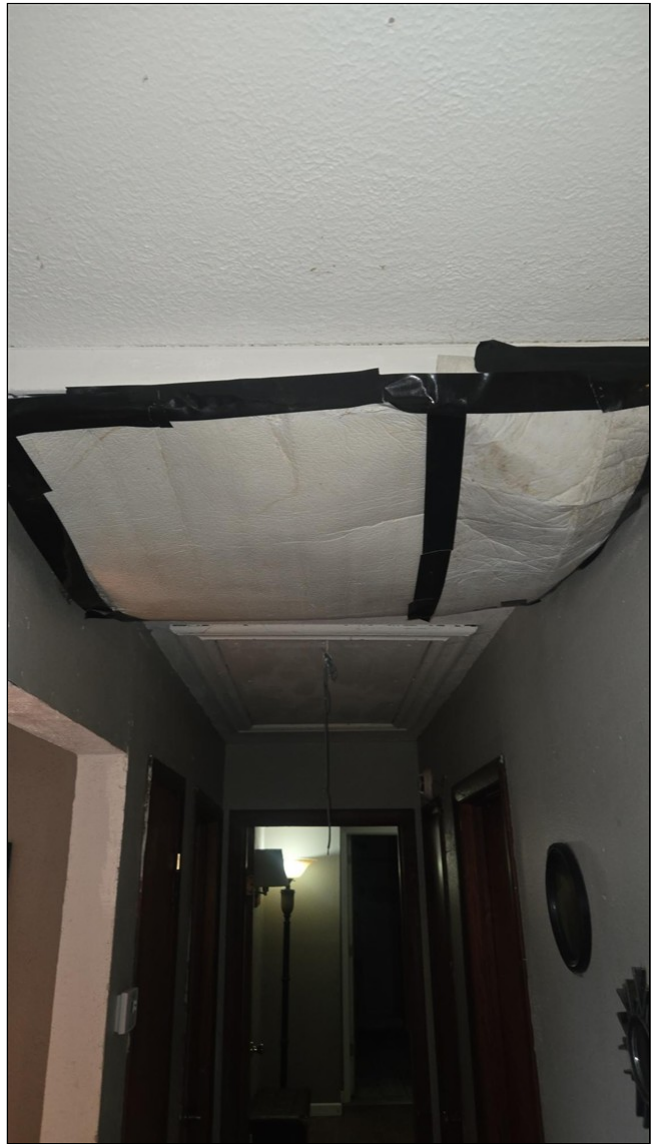
7.0 Item 2(Picture) The attic fan should be deleted and an attic access should be established here. InterNACHI recommends that attic fans are deleted, because overall they are less energy efficient than HVAC.
