Inspection Report

4700 Turley Mill Rd, Farmington, MO 63640, USA

A-Team Consulting and Contracting

Date: 1/2/2025	Time:	Report ID: 2025010202
Property: Address	Customer: NAME	Real Estate Professional:

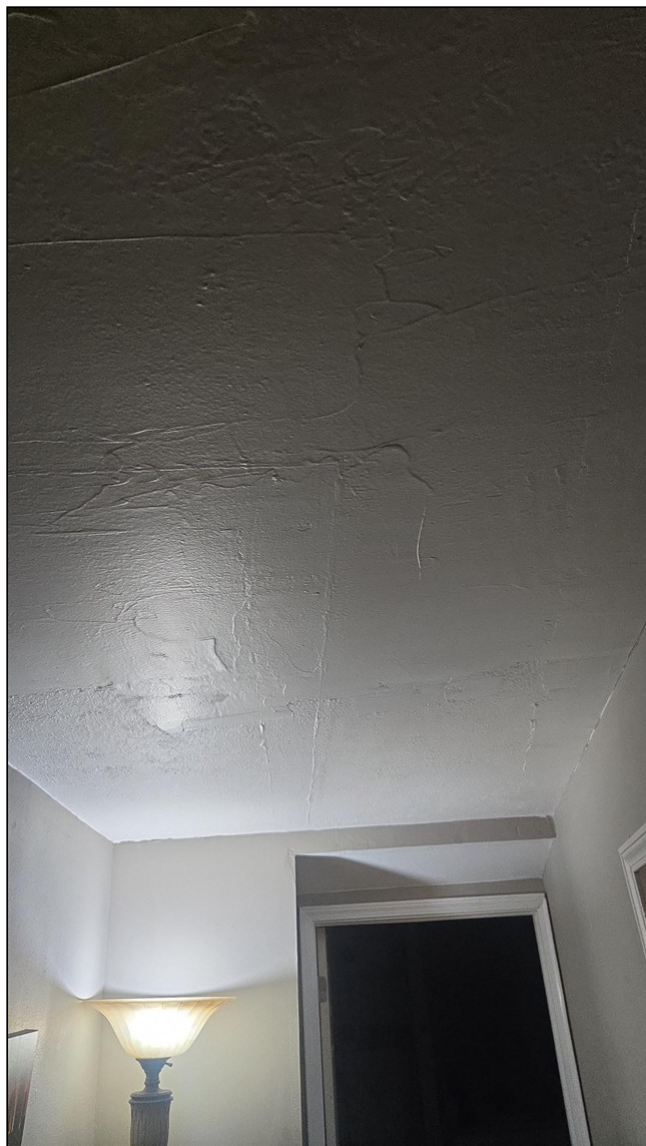
7.0 Item 3(Picture) There were some scuffs, scrapes, cracks, and inconsistent texture noticed throughout the house.

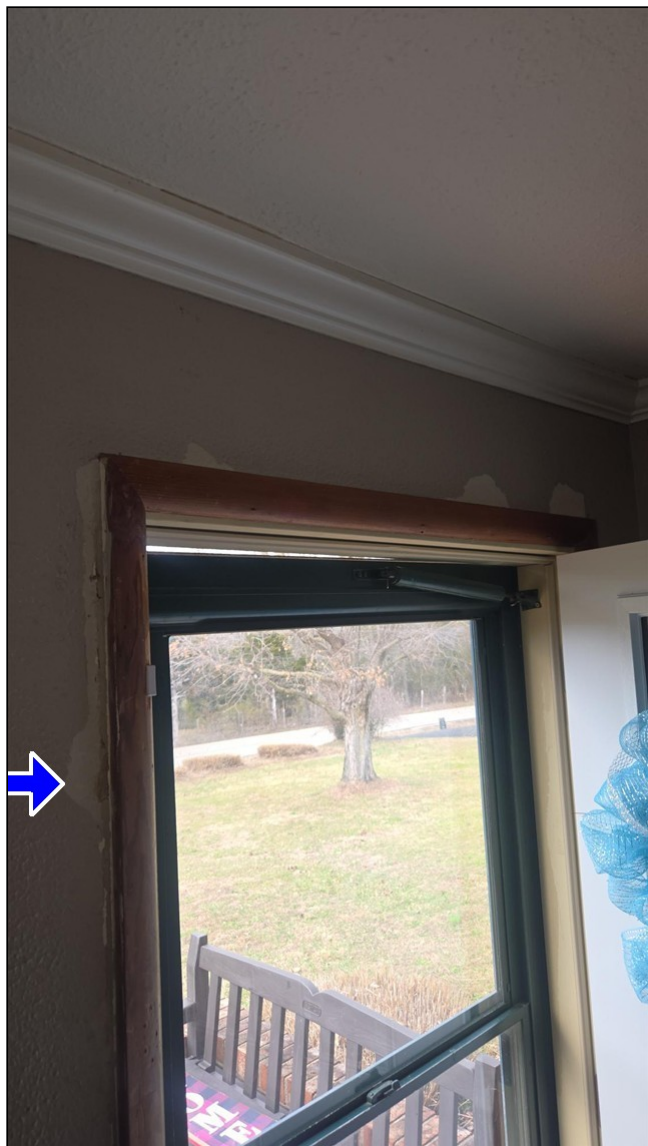
7.1 Item 1(Picture) There were some scuffs, scrapes, cracks, and inconsistent texture noticed throughout the house.

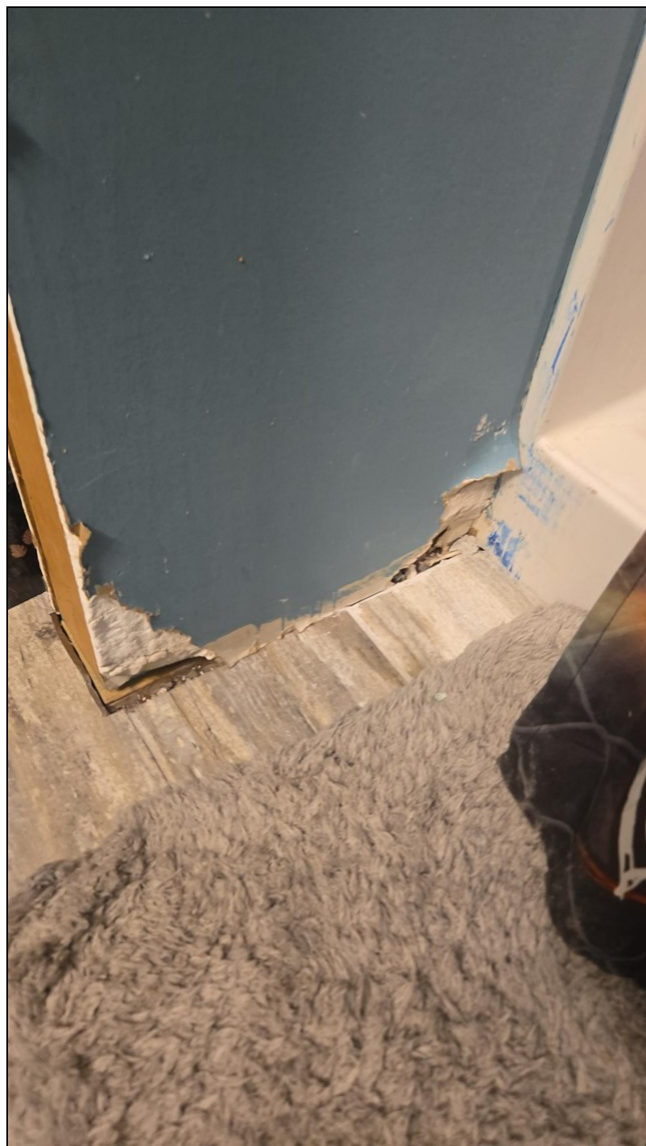
7.1 Item 3(Picture) There were drywall repairs required.

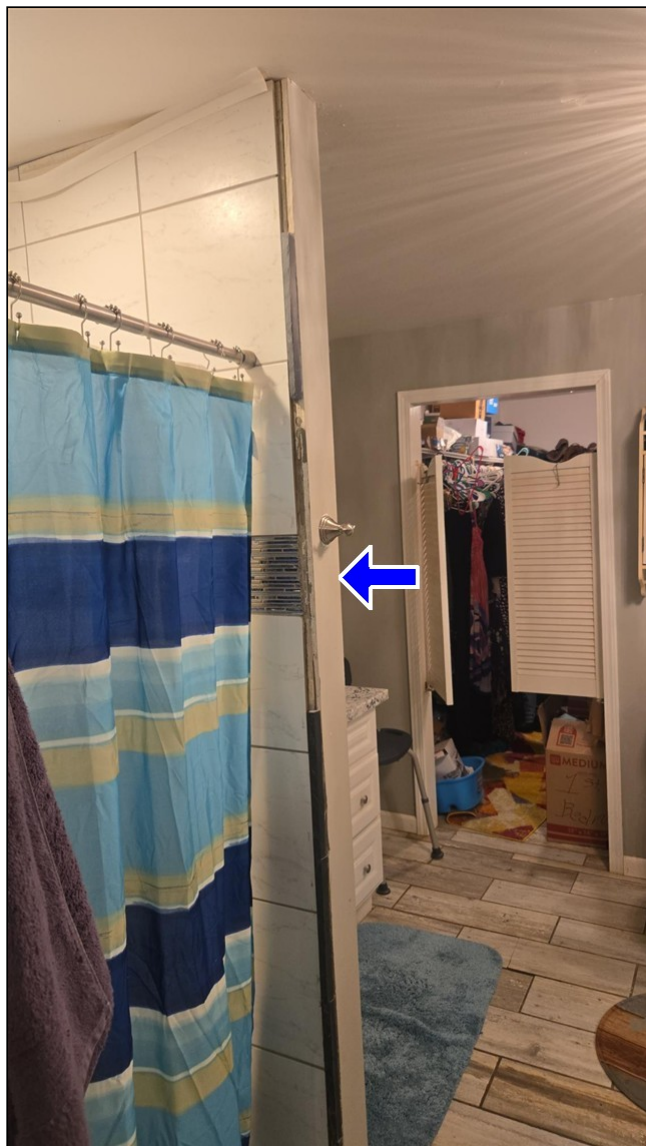
7.1 Item 5(Picture) The master bathroom shower wall looked like it may have some major rot and water damage behind the wall. This wall should be torn down to the studs and inspected.

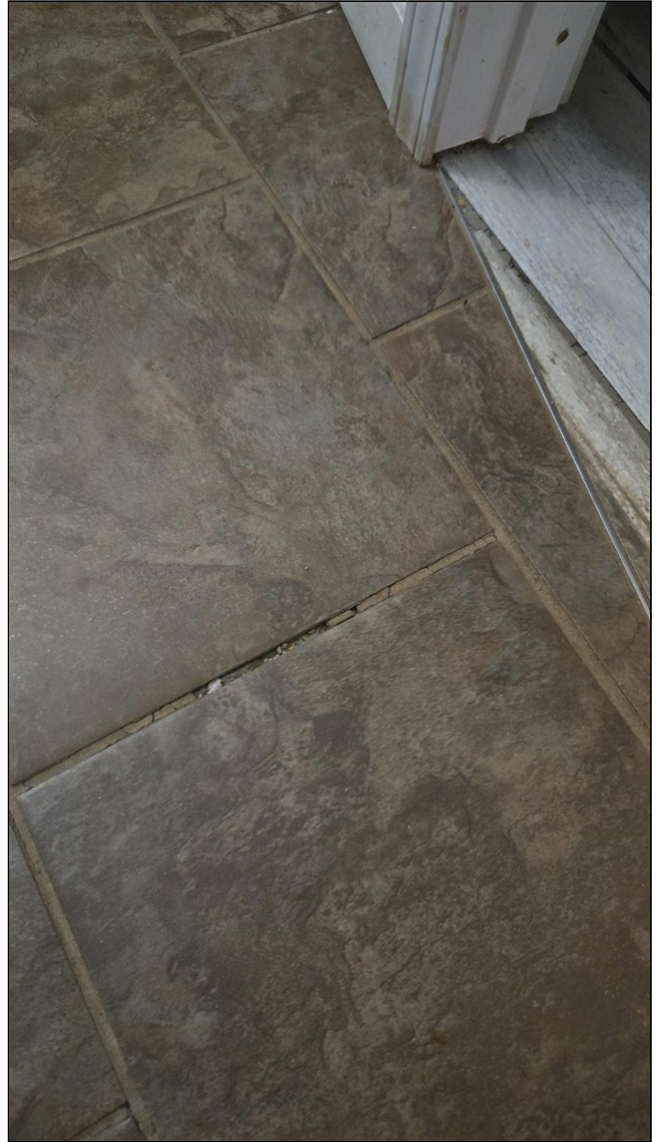
7.2 Item 2(Picture) There was cracked tile and grout throughout the house. Some of the cracked tile and grout appeared to be from structural movement and you should expect to make structural repairs to the subflooring and floor joists in some, but not all areas.

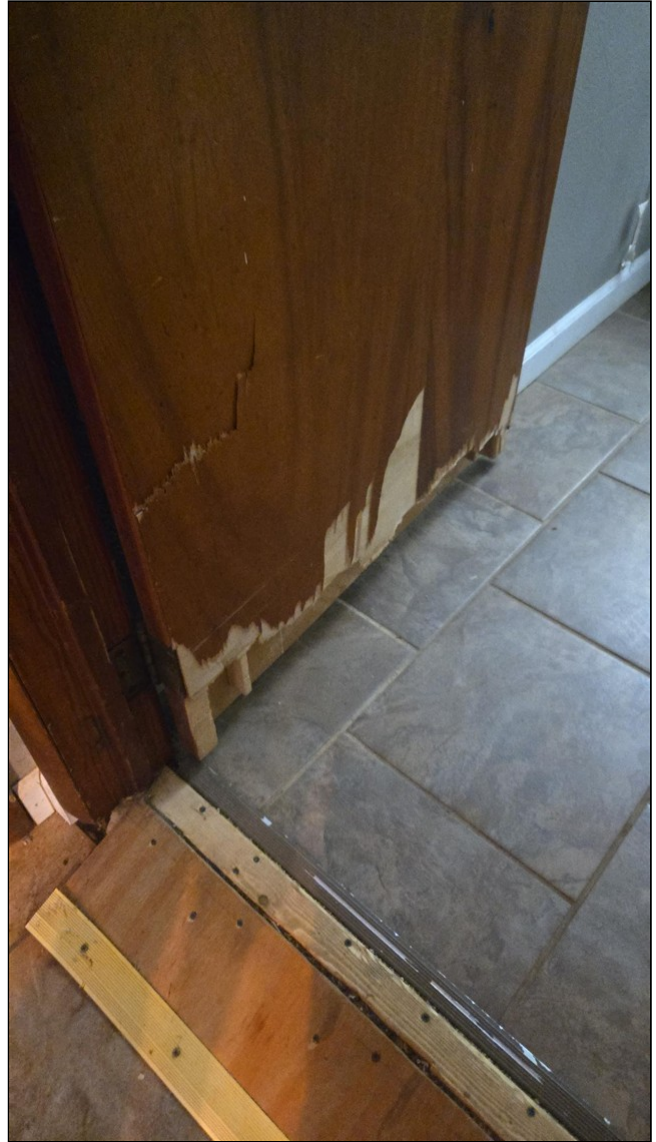
7.5 Item 4(Picture) There were some damaged doors that should be repaired or replaced.

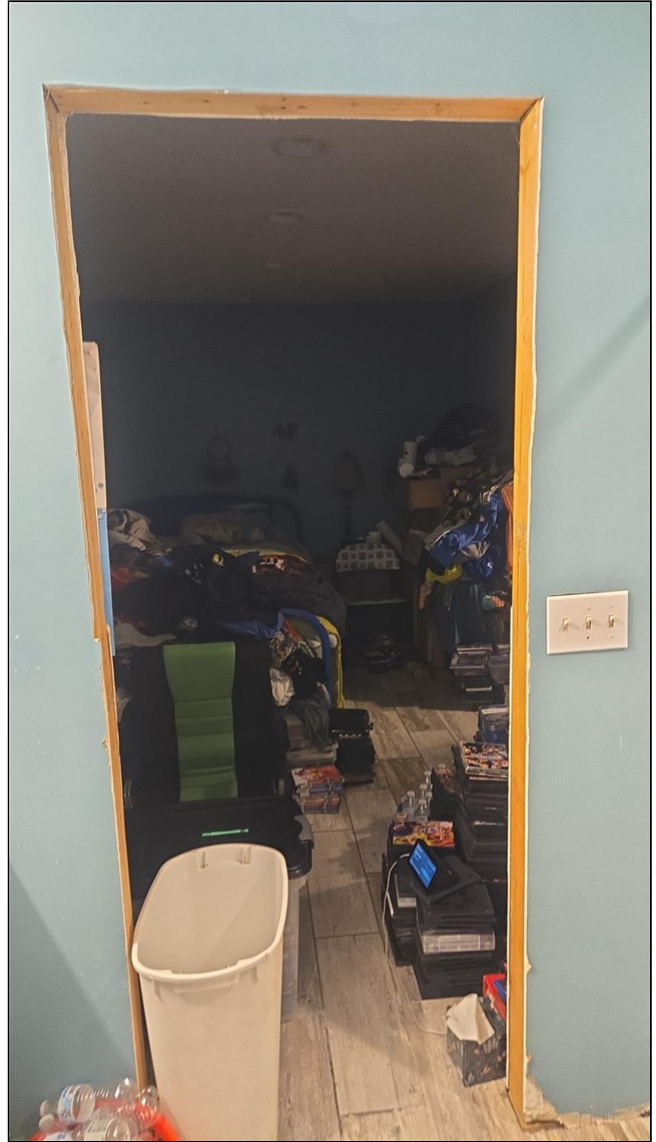
7.5 Item 6(Picture) Cracked door

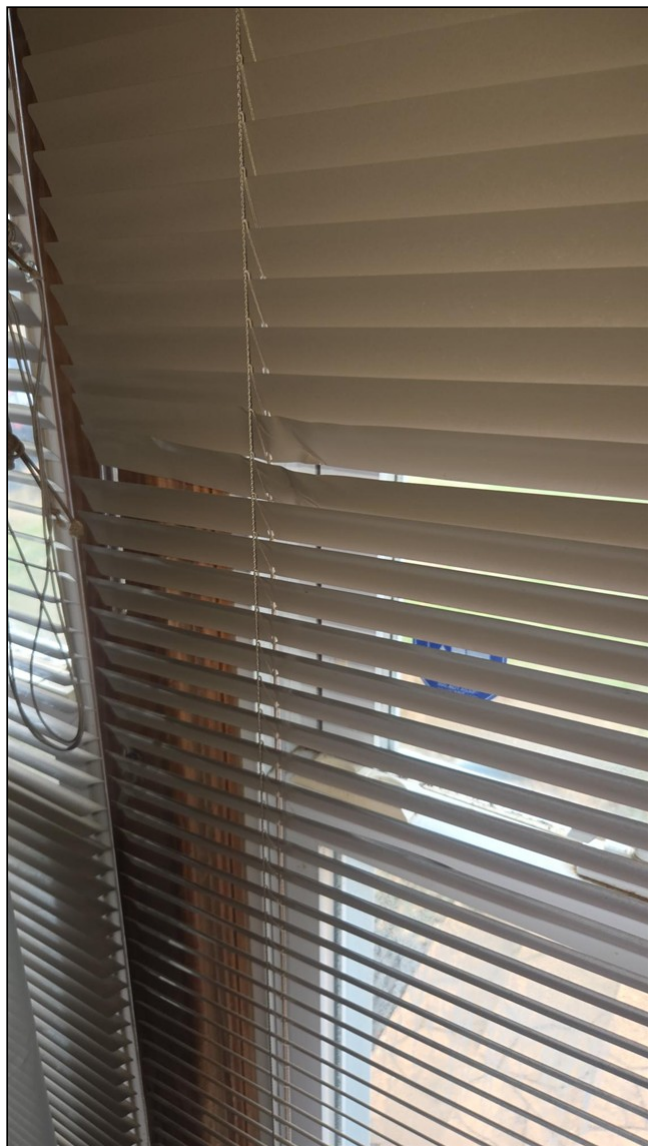
7.6 Item 1(Picture) The blinds were old, brittle, and hard to open/close.

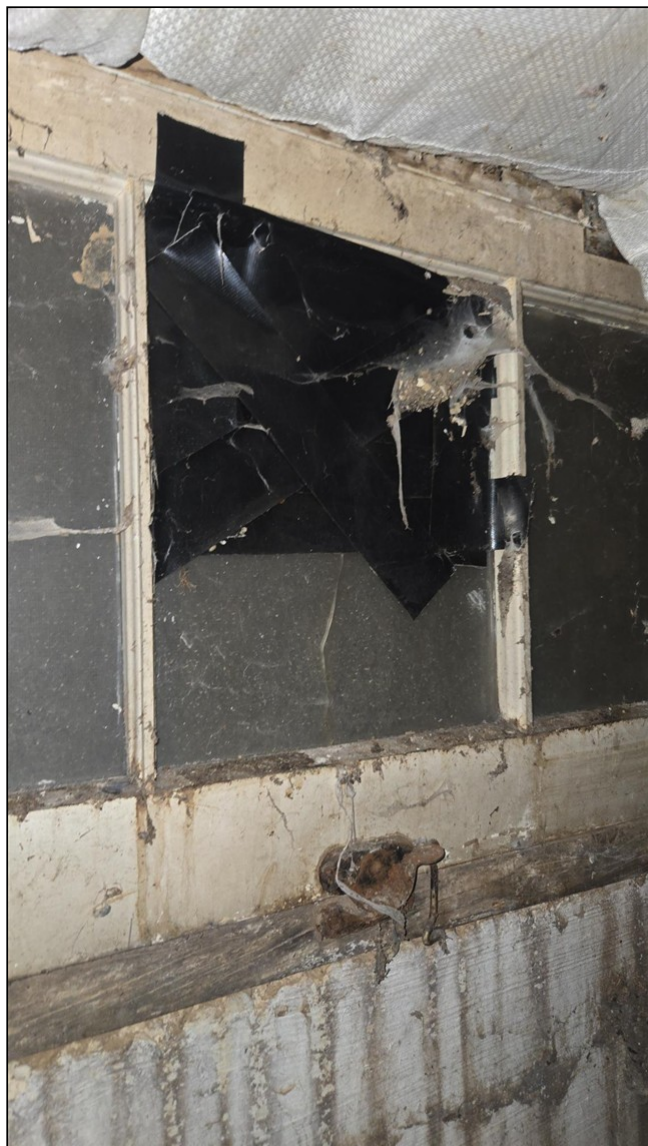
7.6 Item 3(Picture) Broken basement crawlspace entrance.

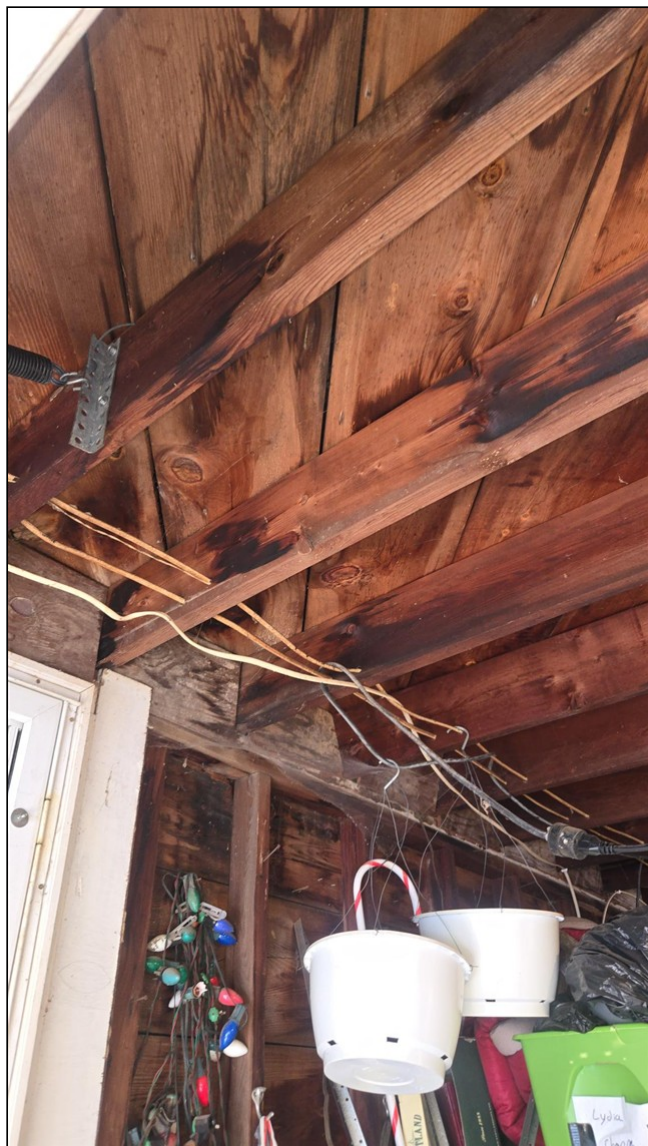
8.0 Item 1(Picture) The garage ceiling should be covered with 5/8" or thicker type-x fire resistant drywall to provide fire protection to the occupancy in the event of a garage fire.

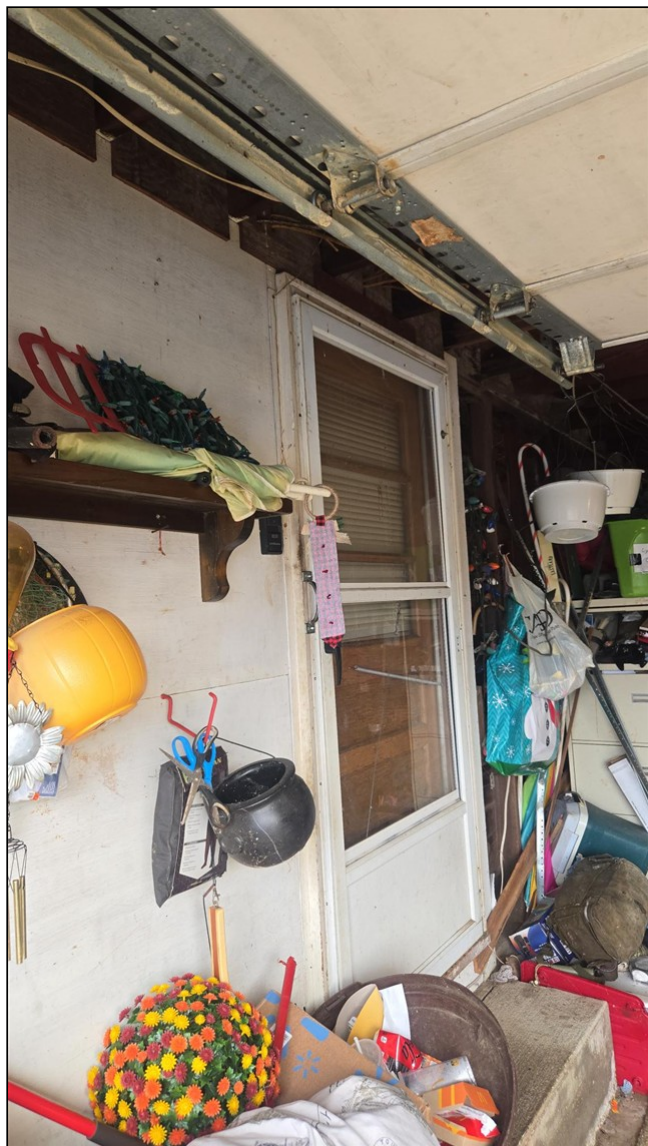
8.1 Item 1(Picture) The garage wall should be covered with ½" or thicker type-x fire resistant drywall to provide fire protection to the occupancy in the event of a garage fire.

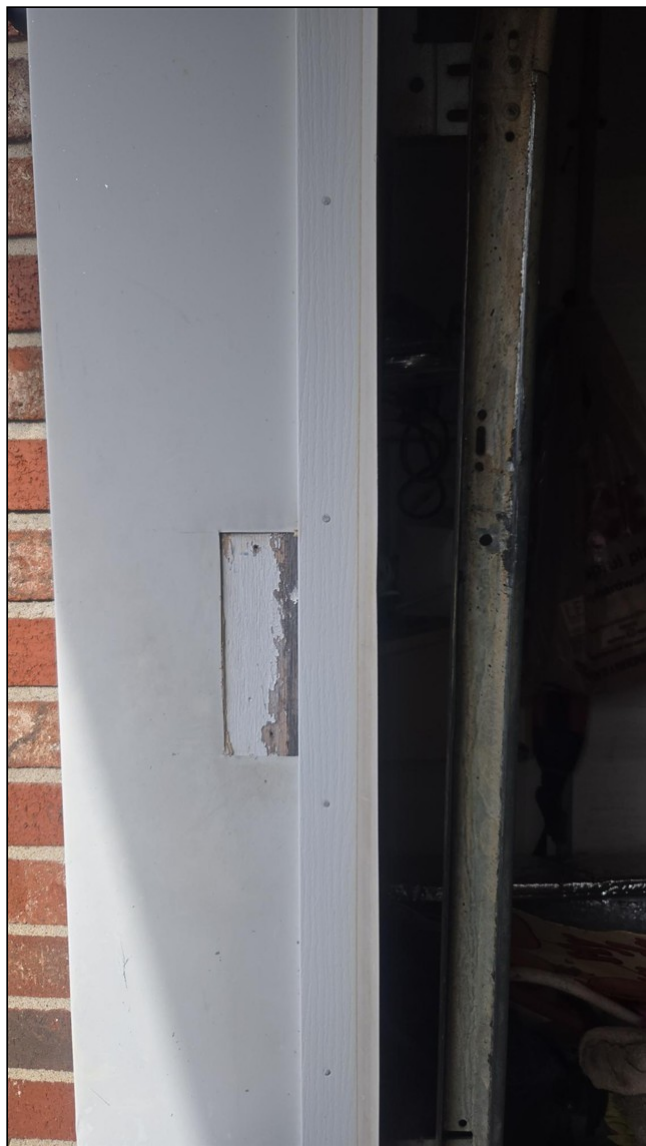
8.3 Item 1(Picture) The garage door fascia required repairs.

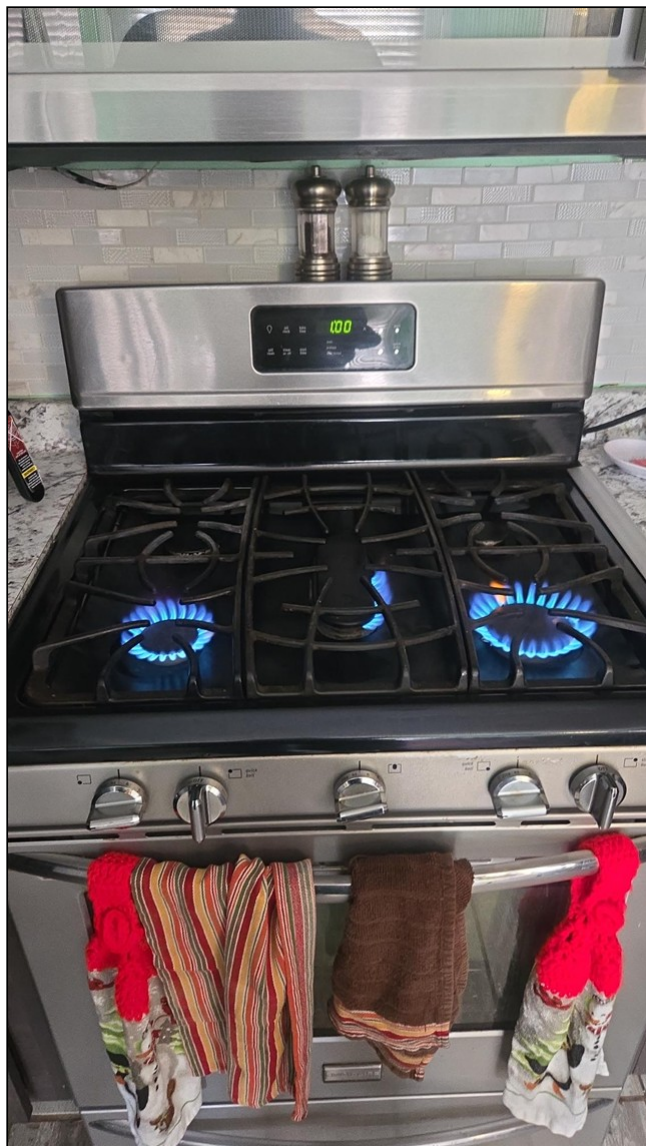
9.1 Item 1(Picture) The stove and oven required repairs. The burners should be cleaned or replaced. CO detectors should be located in every sleeping room of the house and in the basement. CO detectors should be located within 2' of the floor. All detectors more than 10 years old should be replaced
