Inspection Report

4700 Turley Mill Rd, Farmington, MO 63640, USA

A-Team Consulting and Contracting

Date: 1/2/2025	Time:	Report ID: 2025010202
Property: Address	Customer: NAME	Real Estate Professional:

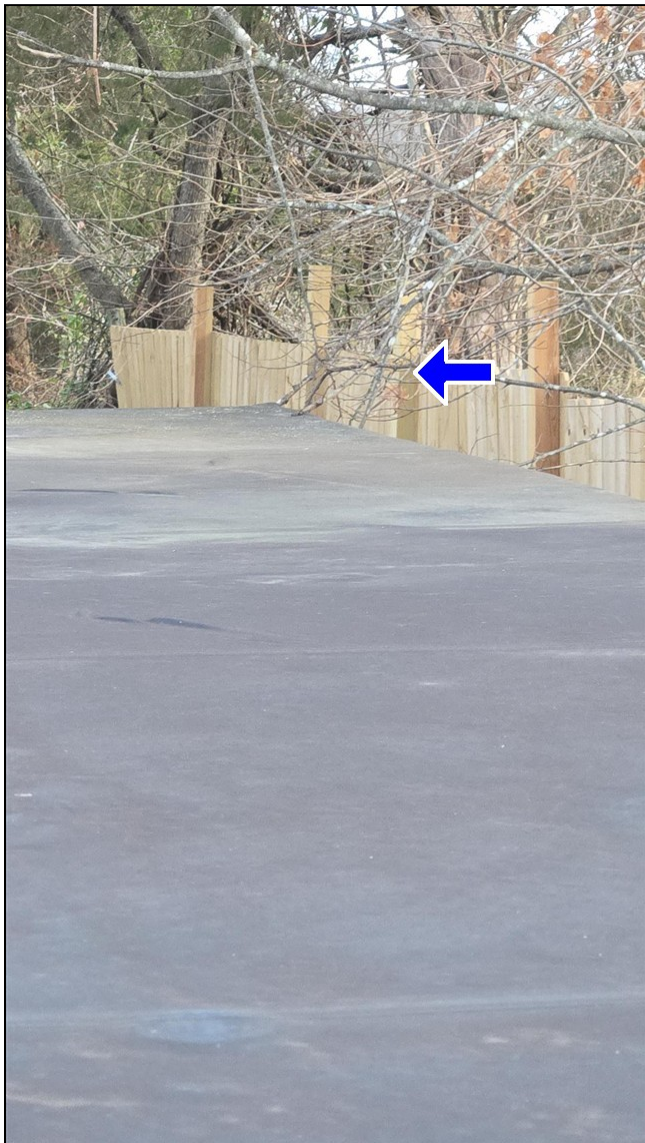
1.0 Item 1(Picture) Tree branches should be cut back 6' outside of the perimeter of the home plumb to the sky. Tree branches that are closer to the home than that may cause sudden damage and leaking.

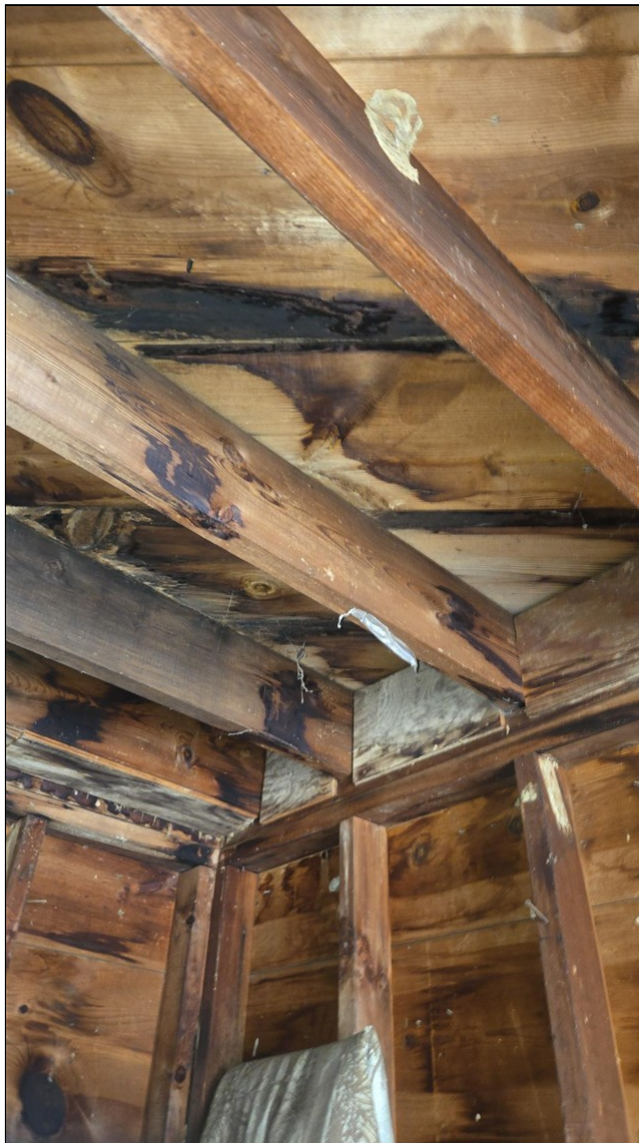
1.0 Item 2(Picture) There appeared to be active leaking and water damage in the area of the tree branches in the garage.

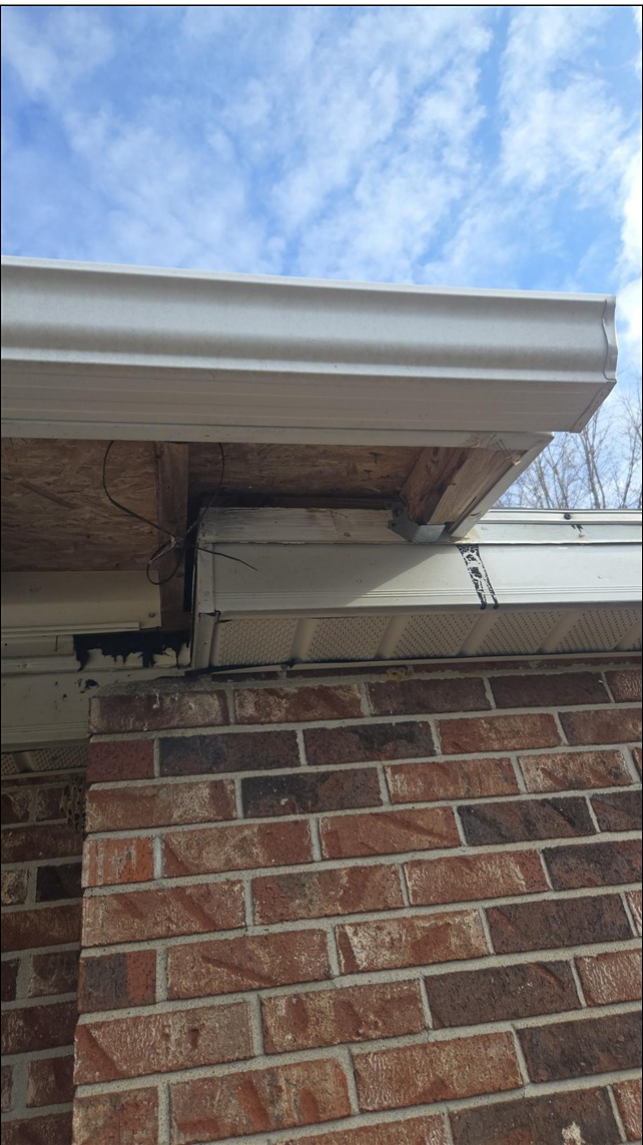
1.1 Item 1(Picture) The flashing on the roof between the flat roof and the house was missing and did not look appropriate. This is an unusual situation and it should be repaired by a qualified roofer. This situation may cause leaks and there may be hidden water damage in this area.

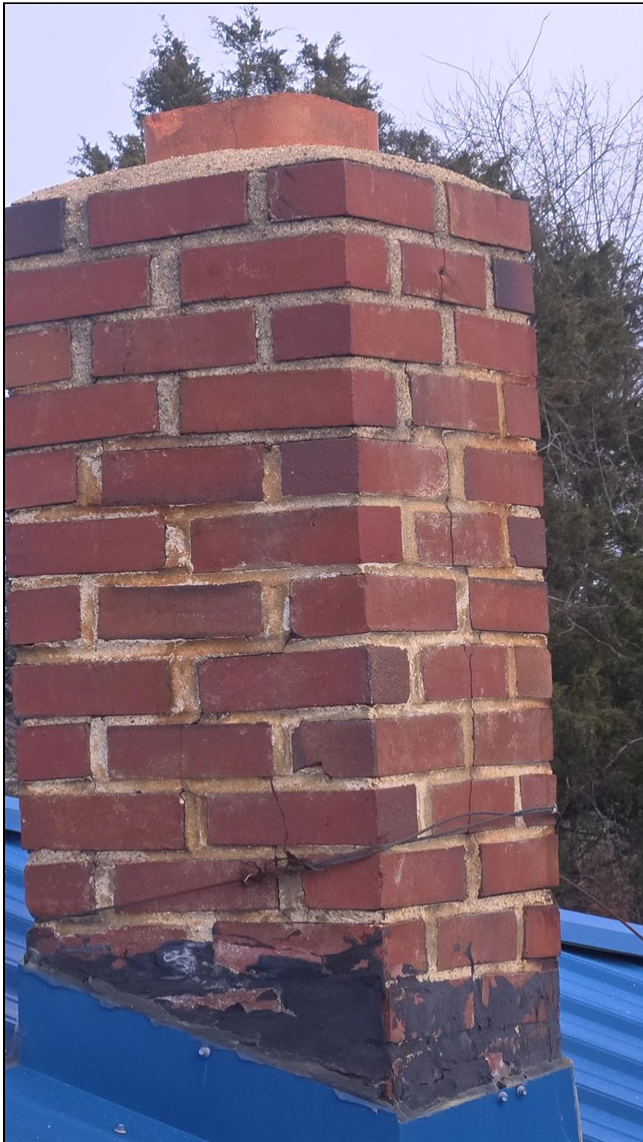
1.2 Item 1(Picture) The flue was cracked. The chimney required tuck pointing. The chimney flashing was not properly installed and should be regularly sealed or replaced. A qualified roofing contractor should repair any and all problem areas of this roof. The flue cap were not installed and flue caps should be installed by a qualified contractor. Flue caps prevent birds and rain from entering the flue and causing the flue to become blocked trapping carbon monoxide in the home. A flue cap should be installed by a qualified contractor. The flue should be swept and repaired by a licensed chimney sweep, prior to the first use and annually thereafter. Masonry repair and tuck pointing is required on the property. Maintaining the mortar is integral to maintaining the asset. All mortar should be cement based.

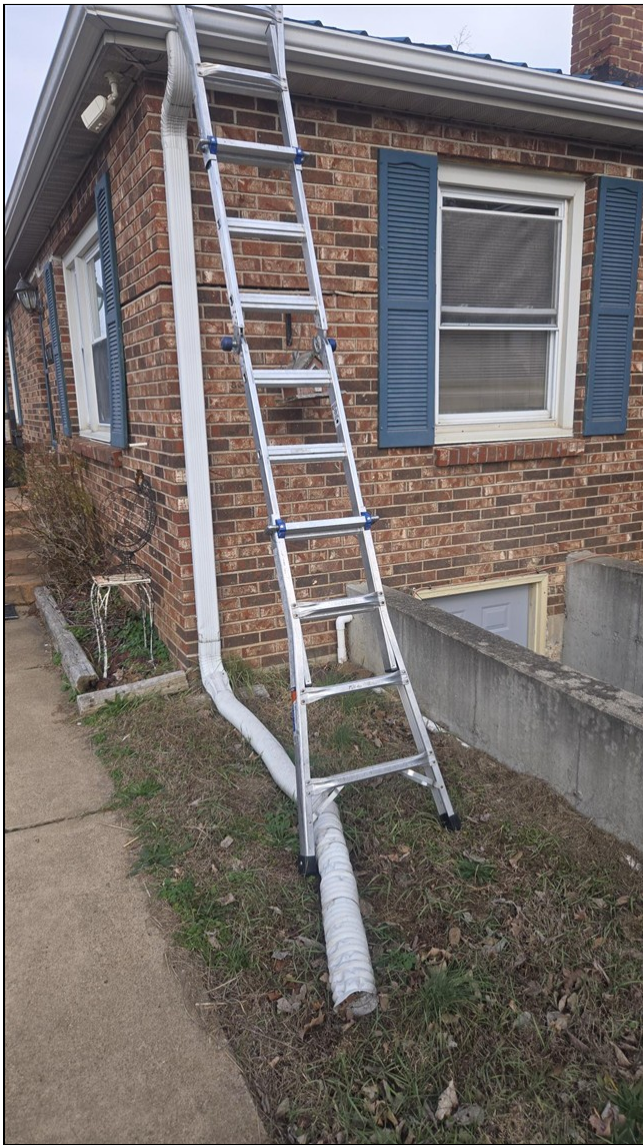
1.3 Item 1(Picture) Gutters should be provided with down spouts and downspout drains that discharge to daylight at least 10' outside of the perimeter of the house. Water should never be allowed to pool, puddle, or run within 10' of the perimeter of the home. The roof was missing some guttering. All roofs should be provided with gutters, downspouts, and drains.

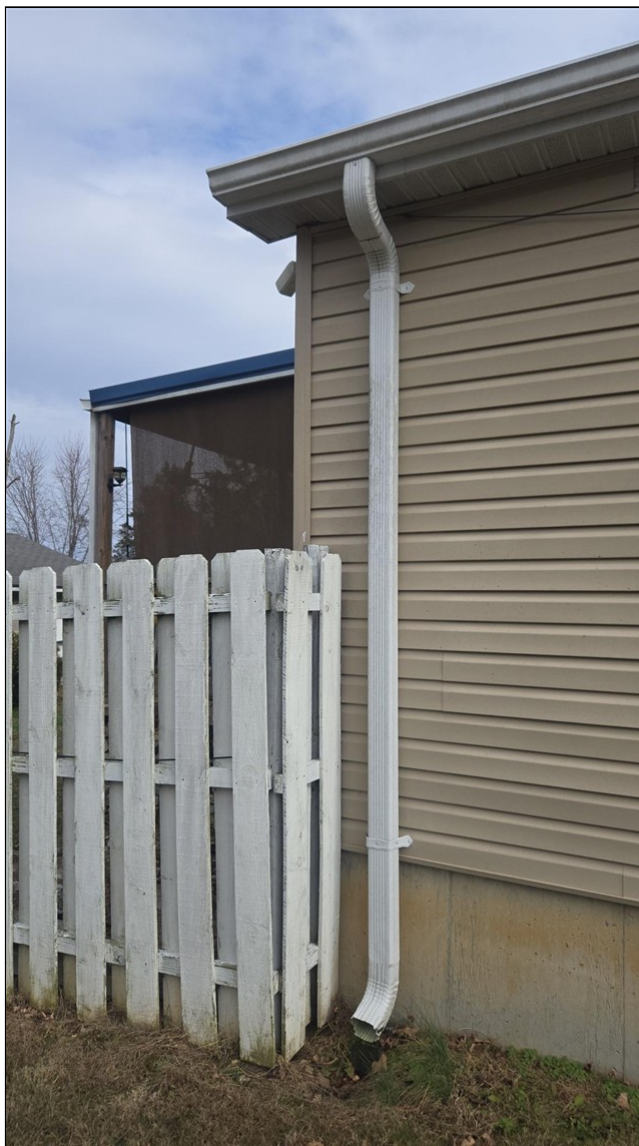
1.3 Item 4(Picture) This basement was actively wet. Improving the surface drainage and downspout drains around the house will increase the likelihood of a dry basement. The basement was dry at the time of the inspection. InterNACHI estimates that over 80% of wet basement issues are from water that is within 10' of the perimeter of the house.

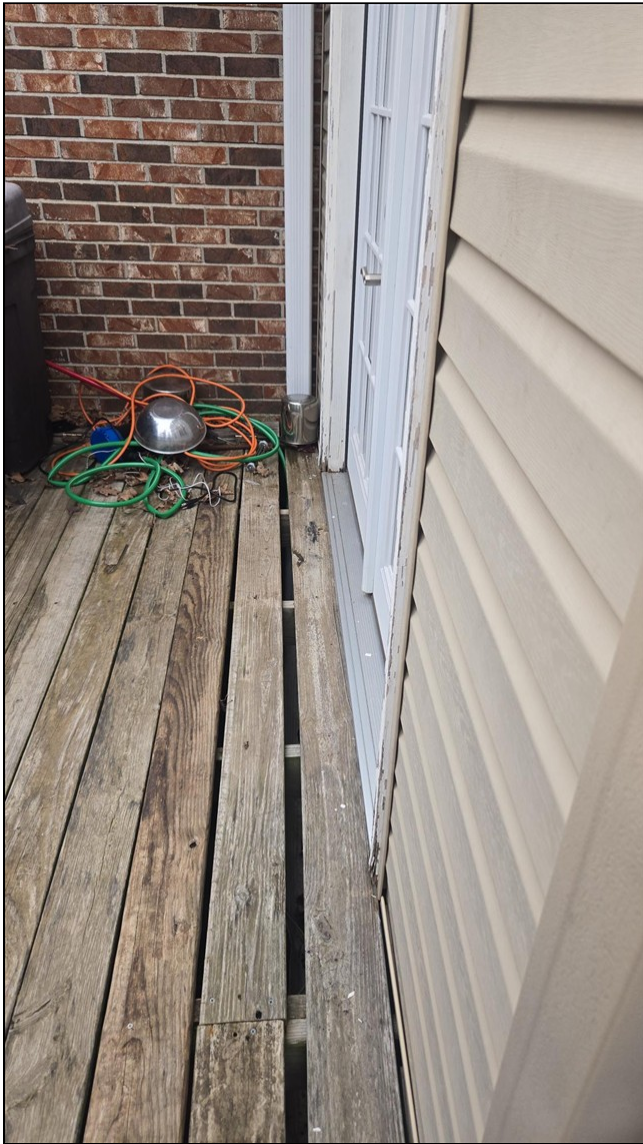
1.3 Item 5(Picture) This basement was actively wet.Improving the surface drainage and downspout drains around the house will increase the likelihood of a dry basement. The basement was dry at the time of the inspection. InterNACHI estimates that over 80% of wet basement issues are from water that is within 10' of the perimeter of the house.

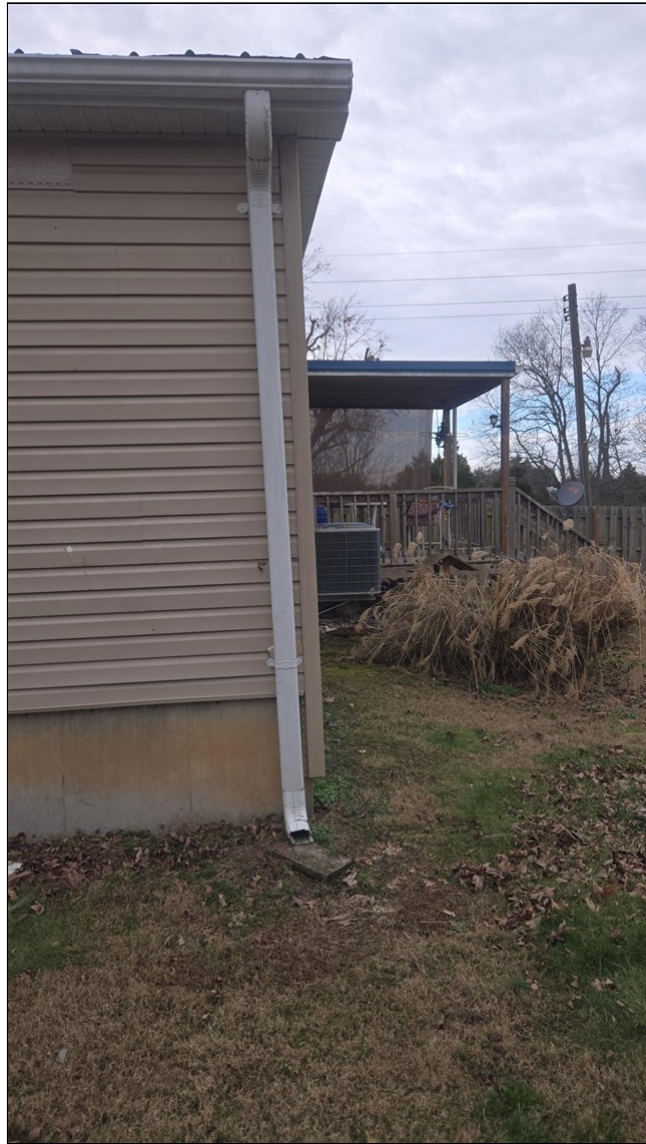
1.3 Item 6(Picture) This basement was actively wet.Improving the surface drainage and downspout drains around the house will increase the likelihood of a dry basement. The basement was dry at the time of the inspection. InterNACHI estimates that over 80% of wet basement issues are from water that is within 10' of the perimeter of the house.

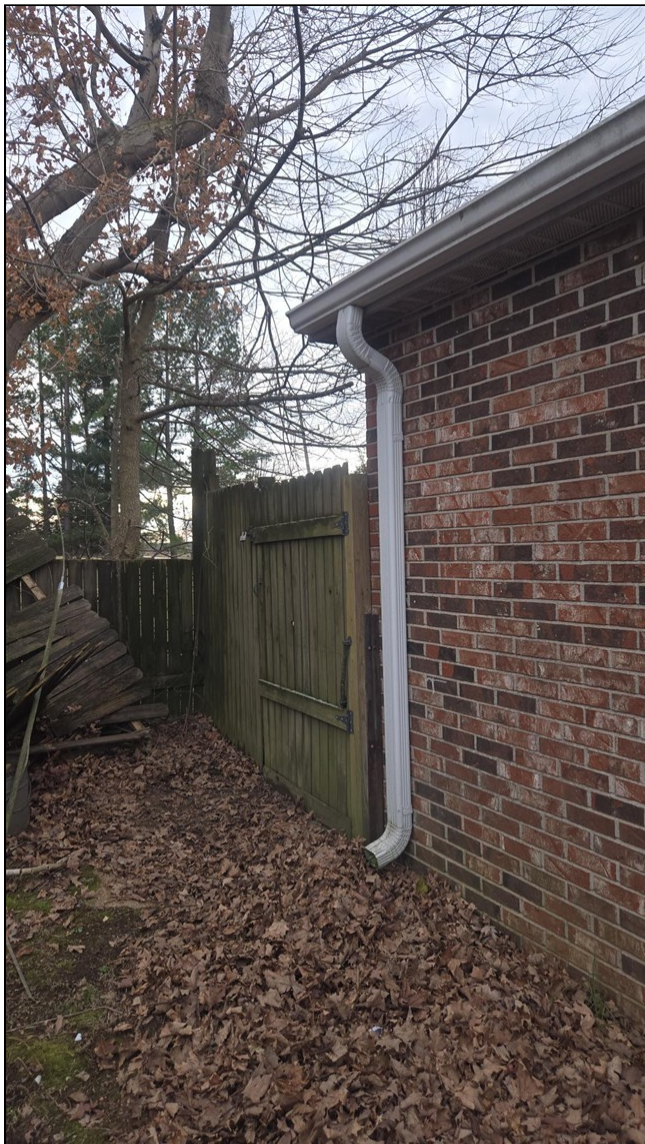
1.3 Item 7(Picture) This basement was actively wet.Improving the surface drainage and downspout drains around the house will increase the likelihood of a dry basement. The basement was dry at the time of the inspection. InterNACHI estimates that over 80% of wet basement issues are from water that is within 10' of the perimeter of the house.

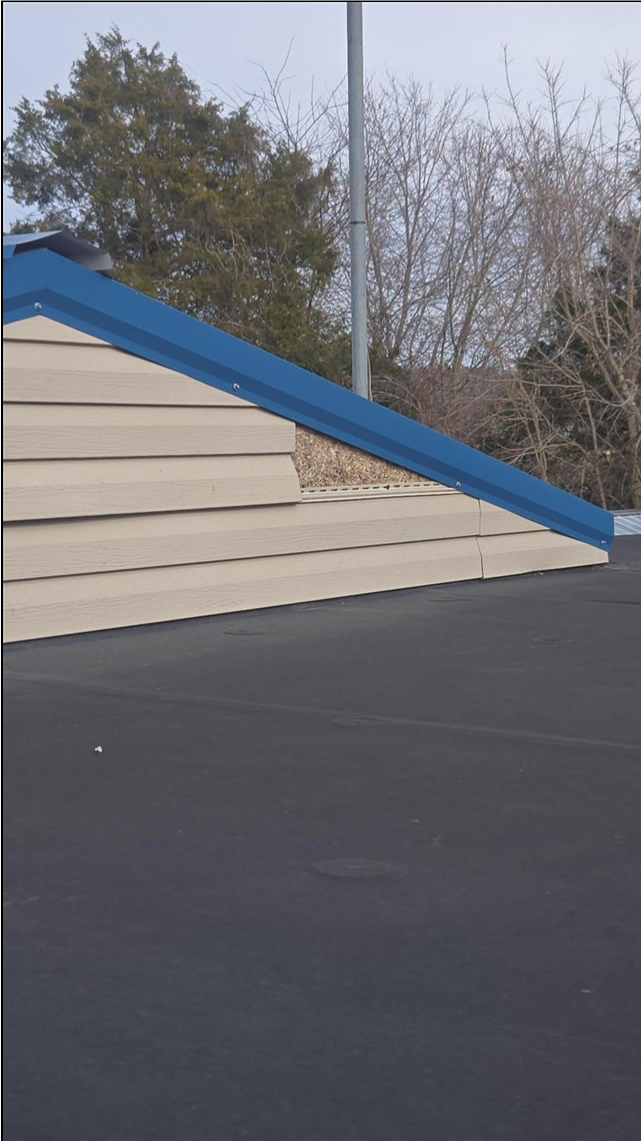
2.0 Item 1(Picture) There was missing siding noticed and the OSB exterior wall sheathing was not protected with a house wrap. The siding should be completely removed. The osb exterior walls should be provided with house wrap and the siding should be reinstalled.

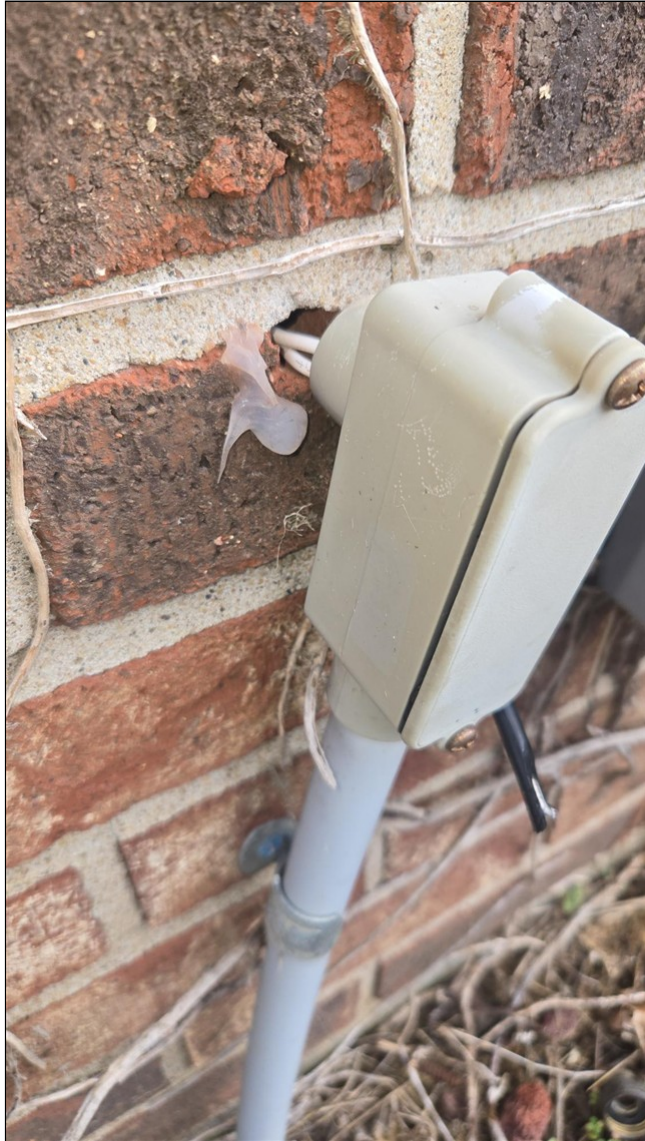
2.0 Item 2(Picture) Any and all holes should be sealed. This conduit should be repaired by a licensed electrical contractor.

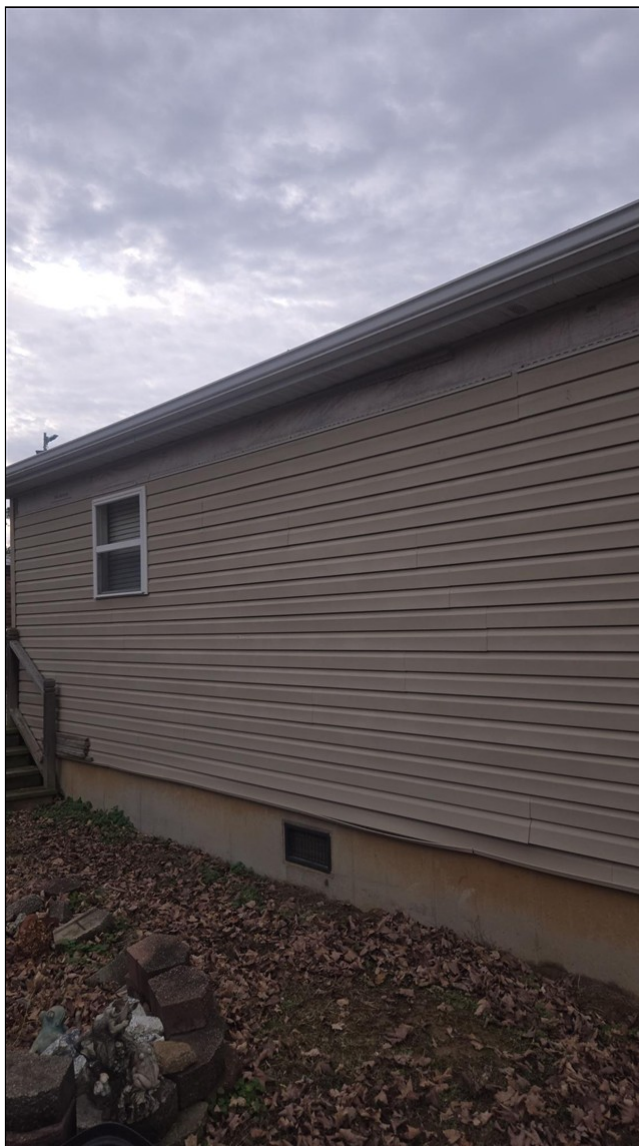
2.0 Item 4(Picture) There was missing siding noticed and the OSB exterior wall sheathing was not protected with a house wrap. The siding should be completely removed. The osb exterior walls should be provided with house wrap and the siding should be reinstalled.

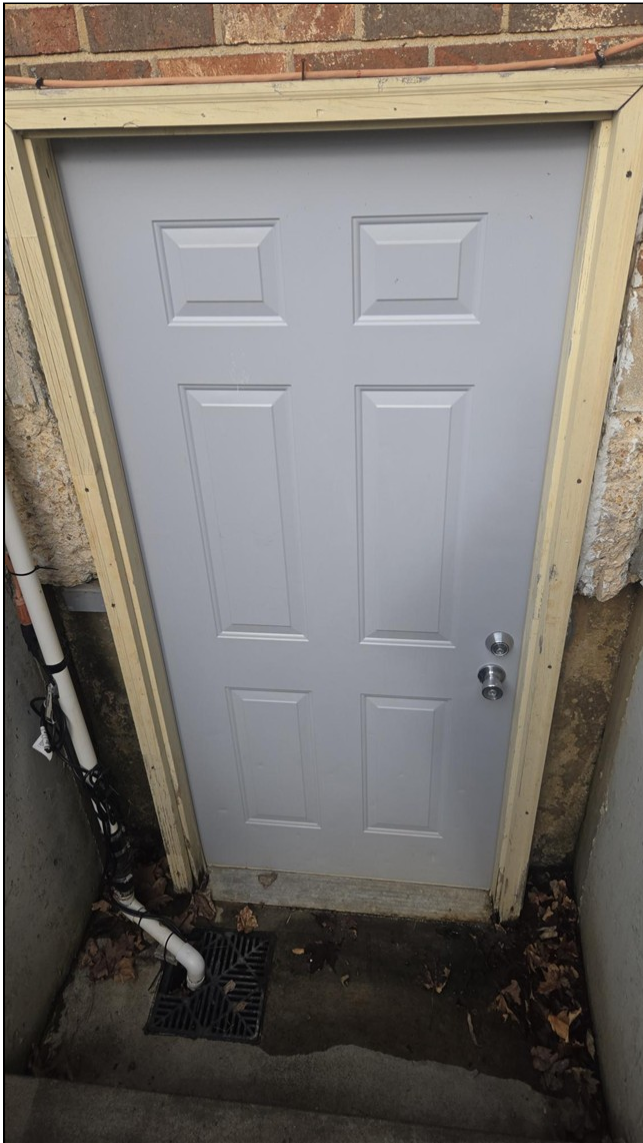
2.1 Item 1(Picture) There was bare wood and rotted wood noticed. There was exposed wood and metal. Exposed materials degrade faster than painted materials. A qualified contractor should repaint, stain, or seal any and all exposed materials. Painting of bare metal/wood is a minimum housing standard requirement.

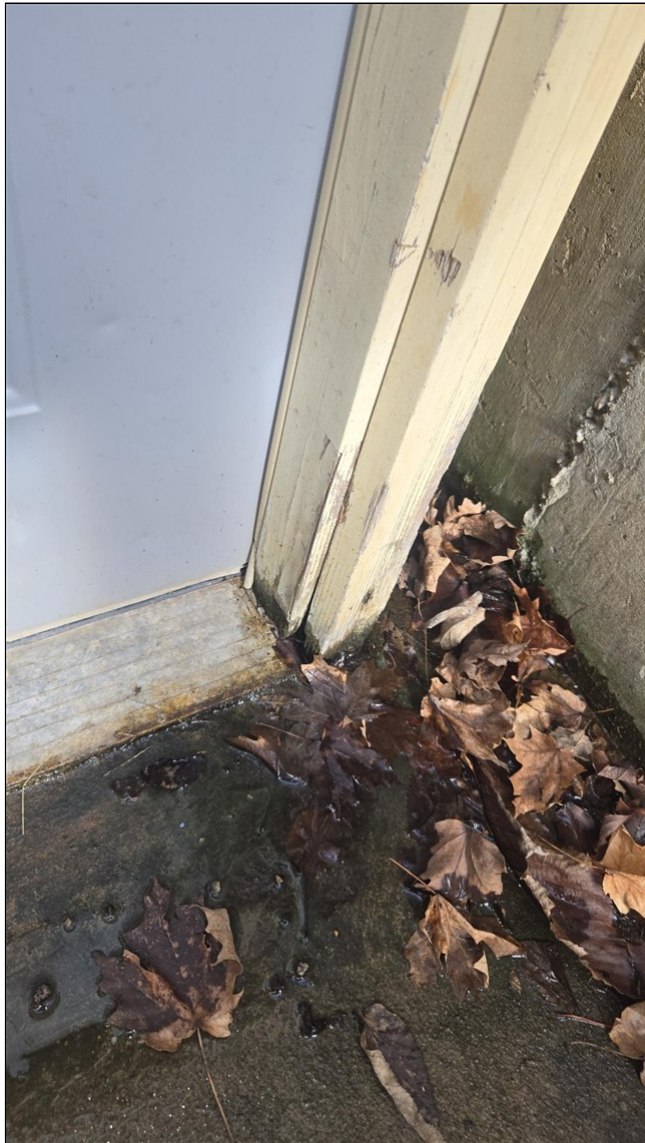
2.1 Item 2(Picture) There was bare wood and rotted wood noticed. There was exposed wood and metal. Exposed materials degrade faster than painted materials. A qualified contractor should repaint, stain, or seal any and all exposed materials. Painting of bare metal/wood is a minimum housing standard requirement.

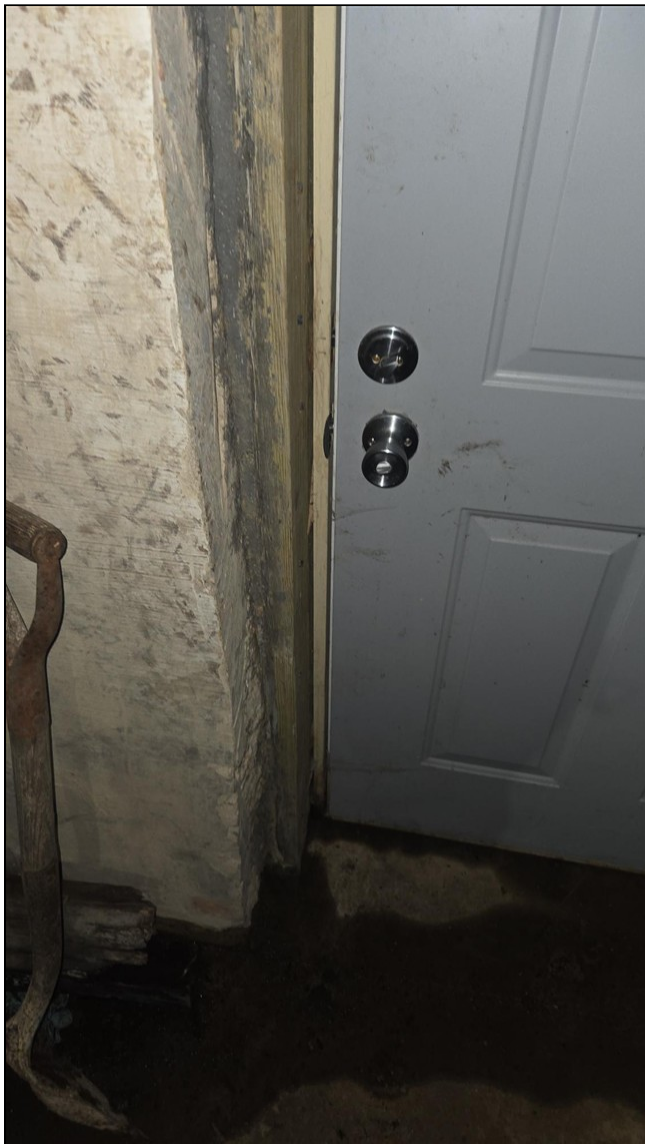
2.1 Item 3(Picture) Bolt doesn't lock on basement door. The basement door required repair.

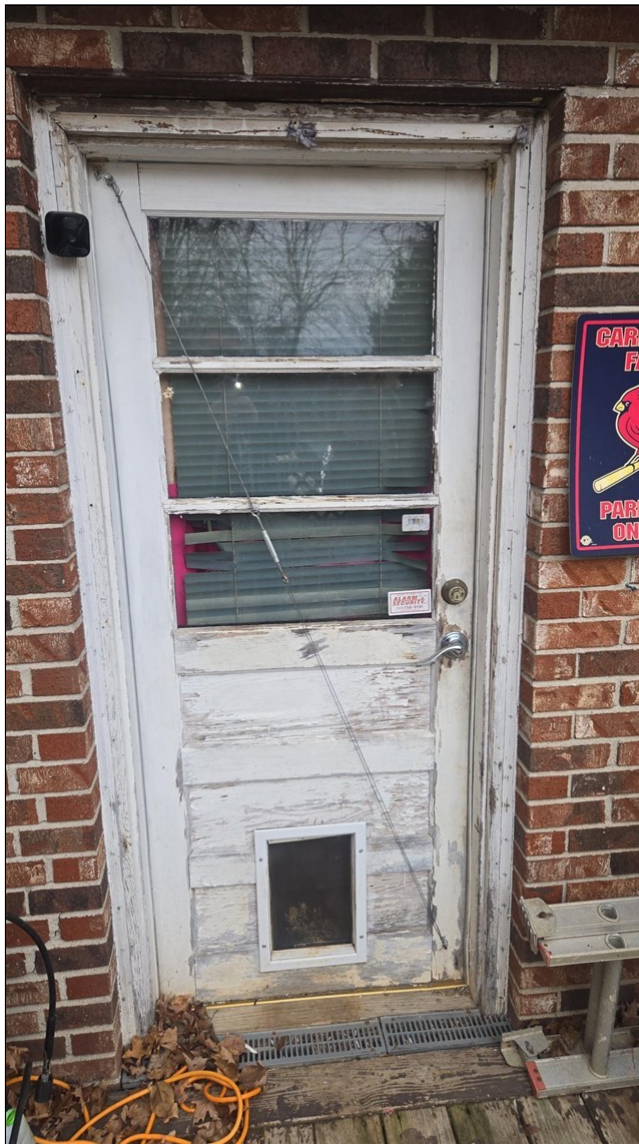
2.1 Item 4(Picture) There was bare wood and rotted wood noticed. There was exposed wood and metal. Exposed materials degrade faster than painted materials. A qualified contractor should repaint, stain, or seal any and all exposed materials. Painting of bare metal/wood is a minimum housing standard requirement.

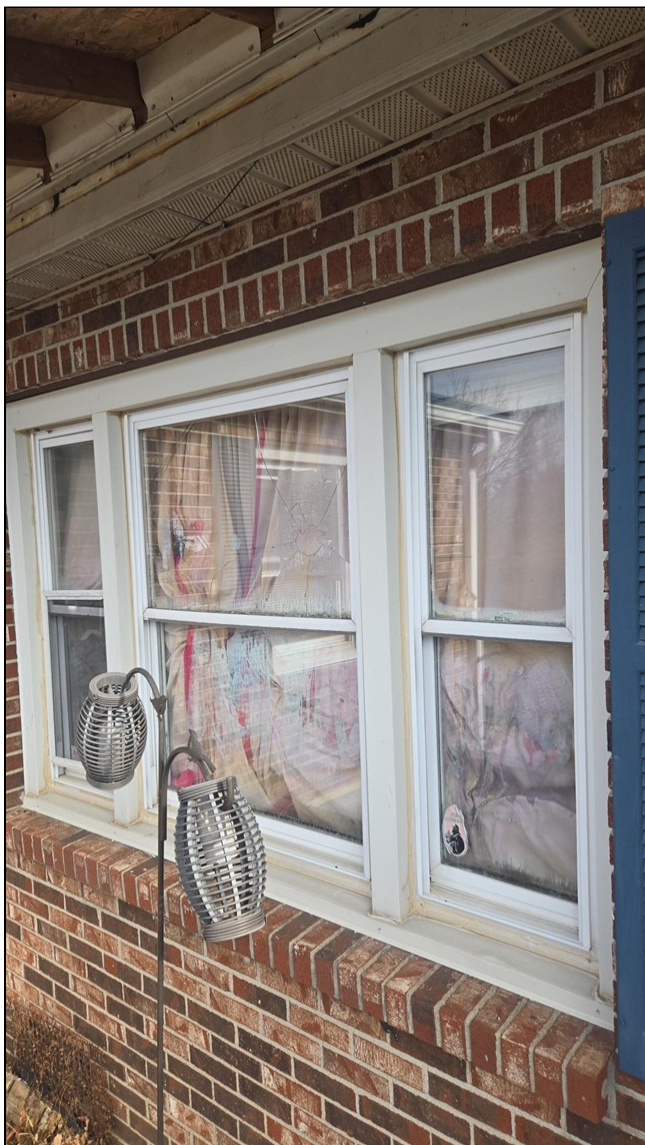
2.2 Item 1(Picture) Broken window - There was at least one broken window; any and all broken windows should be found and replaced by a qualified contractor. Minimum housing standards require all windows to be whole; exterior windows should open, close, latch, and lock. A qualified contractor should find and fix any and all broken or damaged windows.

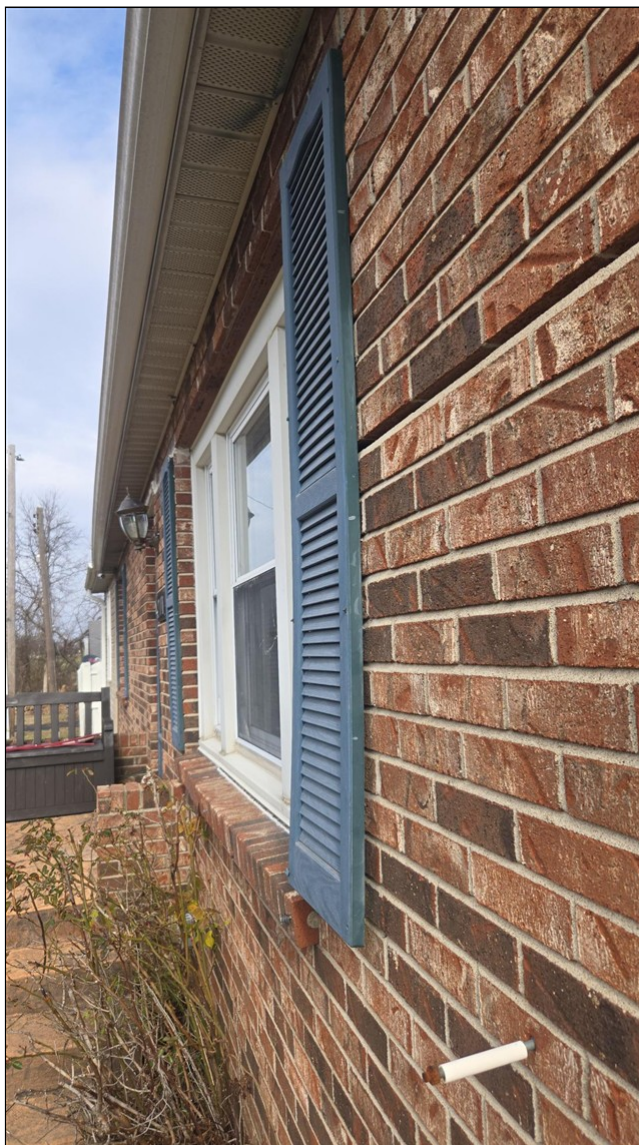
2.2 Item 2(Picture) Loose shutter - There was at least one loose shutter.

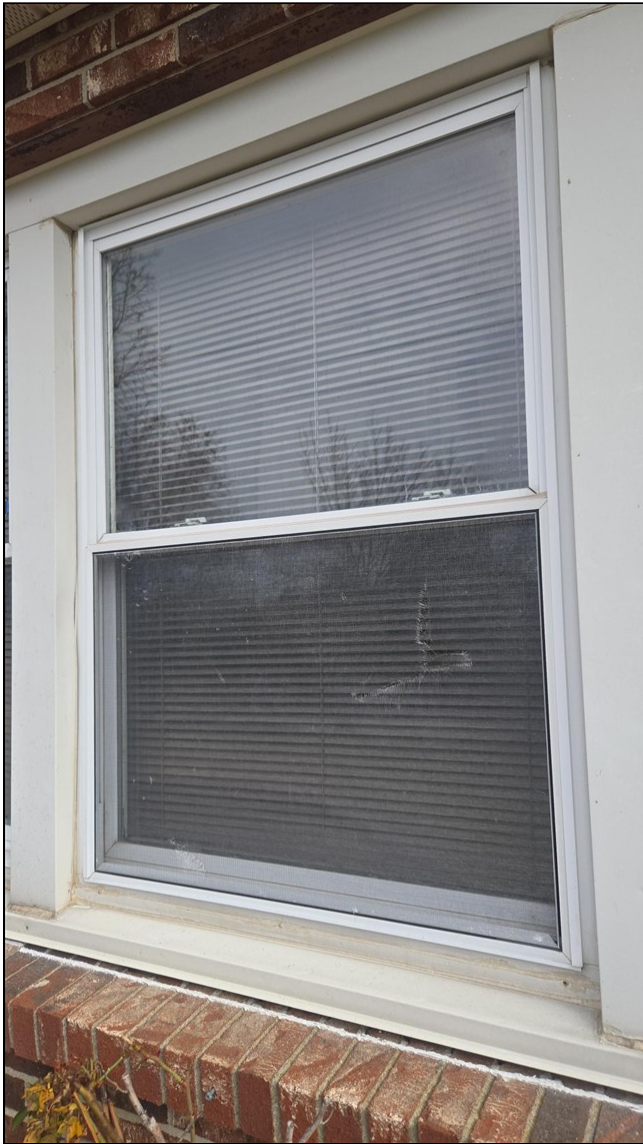
2.2 Item 3(Picture) Broken thermal seals - Dirty windows may appear to be windows with broken thermal panes. Broken thermal seals present as sometimes milky residue between the panes of glass and or condensation in between the thermal panes. Broken thermal seals allow moisture vapor to enter the window between the thermal panes and make the window less efficient from a thermal energy perspective. The windows should be cleaned; any and all broken thermal seals should be found and fixed by a qualified contractor.

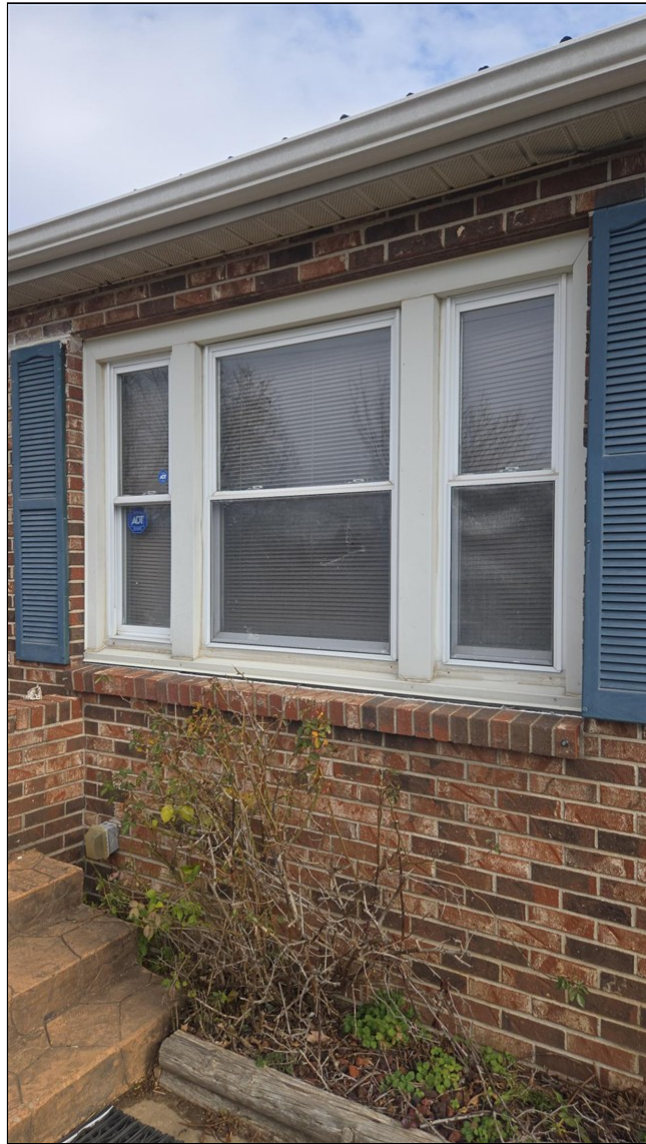
2.2 Item 4(Picture) Broken thermal seals - Dirty windows may appear to be windows with broken thermal panes. Broken thermal seals present as sometimes milky residue between the panes of glass and or condensation in between the thermal panes. Broken thermal seals allow moisture vapor to enter the window between the thermal panes and make the window less efficient from a thermal energy perspective. The windows should be cleaned; any and all broken thermal seals should be found and fixed by a qualified contractor.

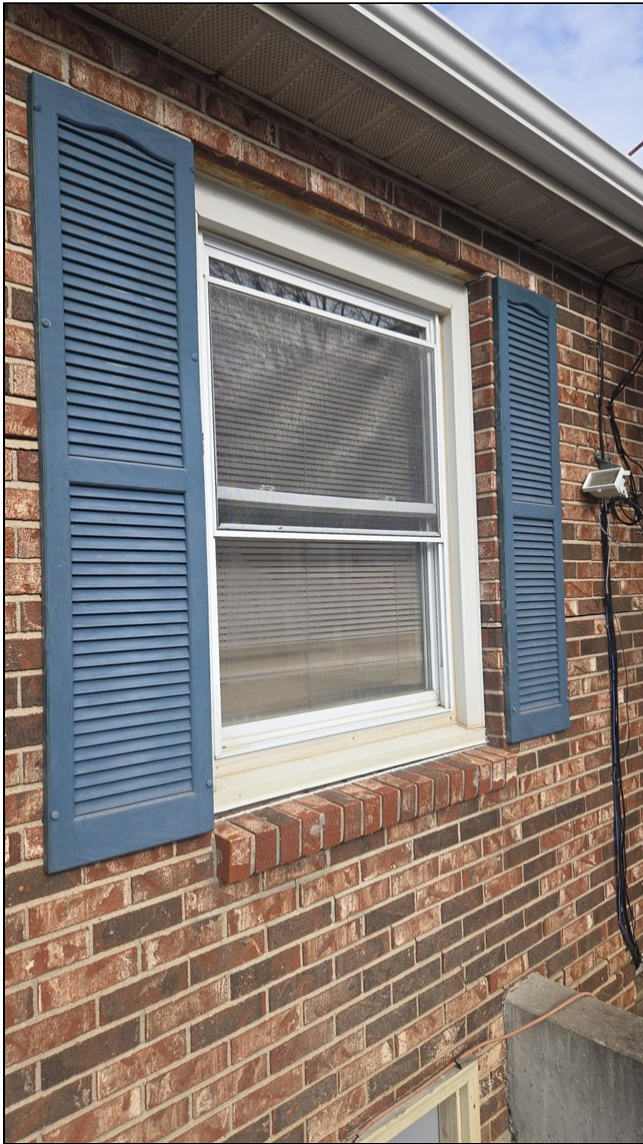
2.2 Item 5(Picture) Broken thermal seals - Dirty windows may appear to be windows with broken thermal panes. Broken thermal seals present as sometimes milky residue between the panes of glass and or condensation in between the thermal panes. Broken thermal seals allow moisture vapor to enter the window between the thermal panes and make the window less efficient from a thermal energy perspective. The windows should be cleaned; any and all broken thermal seals should be found and fixed by a qualified contractor.

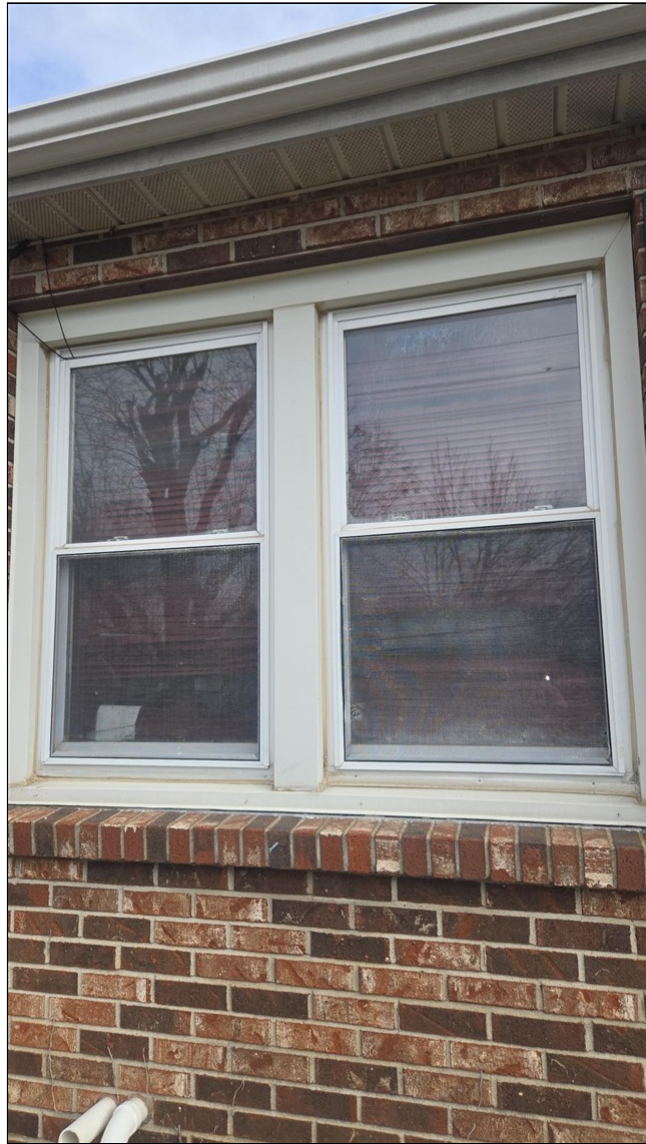
2.2 Item 6(Picture) Dirty windows may appear to be windows with broken thermal panes. Broken thermal seals present as sometimes milky residue between the panes of glass and or condensation in between the thermal panes. Broken thermal seals allow moisture vapor to enter the window between the thermal panes and make the window less efficient from a thermal energy perspective. The windows should be cleaned; any and all broken thermal seals should be found and fixed by a qualified contractor.

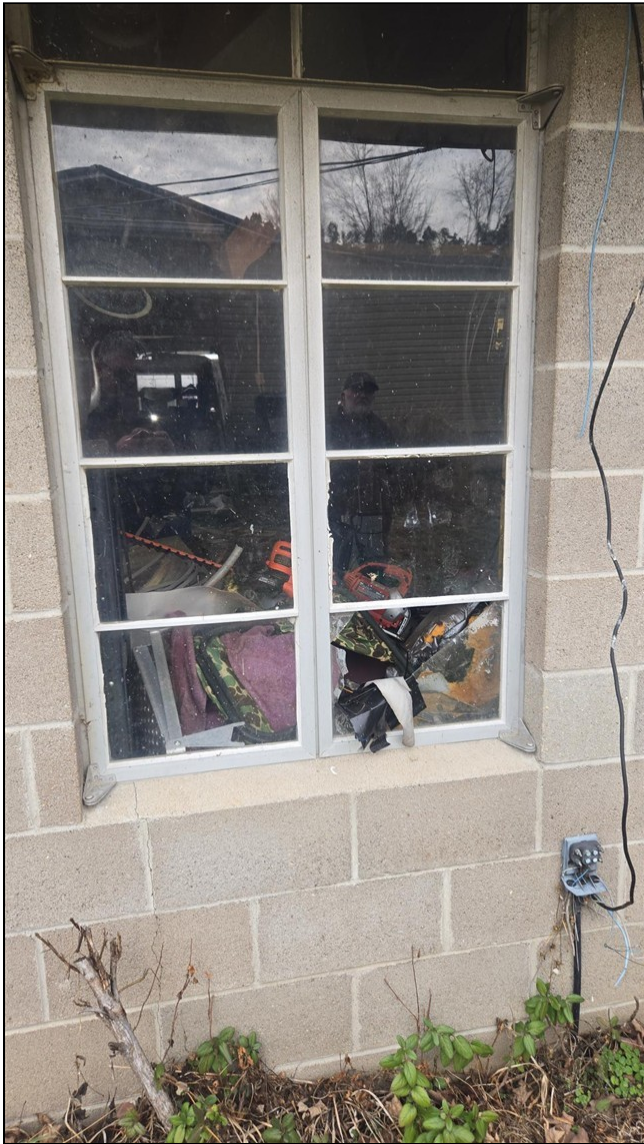
2.2 Item 7(Picture) Broken window on outbuilding.

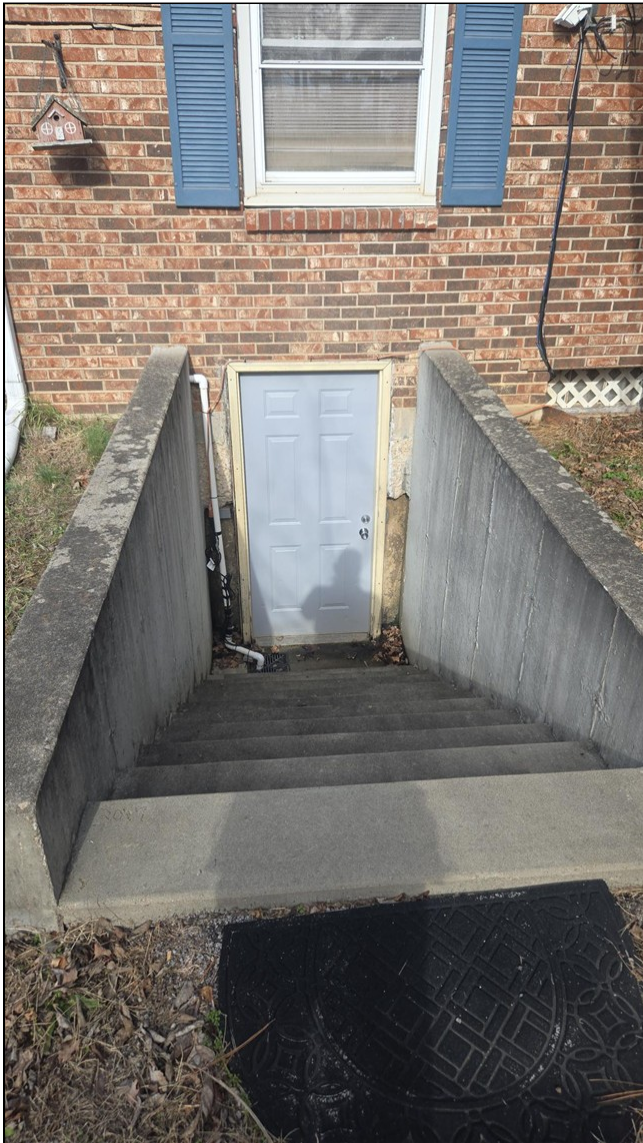
2.3 Item 1(Picture) Missing handrail. Handrails should be designed to handle 300# of force applied in any direction. Handrails should also be graspable by wrapping a hand completely around the handrail to help prevent slips, trips, and falls. Every stairwell with 4 risers or more should have a handrail. A qualified contractor should repair the handrails that don't meet those requirements.

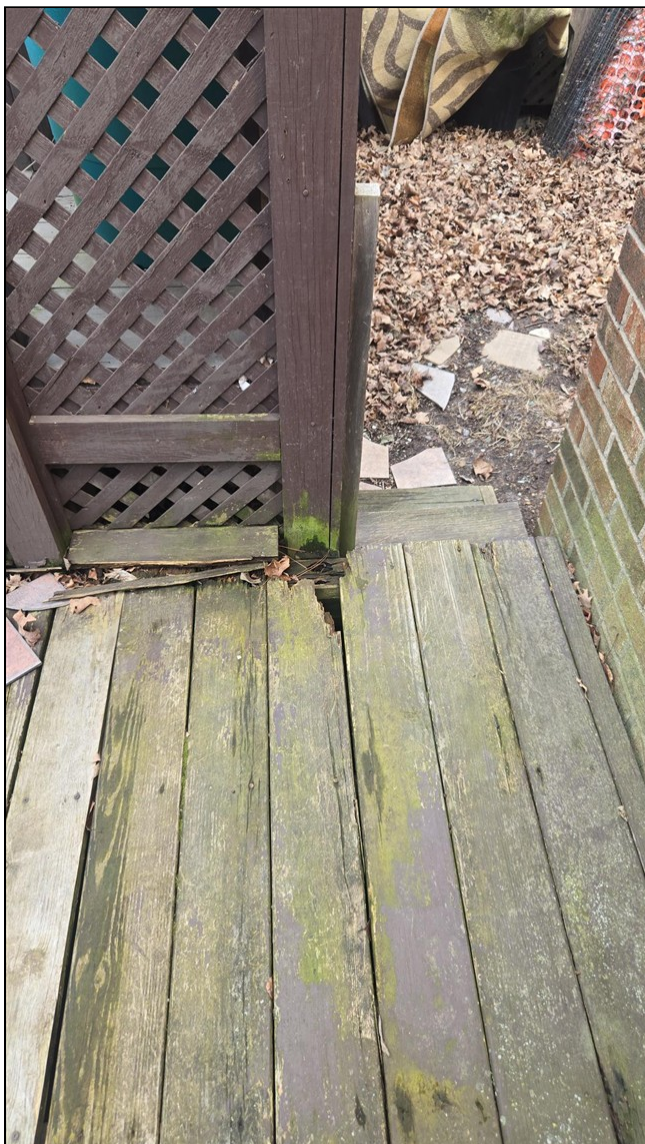
2.3 Item 3(Picture) Rotted wood noticed. There was bare wood and rotted wood noticed. There was exposed wood and metal. Exposed materials degrade faster than painted materials. A qualified contractor should repaint, stain, or seal any and all exposed materials. Painting of bare metal/wood is a minimum housing standard requirement.

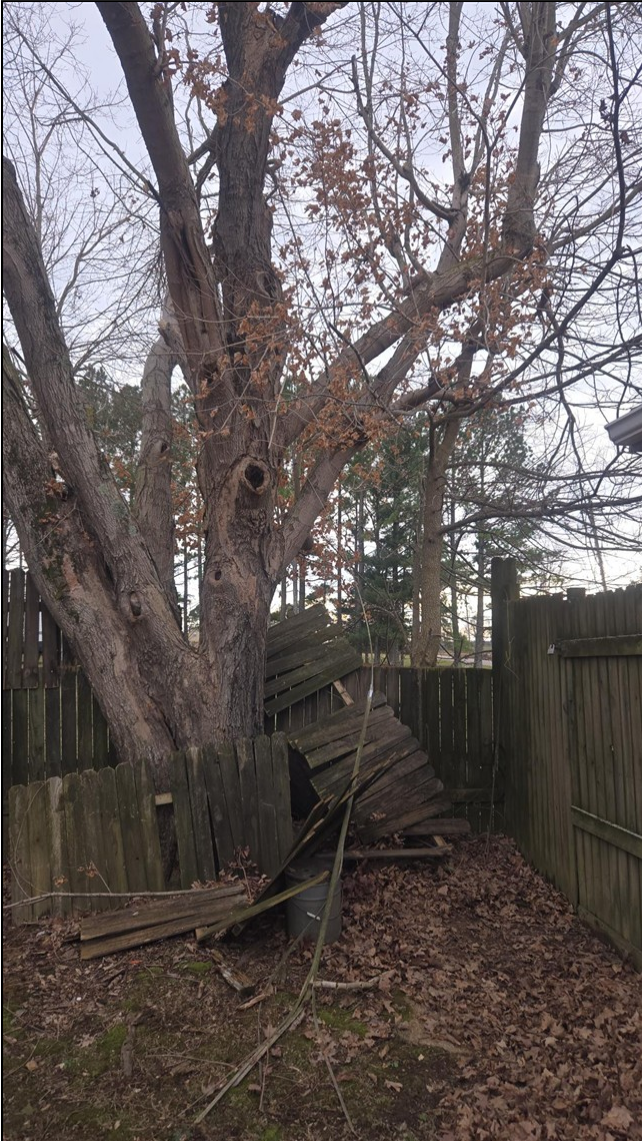
2.4 Item 1(Picture) All trees within 15' of the house should be completely removed because the roots may damage the foundation and the branches may damage the home.

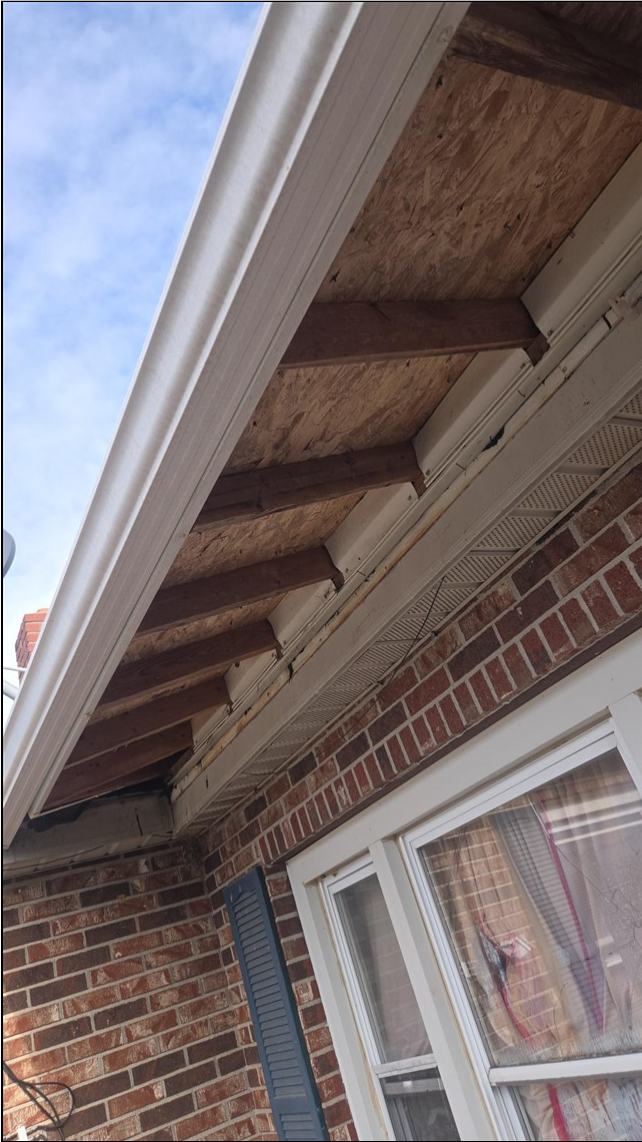
2.5 Item 1(Picture) There was missing soffit noticed.

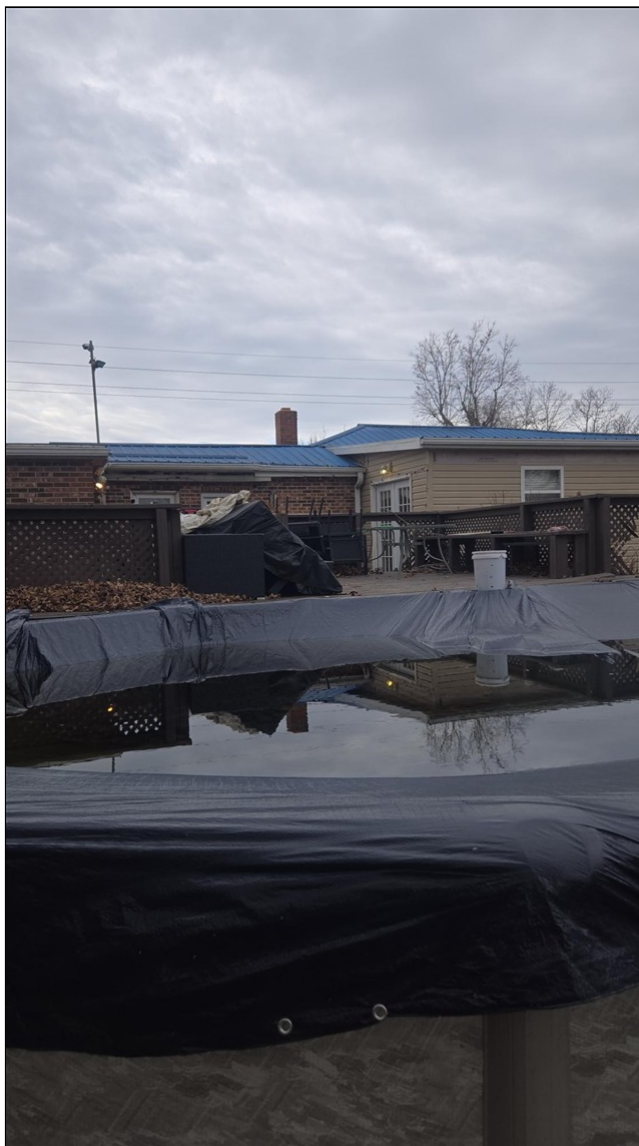
2.6 Item 2(Picture) The pool was closed for winter and could not be fully inspected.
