Inspection Report

4700 Turley Mill Rd, Farmington, MO 63640, USA

A-Team Consulting and Contracting

Date: 1/2/2025	Time:	Report ID: 2025010202
Property: Address	Customer: NAME	Real Estate Professional:

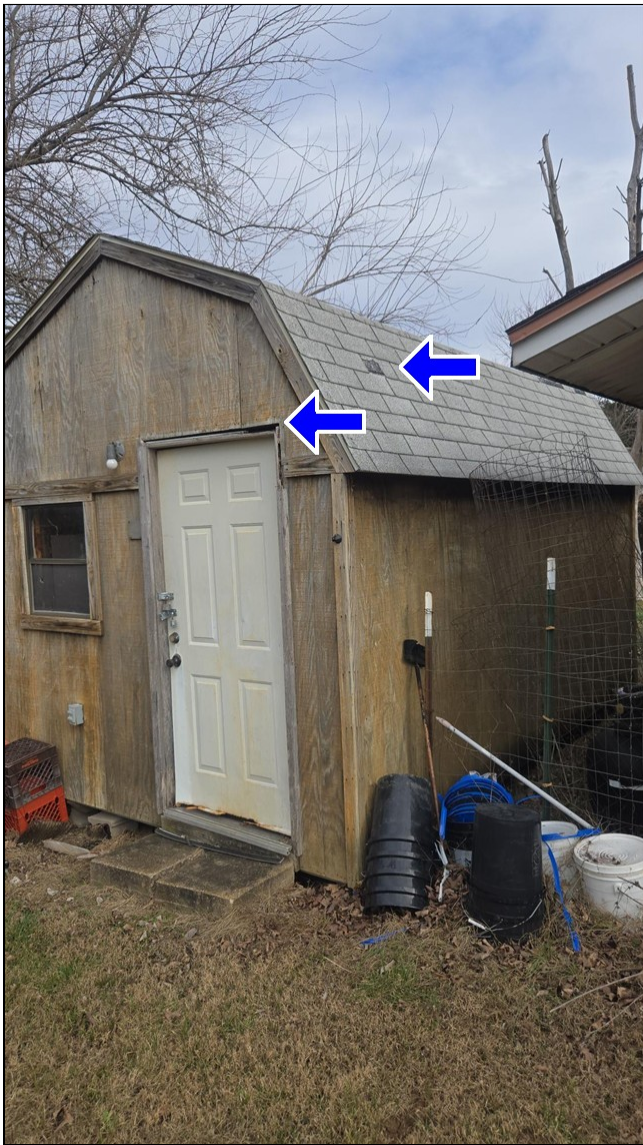
2.7 Item 1(Picture) There was exposed wood and metal. Exposed materials degrade faster than painted materials. A qualified contractor should repaint, stain, or seal any and all exposed materials. Painting of bare metal/wood is a minimum housing standard requirement.

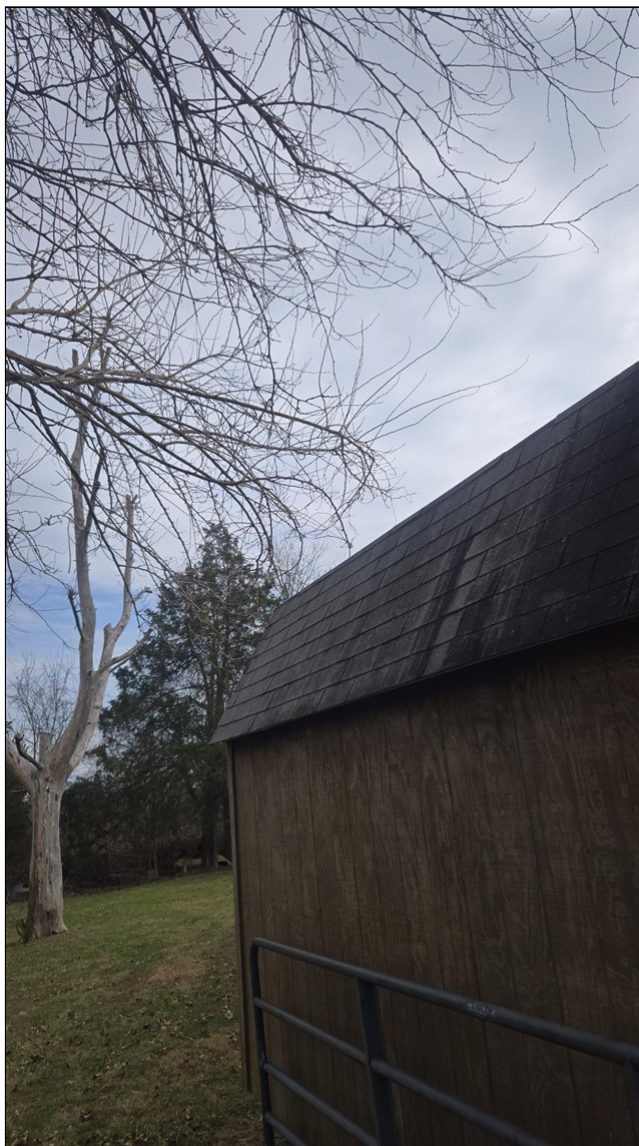
2.7 Item 4(Picture) Tree branches over outbuilding roof.

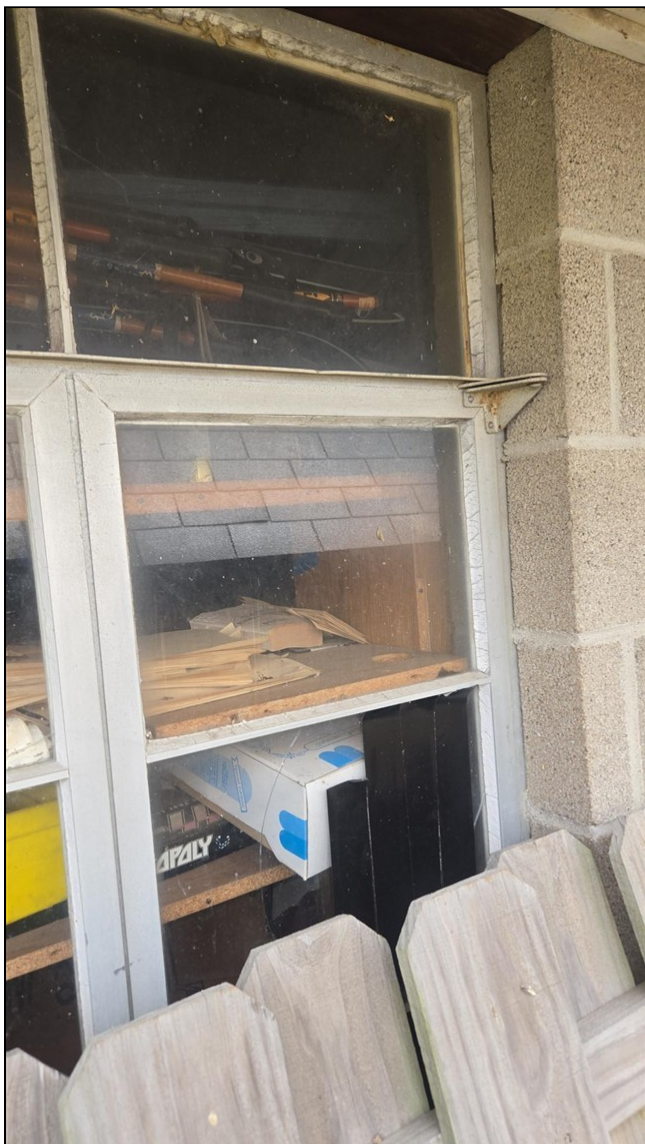
2.7 Item 5(Picture) Broken outbuilding window.

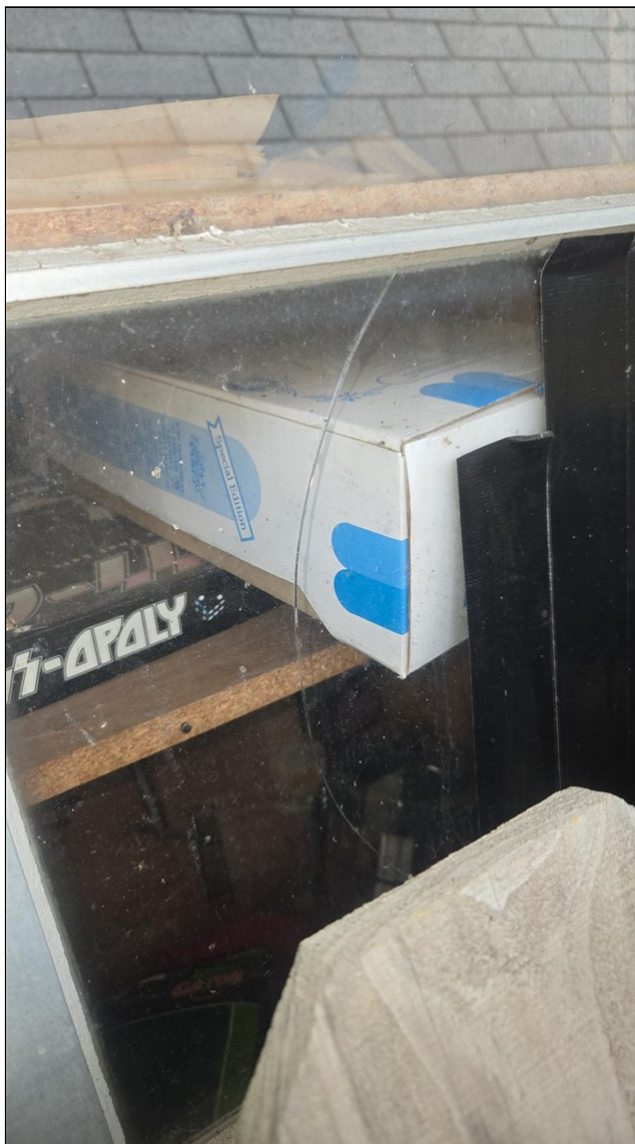
2.7 Item 6(Picture) There was at least one broken window; any and all broken windows should be found and replaced by a qualified contractor. Minimum housing standards require all windows to be whole; exterior windows should open, close, latch, and lock. A qualified contractor should find and fix any and all broken or damaged windows.

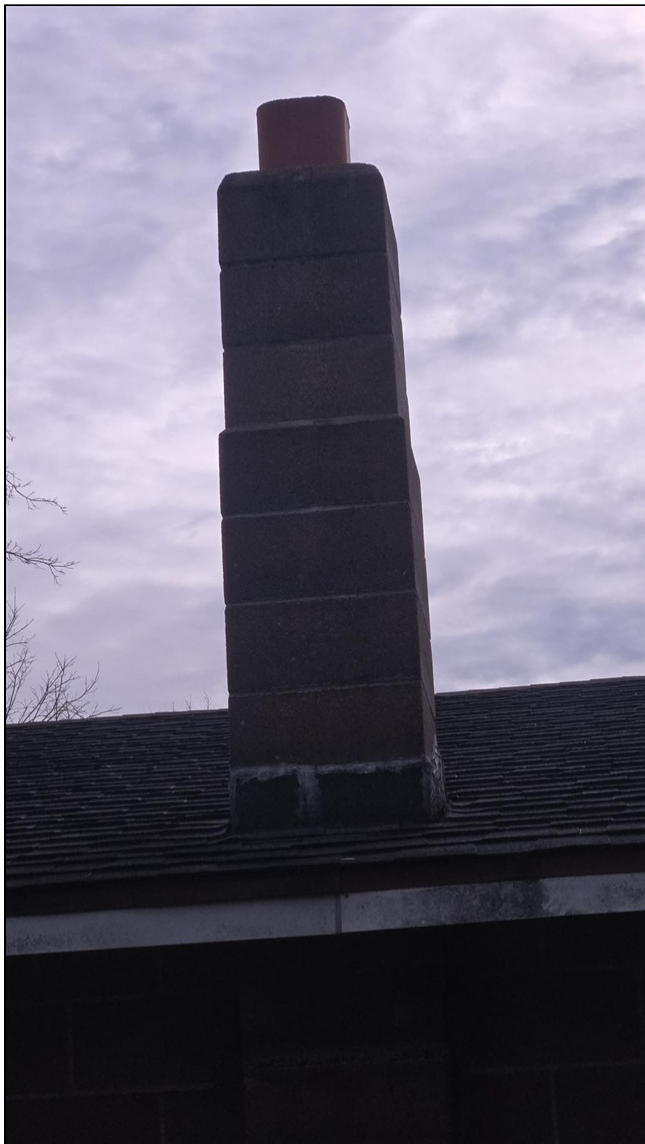
2.7 Item 7(Picture) The outbuilding flue should be swept and repaired by a licensed chimney sweep.

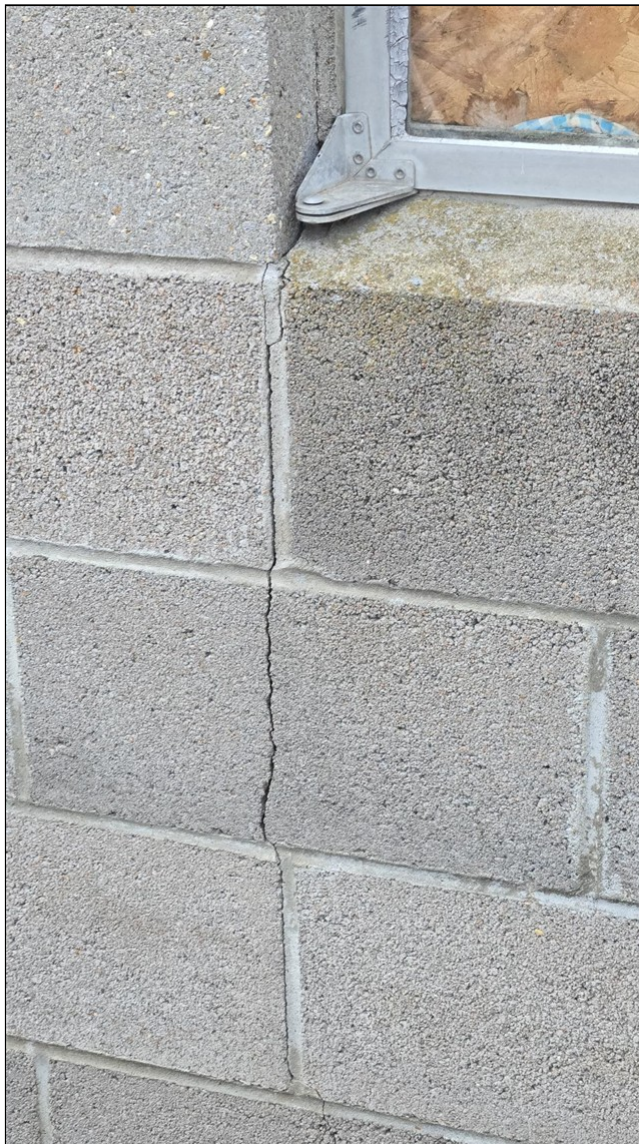
2.7 Item 8(Picture) Masonry repairs required to outbuilding.

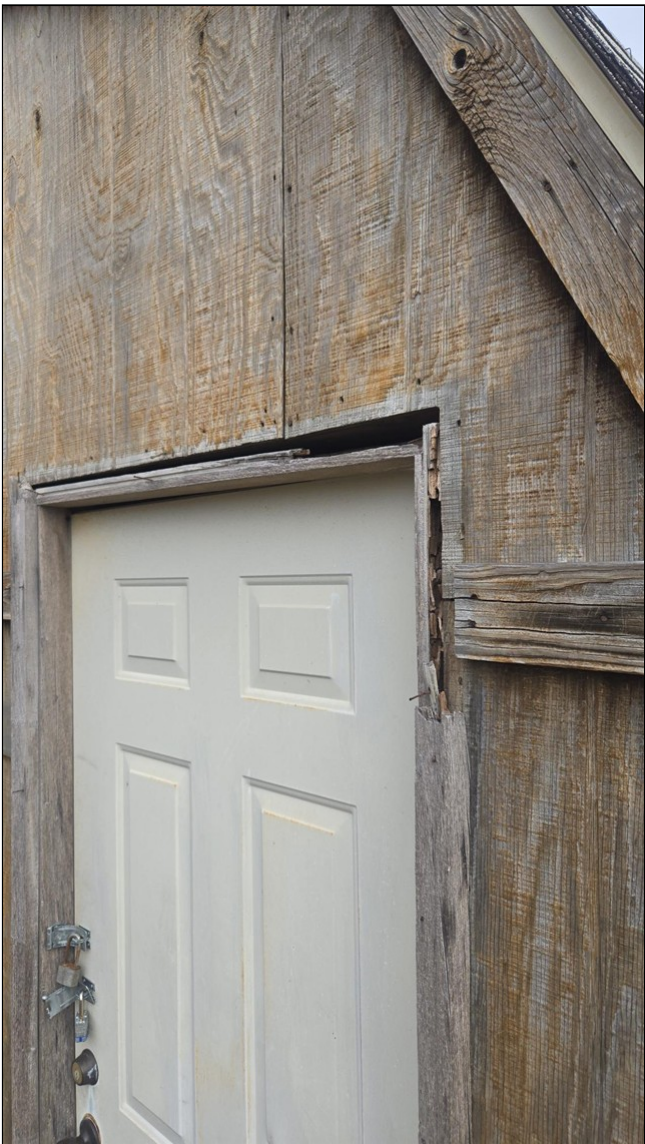
2.7 Item 10(Picture) Rotted wood outbuilding.

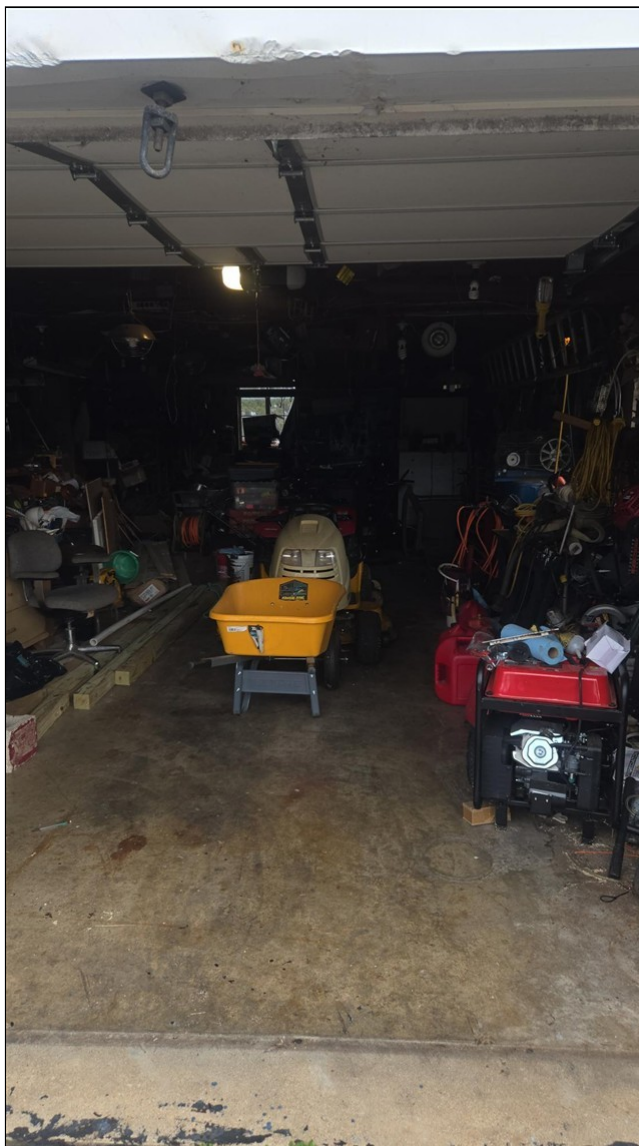
2.7 Item 12(Picture) Inspection limited by seller and seller possessions.

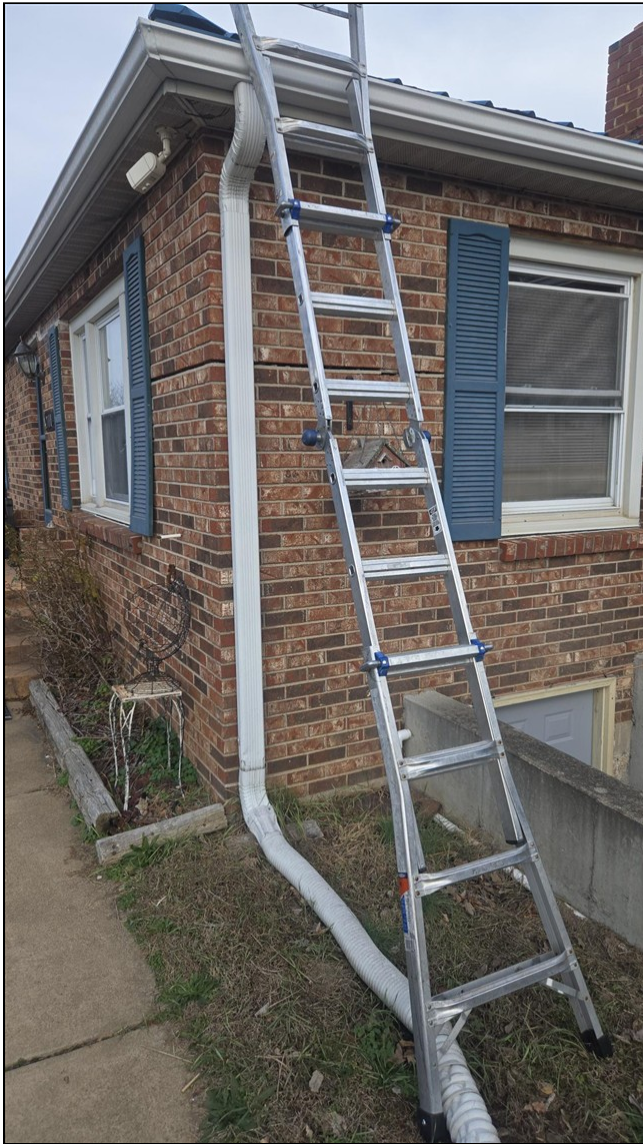
3.0 Item 1(Picture) The exterior brick veneer had subsided because of excessively wet conditions near the foundation of the veneer and removal of foundational support near the basement walk-out door. This is a structural issue for the veneer only and could be repaired in several ways. Scoping repairs is beyond the scope of the inspection. The brick veneer should be repaired to prevent water damage to the exterior wall envelope.

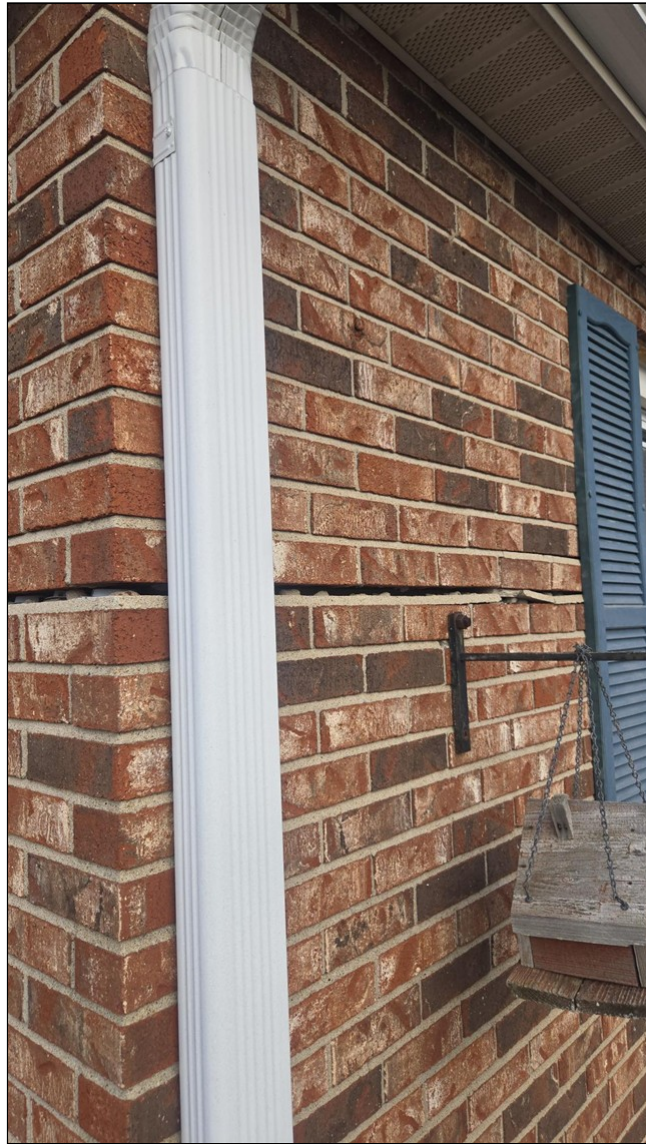
3.0 Item 2(Picture) The exterior brick veneer had subsided because of excessively wet conditions near the foundation of the veneer and removal of foundational support near the basement walk-out door. This is a structural issue for the veneer only and could be repaired in several ways. Scoping repairs is beyond the scope of the inspection. The brick veneer should be repaired to prevent water damage to the exterior wall envelope.

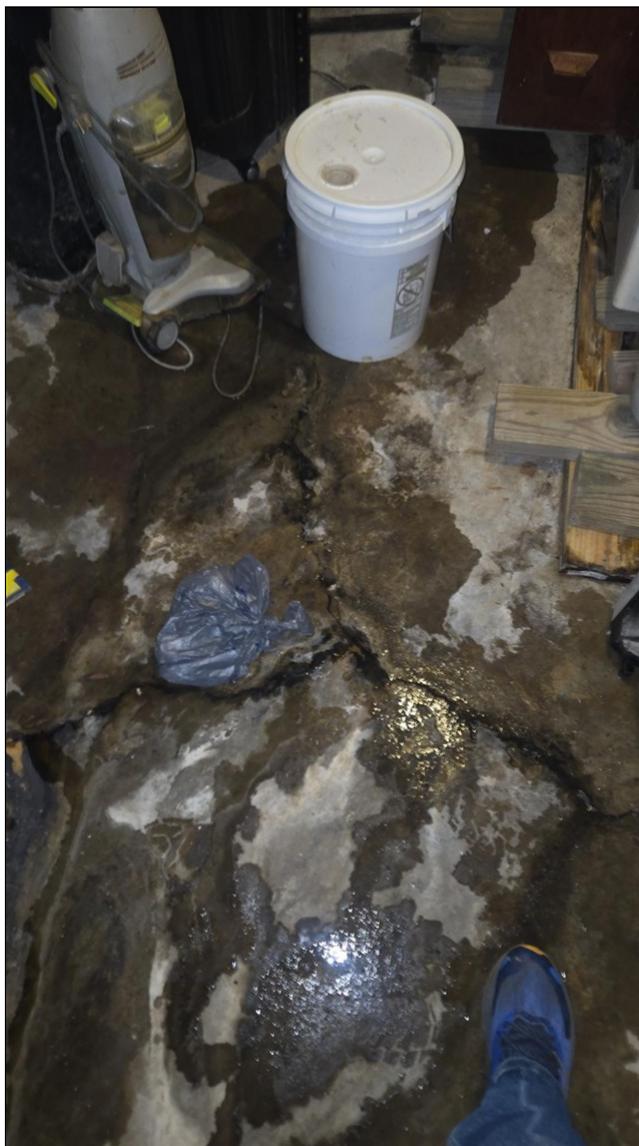
3.0 Item 4(Picture) The basement was wet at the time of the inspection. This appeared to be from hydrostatic pressure and may be due to a combination of circumstances. Based on the floor staining and the seller's description of the septic tank lid as metal, I suspect that most of this water is from a failed septic tank that is leaking near the foundation of the home and putting hydrostatic pressure on the concrete. Additional factors that may be contributing to this condition include improper downspout drainage and surface drainage around the home. I recommend that the septic tank is completely replaced and that the downspouts are installed into separate downspout drains that drain to daylight near the road ditch. Hydrostatic pressure may cause catastrophic damage to the foundation and this situation should be repaired as soon as practical.

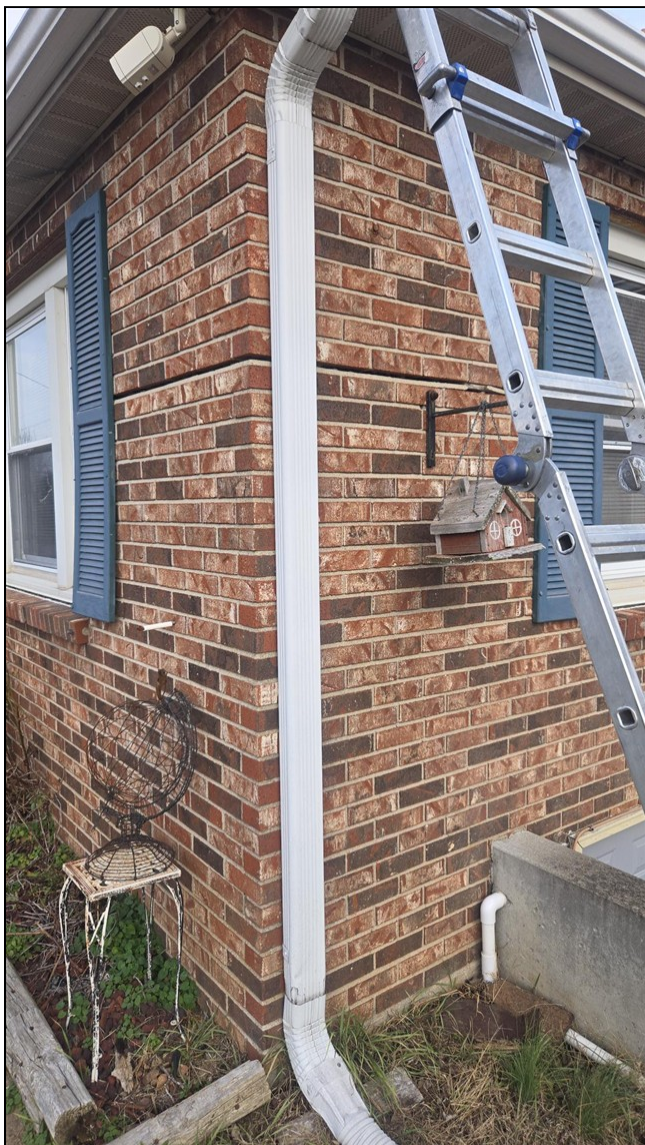
3.1 Item 1(Picture) The brick veneer required immediate repairs.

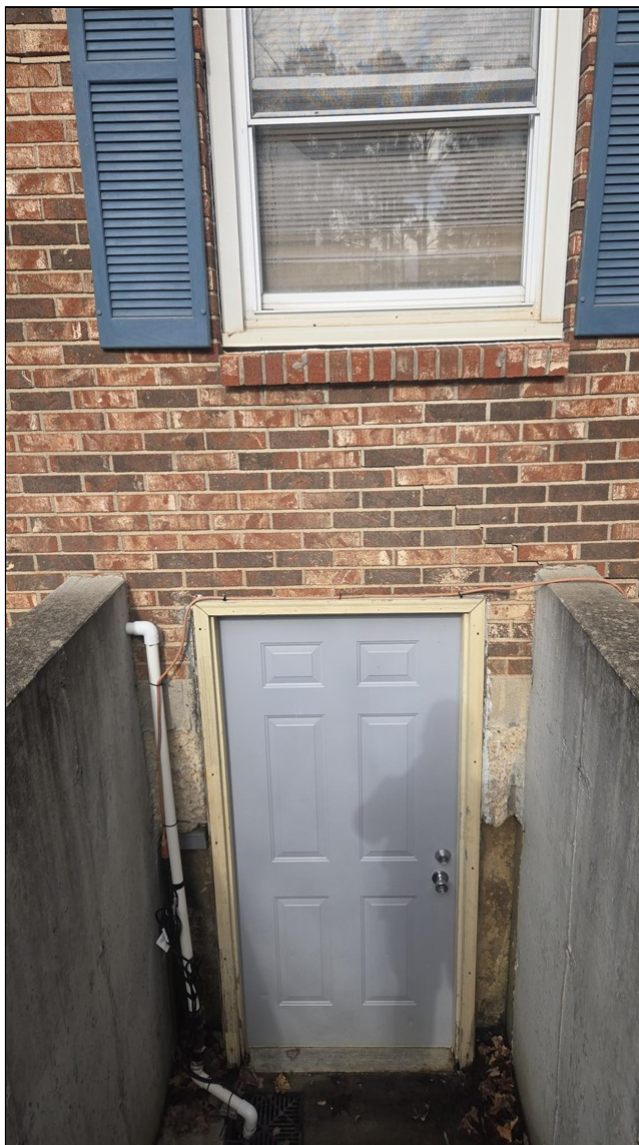
3.1 Item 2(Picture) The brick veneer required immediate repairs.

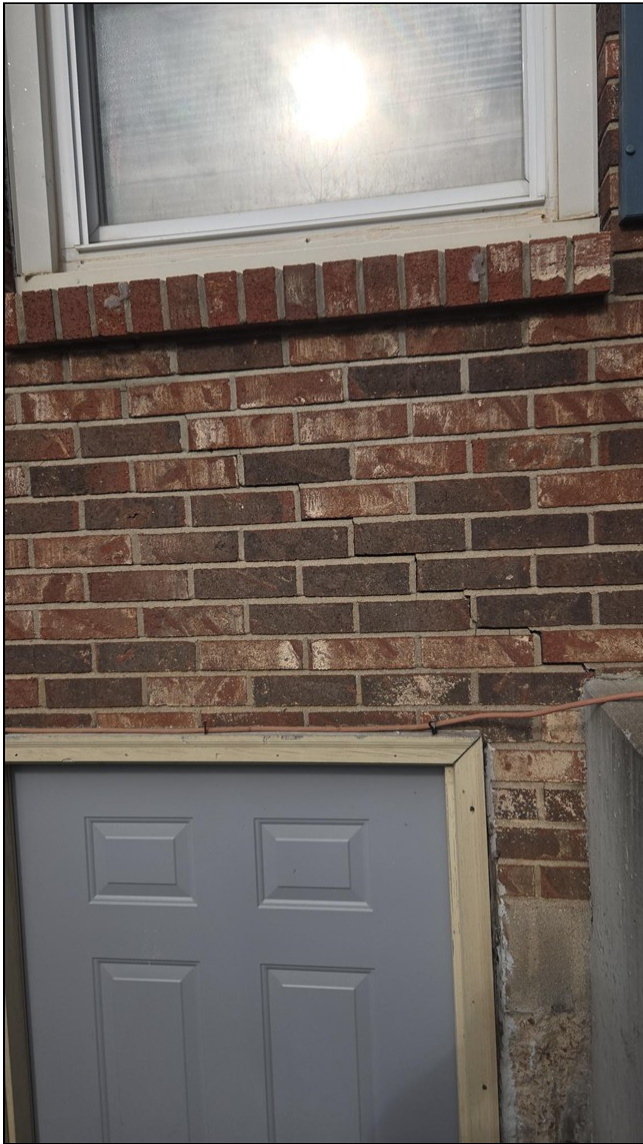
3.1 Item 3(Picture) The brick veneer required immediate repairs.

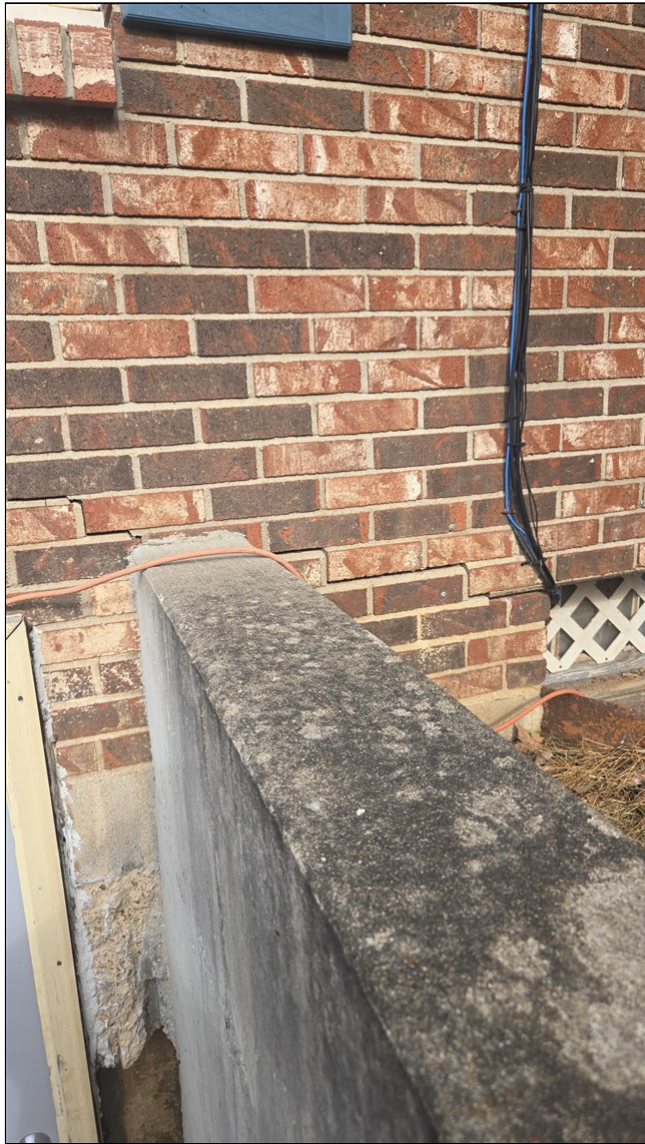
3.1 Item 4(Picture) The brick veneer required immediate repairs.

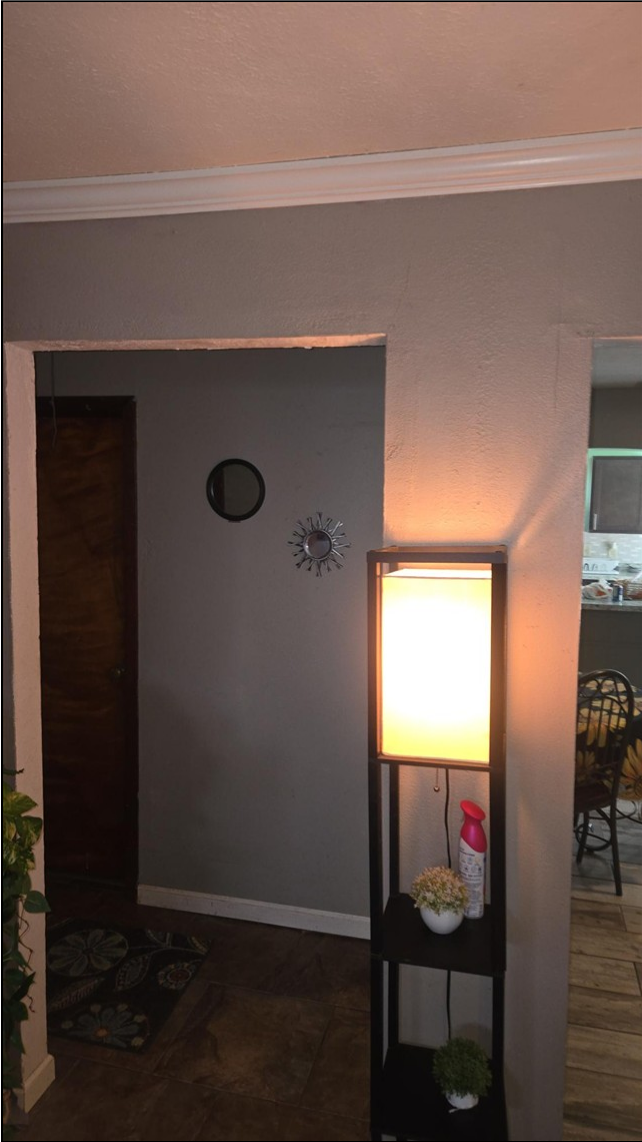
3.1 Item 5(Picture) There was visible structural movement due to termite damage and a sagging main beam. The main beam of the house should be replaced.

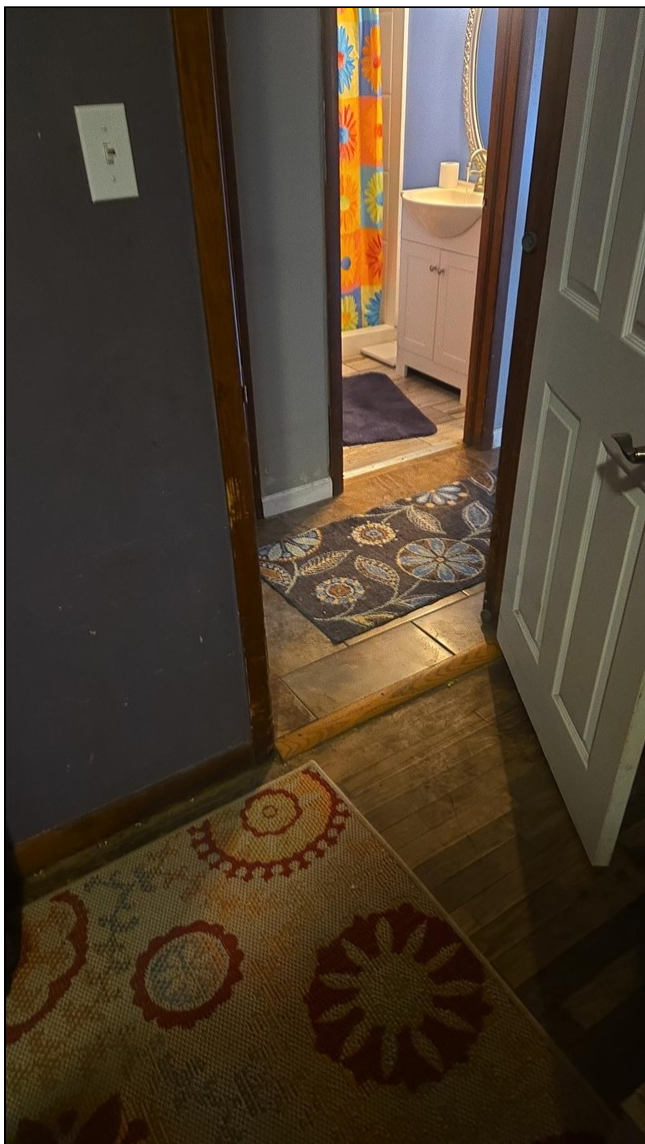
3.3 Item 1(Picture) Some areas of the home were inaccessible at the time of the inspection. We were unable to inspect the crawlspace or attic area. There was noticeable deflection in the floors in some areas and I expect that there are some floor joists that require repairs.

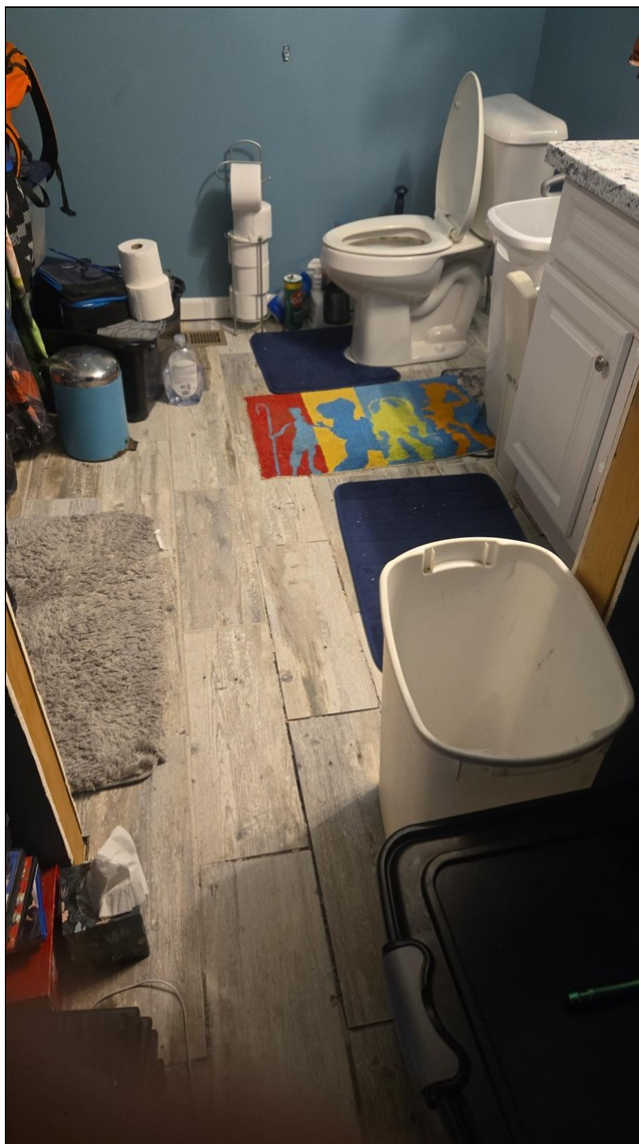
3.3 Item 2(Picture) Some areas of the home were inaccessible at the time of the inspection. We were unable to inspect the crawlspace or attic area. There was noticeable deflection in the floors in some areas and I expect that there are some floor joists that require repairs.

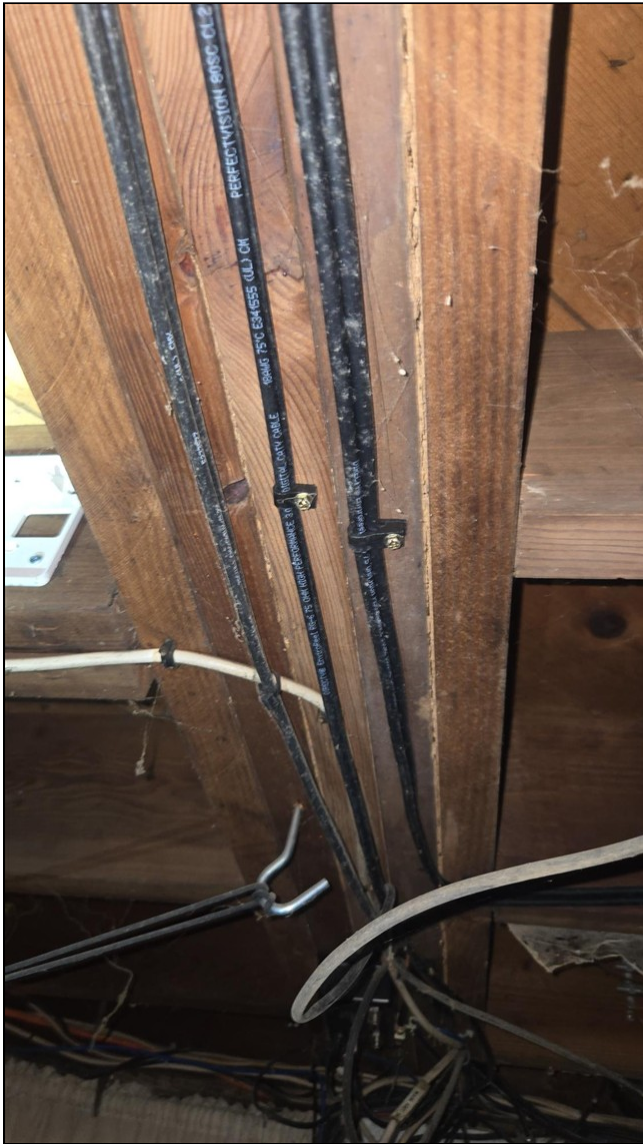
3.3 Item 3(Picture) Main beam termite damage noticed. The main beam should be replaced.

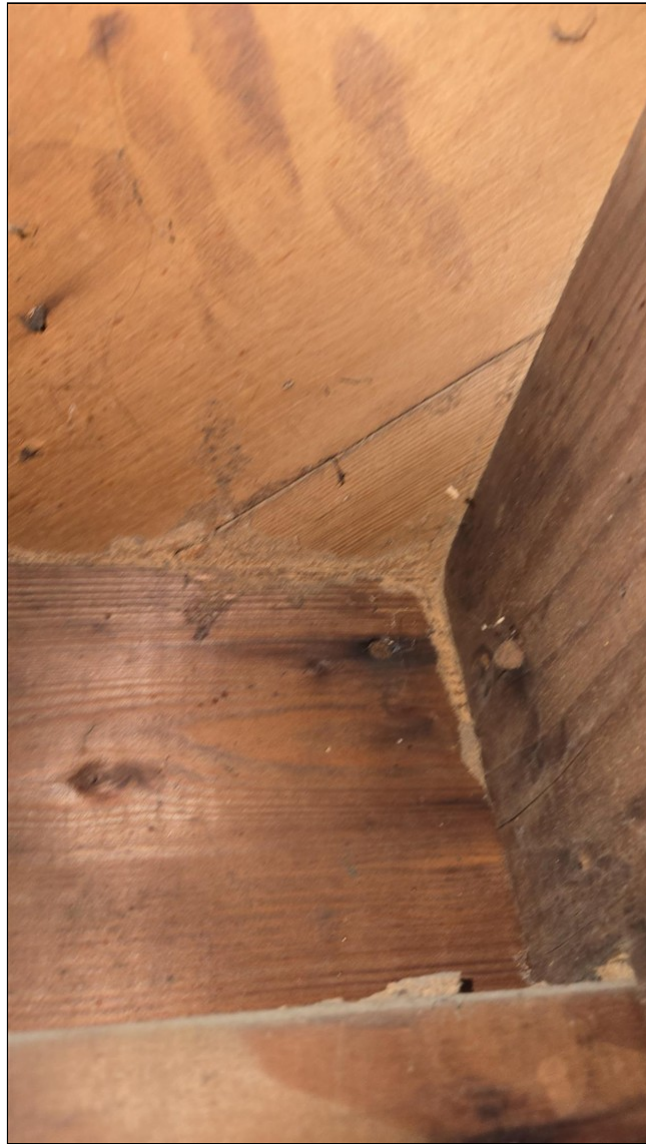
3.3 Item 4(Picture) Floor joist termite damage noticed. There was noticeable deflection in the floors in some areas and I expect that there are some floor joists that require repairs. Evidence of termites and some termite damage was found. Some termite damage may be hidden. We recommend termite treatment. Any and all termite damaged wood should be repaired or replaced. A qualified contractor should repair or replace any and all damaged, cracked, or buckled floor joists. The floor joists should be sistered with a continuous board that is the same size as width as the existing floor joist and the same length as the existing floor joist. The sistered floor joist should be bearing on the sill plate on one side and bearing on the beam on the otherside. The sistered floor joist should be #6 screwed or 6d nailed to the old floor joist on an eschelon pattern with 6" offset between the fasteners. The fasteners should alternate between top and bottom of the floor joist. The fasteners should not be located less than 2" from the outside edge of the board. The sistered board should be installed crown facing up.

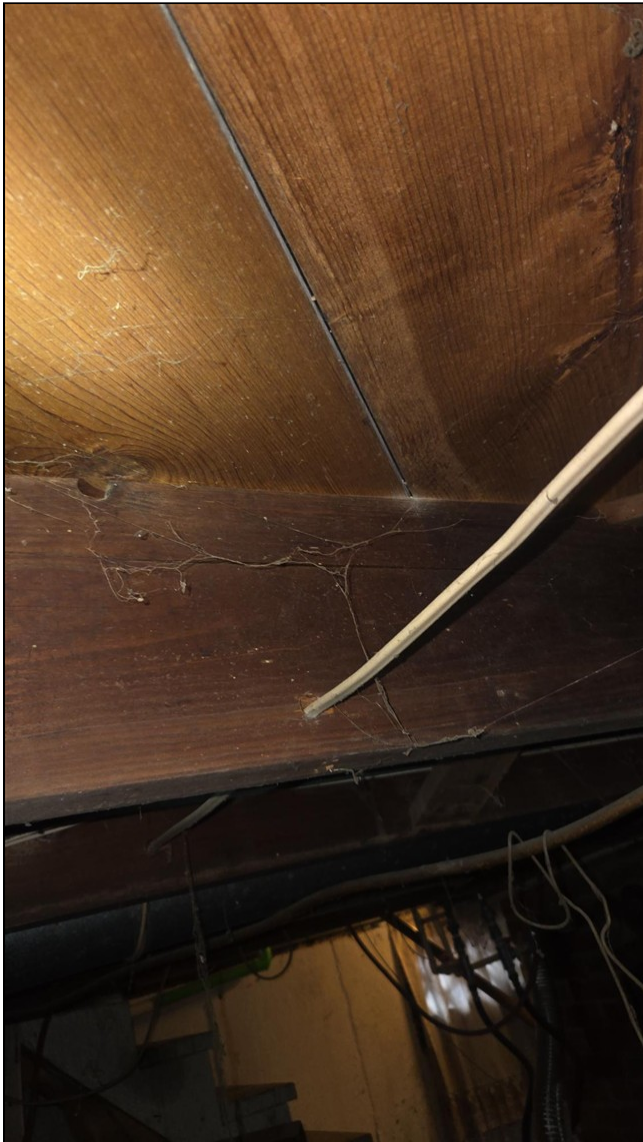
3.3 Item 5(Picture) There was noticeable deflection in the floors in some areas and I expect that there are some floor joists that require repairs. Evidence of termites and some termite damage was found. Some termite damage may be hidden. We recommend termite treatment. Any and all termite damaged wood should be repaired or replaced. A qualified contractor should repair or replace any and all damaged, cracked, or buckled floor joists. The floor joists should be sistered with a continuous board that is the same size as width as the existing floor joist and the same length as the existing floor joist. The sistered floor joist should be bearing on the sill plate on one side and bearing on the beam on the otherside. The sistered floor joist should be #6 screwed or 6d nailed to the old floor joist on an eschelon pattern with 6" offset between the fasteners. The fasteners should alternate between top and bottom of the floor joist. The fasteners should not be located less than 2" from the outside edge of the board. The sistered board should be installed crown facing up.

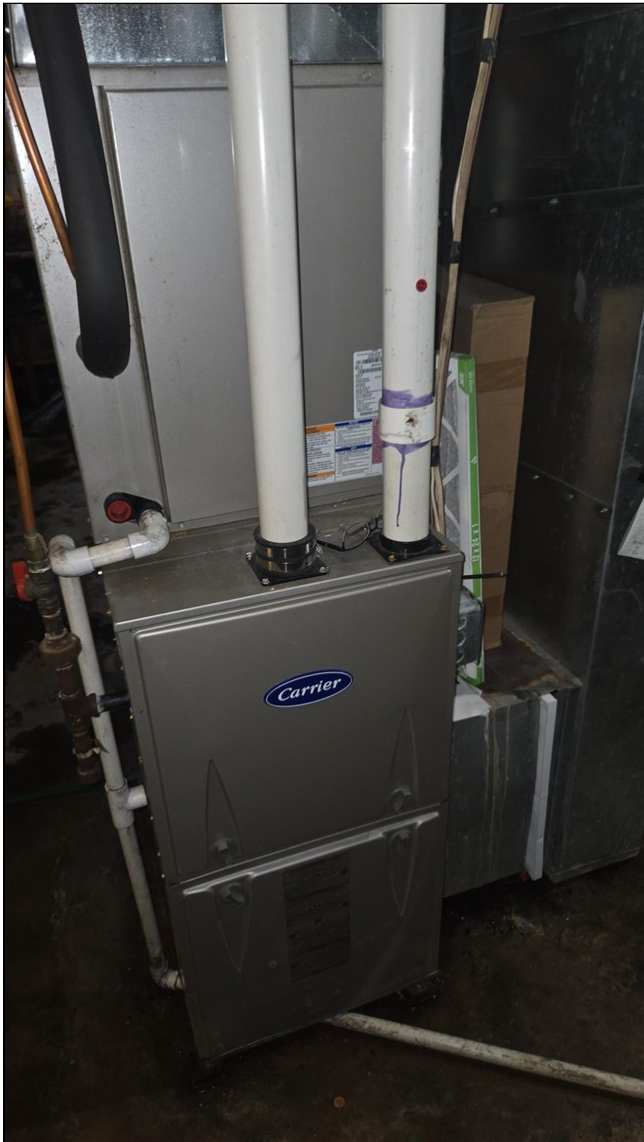
4.0 Item 1(Picture) 2016 Carrier gas furnace inspected and operable at the time of the inspection.

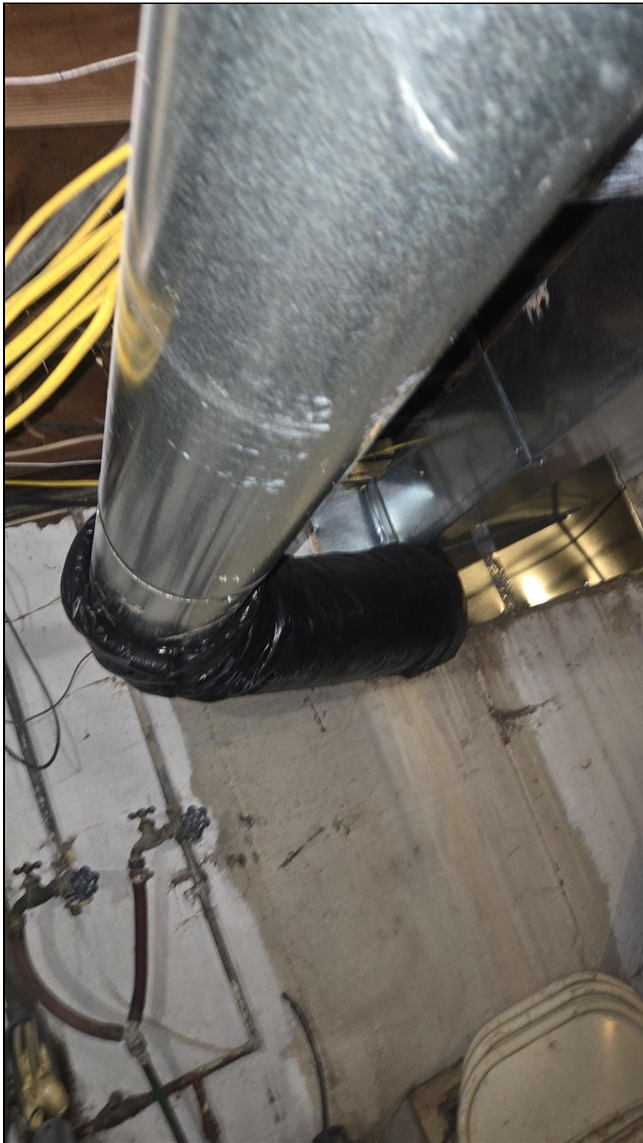
4.3 Item 1(Picture) The ducts were sweating. Ducts sweat whenever moisture vapor condenses on the duct due to temperature and humidity. Installing a return air vent in this area and/or adding insulation may help limit the condensation. A qualified HVAC contractor should repair the sweating ducts.

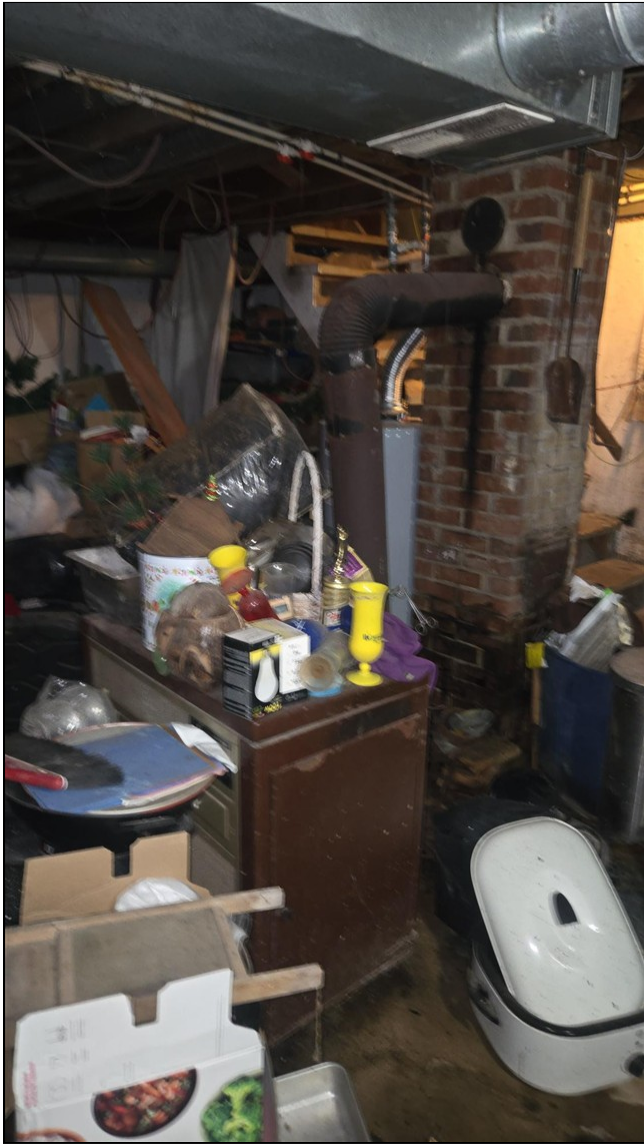
4.5 Item 1(Picture) The wood stove is beyond the scope of the inspection and blocked by the occupants belongings. InterNACHI always recommends that the flue is swept by a licensed chimney sweep, prior to the first use and annually thereafter. The wood stove should be inspected and repaired by a licensed chimney sweep.

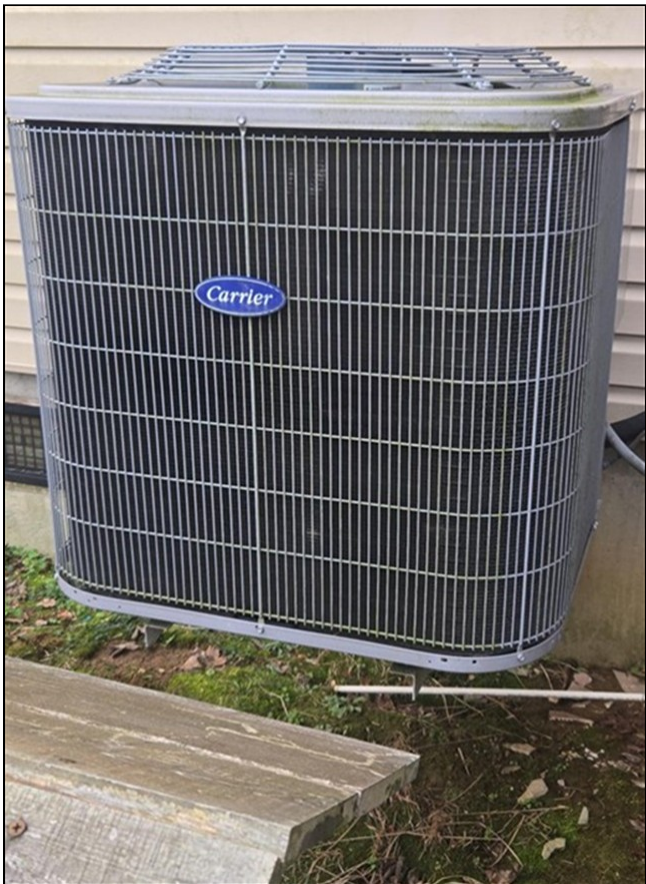
4.6 Item 1(Picture) 2016 Carrier AC not inspected. I recommended that both the AC unit and the furnace unit should be cleaned and serviced prior to use and annually thereafter to extend the life of the units. It was below 60 degrees Fahrenheit on the day of the inspection and operating the air conditioner whenever the ambient temperature is below 60 degrees Fahrenheit can damage the compressor; so, I was unable to activate the air conditioner for a full cycle test. However, visually it appeared to be in good mechanical condition.

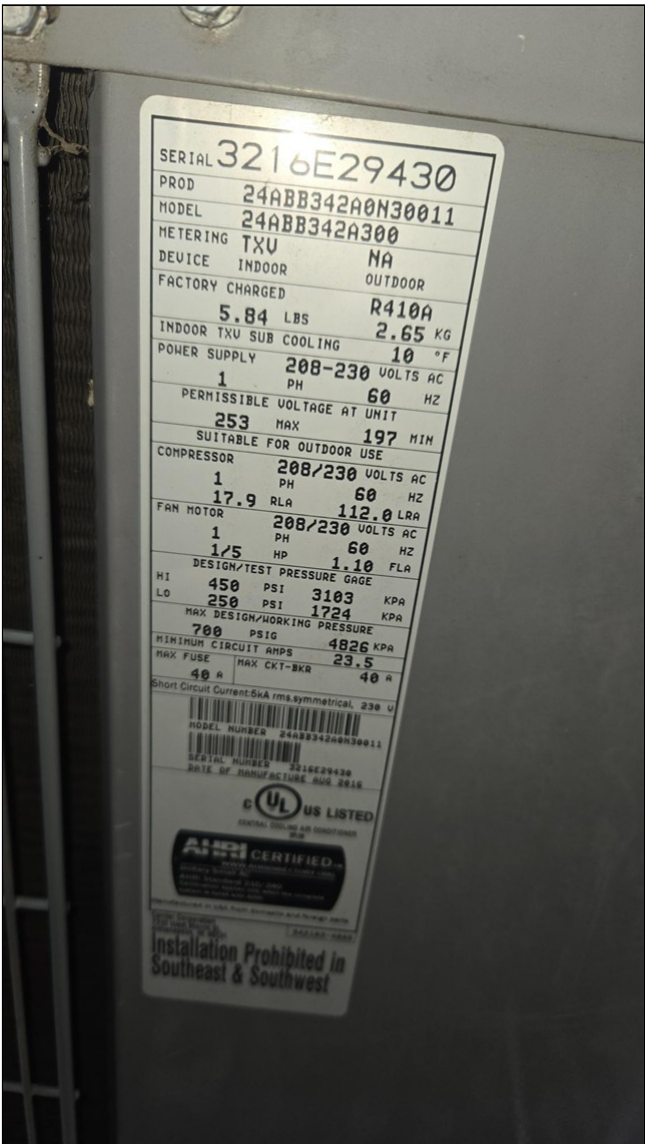
4.6 Item 2(Picture) 2016 Carrier AC not inspected. I recommended that both the AC unit and the furnace unit should be cleaned and serviced prior to use and annually thereafter to extend the life of the units. It was below 60 degrees Fahrenheit on the day of the inspection and operating the air conditioner whenever the ambient temperature is below 60 degrees Fahrenheit can damage the compressor; so, I was unable to activate the air conditioner for a full cycle test. However, visually it appeared to be in good mechanical condition.

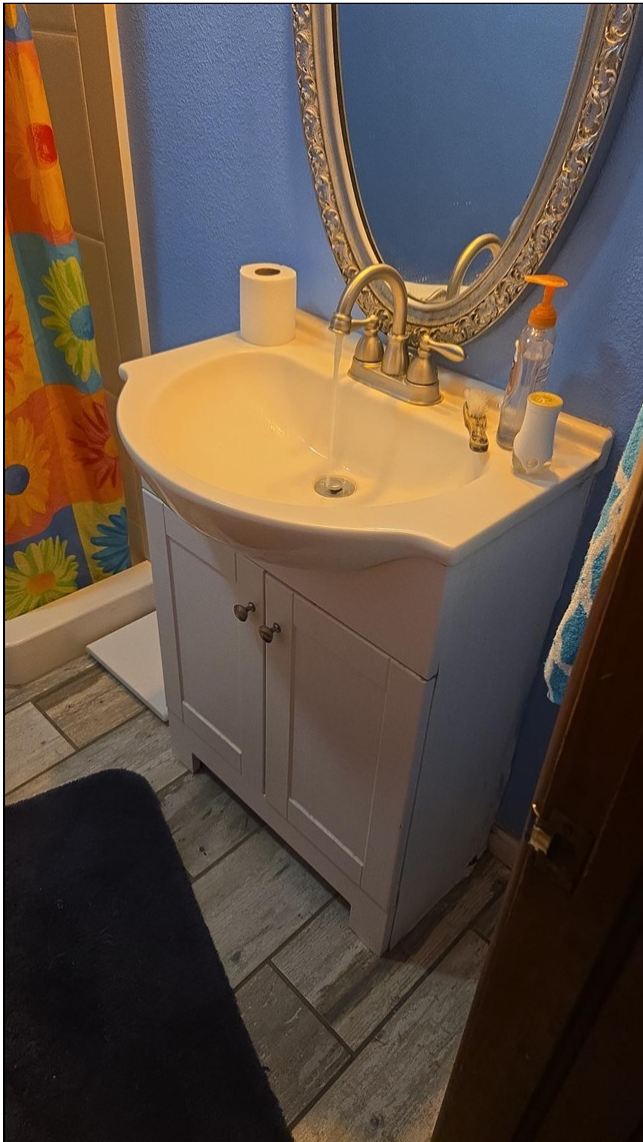
5.0 Item 1(Picture) There was a sewer gas smell notice in this bathroom. A plumbing vent may be clogged or something in this bathroom may not be vented properly. A qualified plumbing contractor should find and fix any and all plumbing issues. . After any plumbing work the plumber should pressure check and leak check all the pipes.

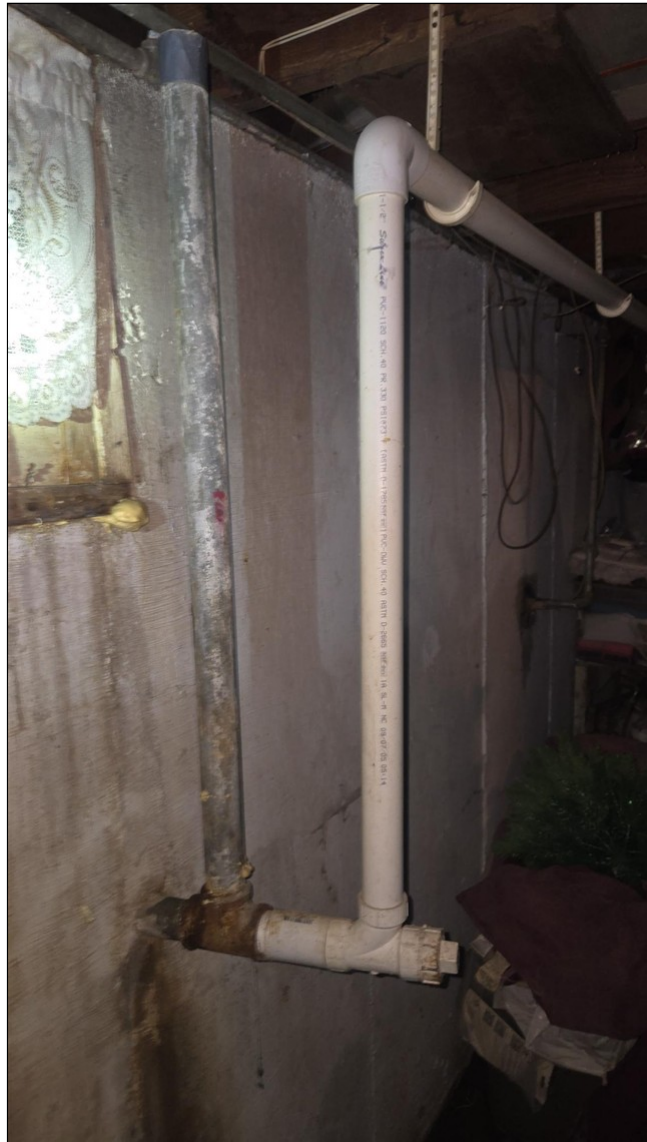
5.0 Item 2(Picture) Plumbing vents into the basement improperly...I recommend that a sewer lateral locator service is hired to trace all sewer line and floor drains that leave the basement prior to making any septic system inspections or repairs.
