Inspection Report

4700 Turley Mill Rd, Farmington, MO 63640, USA

A-Team Consulting and Contracting

Date: 1/2/2025	Time:	Report ID: 2025010202
Property: Address	Customer: NAME	Real Estate Professional:

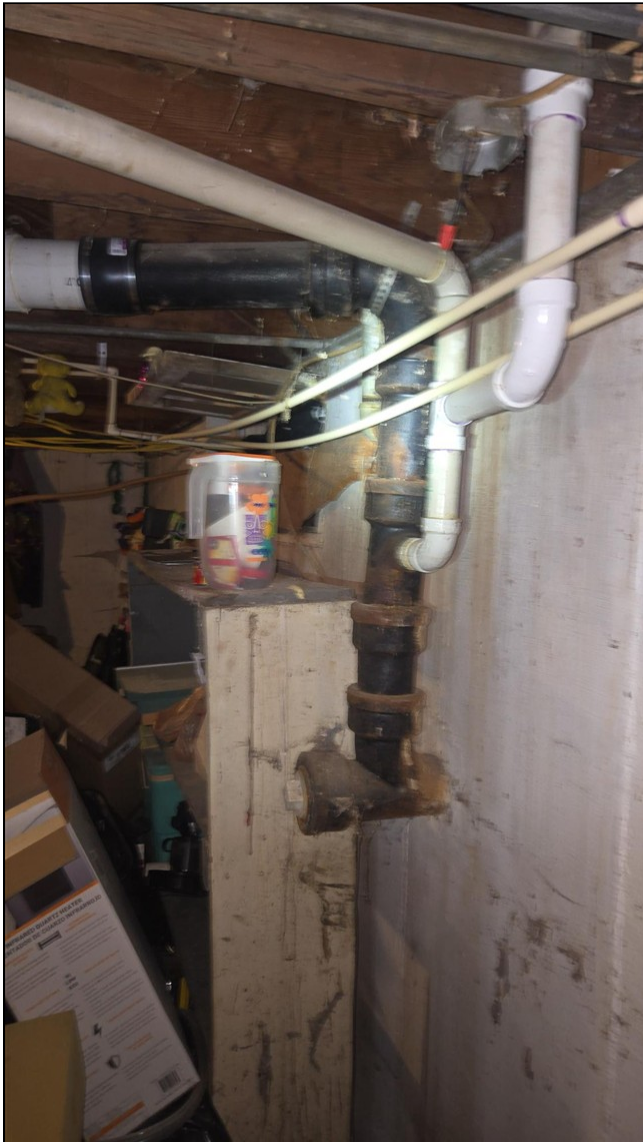
5.0 Item 3(Picture) I recommend that a sewer lateral locator service is hired to trace all sewer line and floor drains that leave the basement prior to making any septic system inspections or repairs. The cast iron plumbing is nearing the end of its useful life expectancy and may require repair or replacement soon. I recommended a sewer lateral inspection.

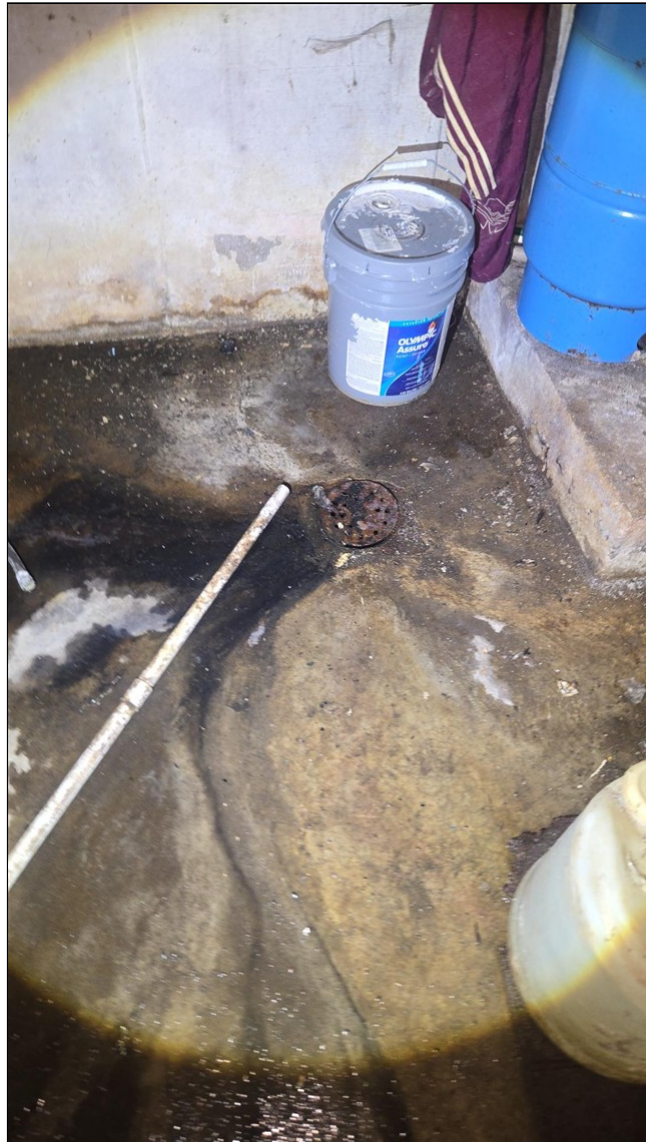
5.0 Item 4(Picture) I recommend that a sewer lateral locator service is hired to trace all sewer line and floor drains that leave the basement prior to making any septic system inspections or repairs. I recommended to call "The Pipe Guard" Allen Carter to locate all these lines. 314-278-7237

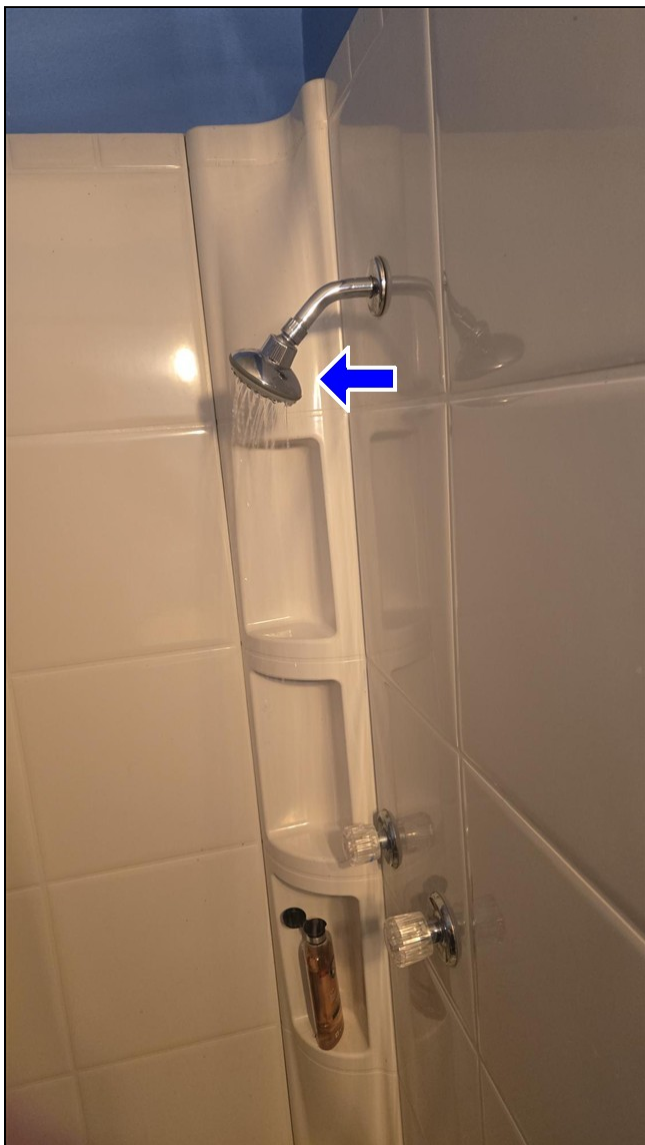
5.1 Item 1(Picture) There was low water pressure in the hall shower.

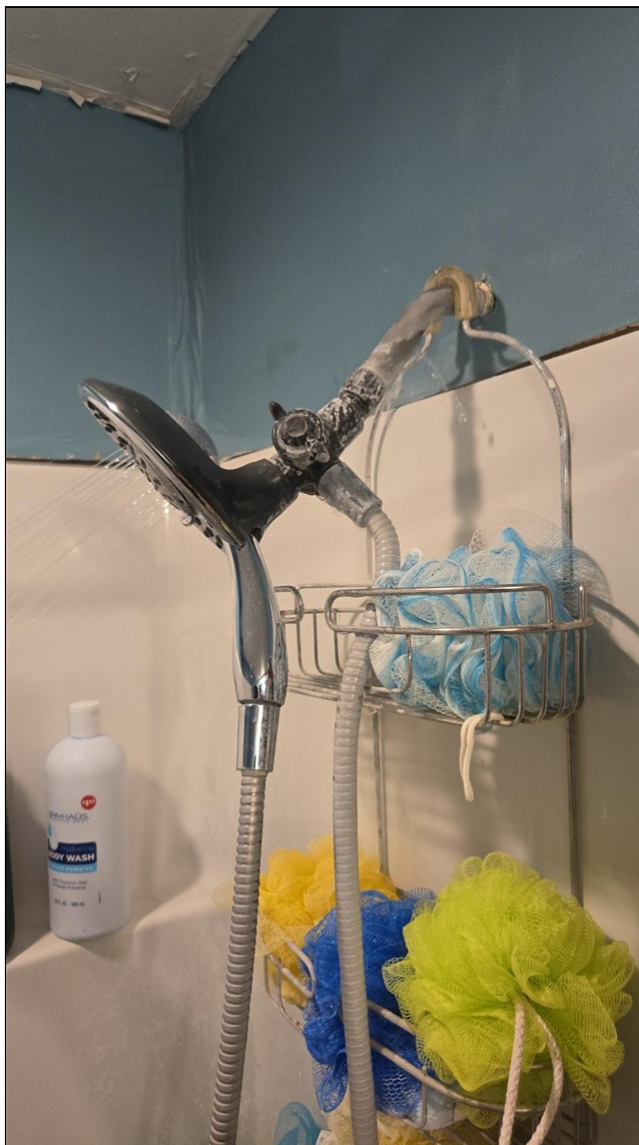
5.1 Item 2(Picture) This shower head leaked and required repairs.

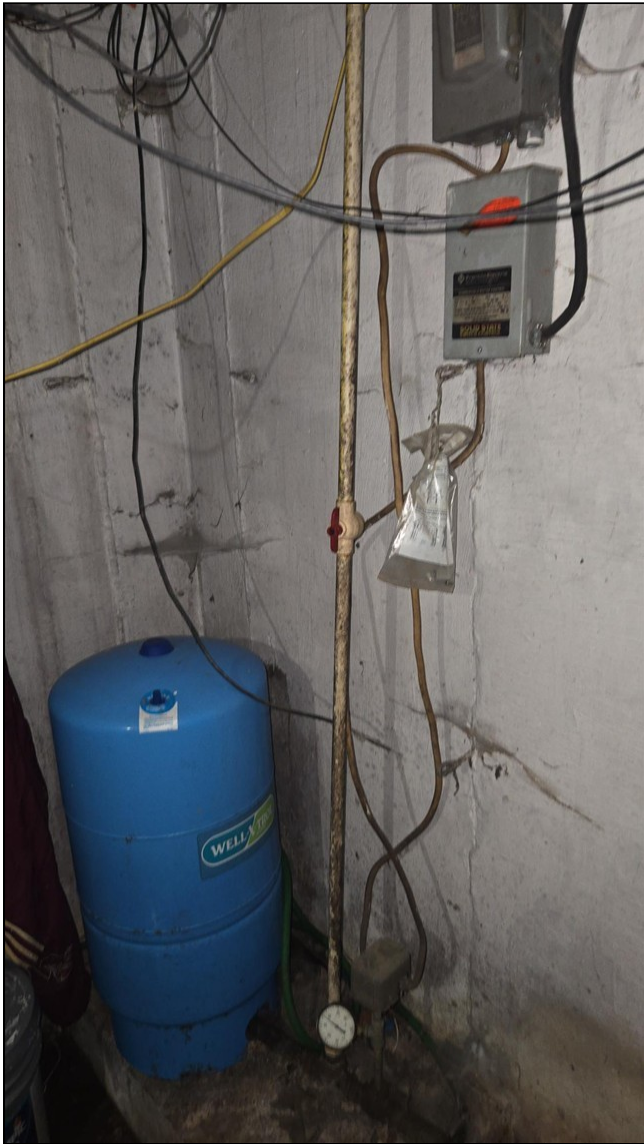
5.1 Item 3(Picture) This pressure tanks should be drained and de-scaled.

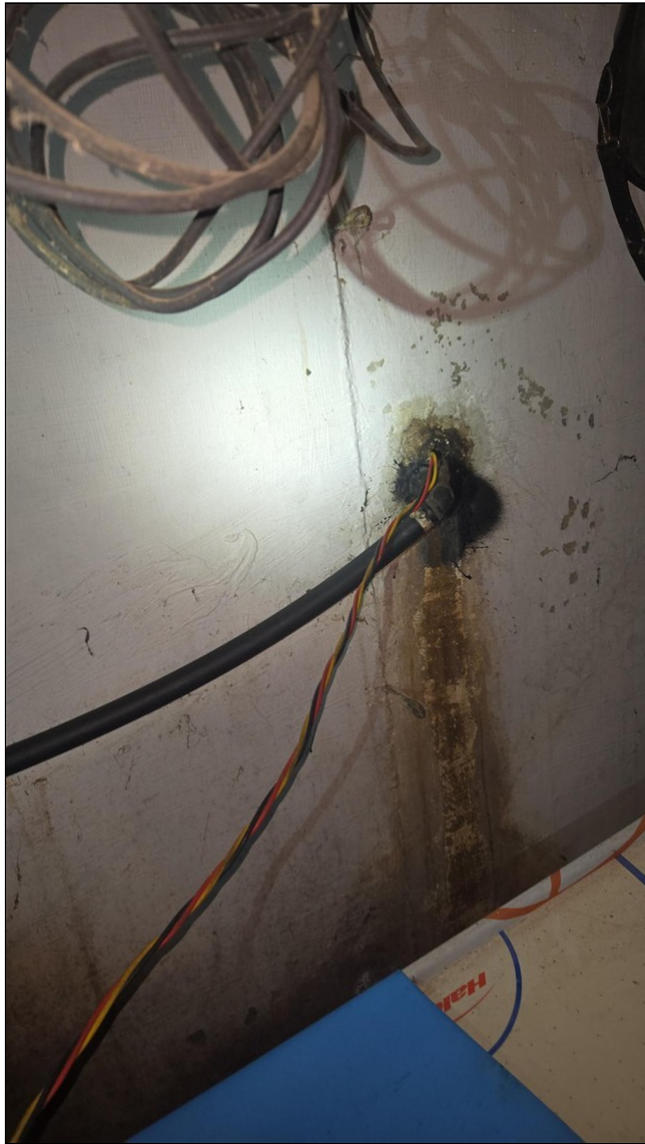
5.1 Item 4(Picture) Main line from well is plastic hdpe.

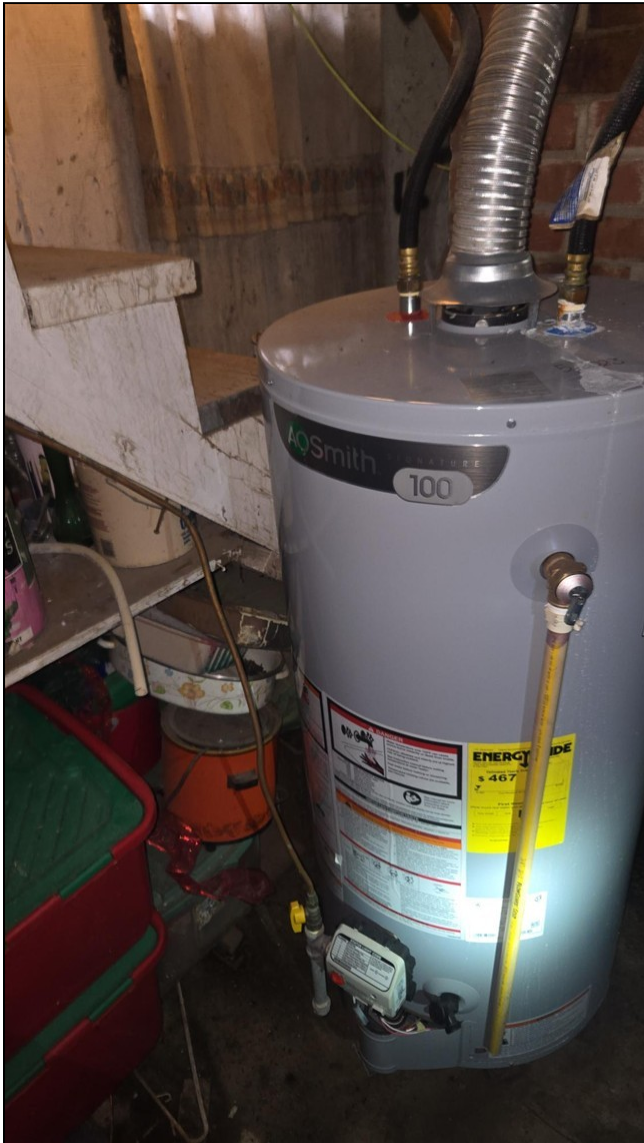
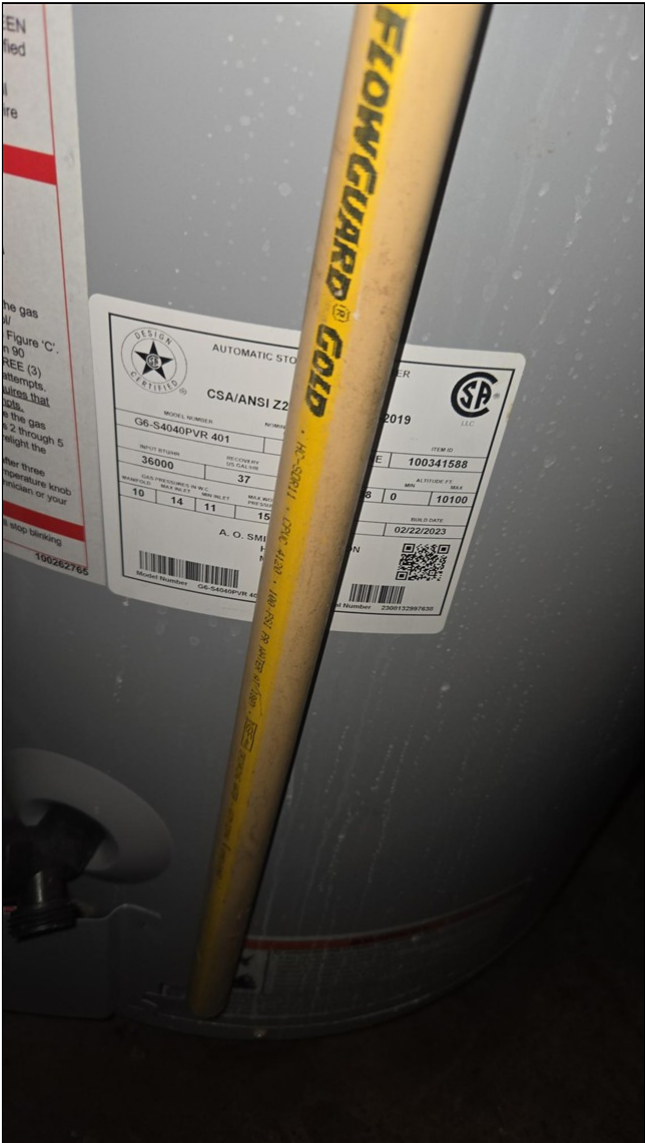
5.2 Item 1(Picture) 2008 AO Smith propane 40 gallon water heater inspected and operable at the time of the inspection. This unit is nearing the end of the useful life expectancy and may require repair or replacement during the period of ownership.

5.2 Item 2(Picture) 2008 AO Smith propane 40 gallon water heater inspected and operable at the time of the inspection. This unit is nearing the end of the useful life expectancy and may require repair or replacement during the period of ownership.

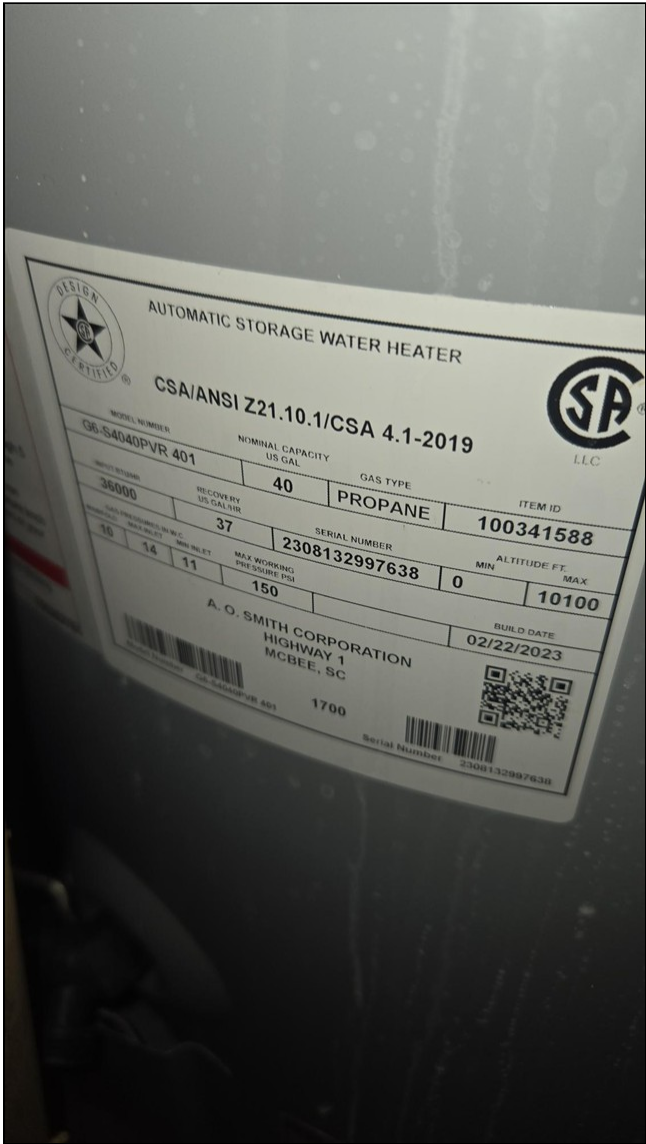
5.2 Item 3(Picture) 2008 AO Smith propane 40 gallon water heater inspected and operable at the time of the inspection. This unit is nearing the end of the useful life expectancy and may require repair or replacement during the period of ownership.

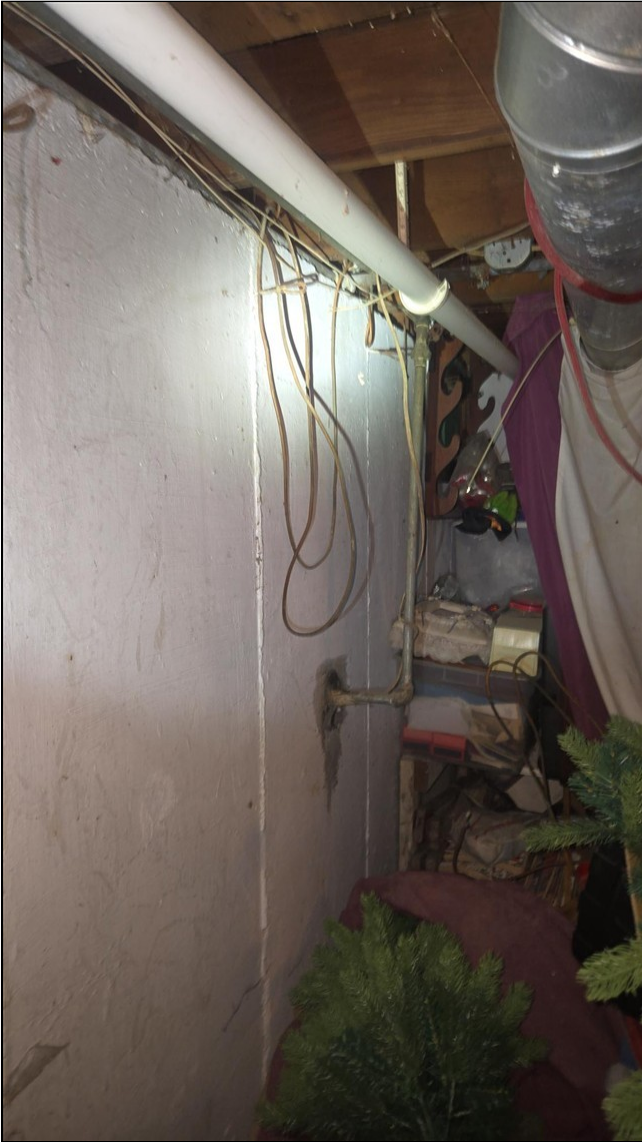
5.3 Item 1(Picture) Shutting off the well pump shuts off the water.

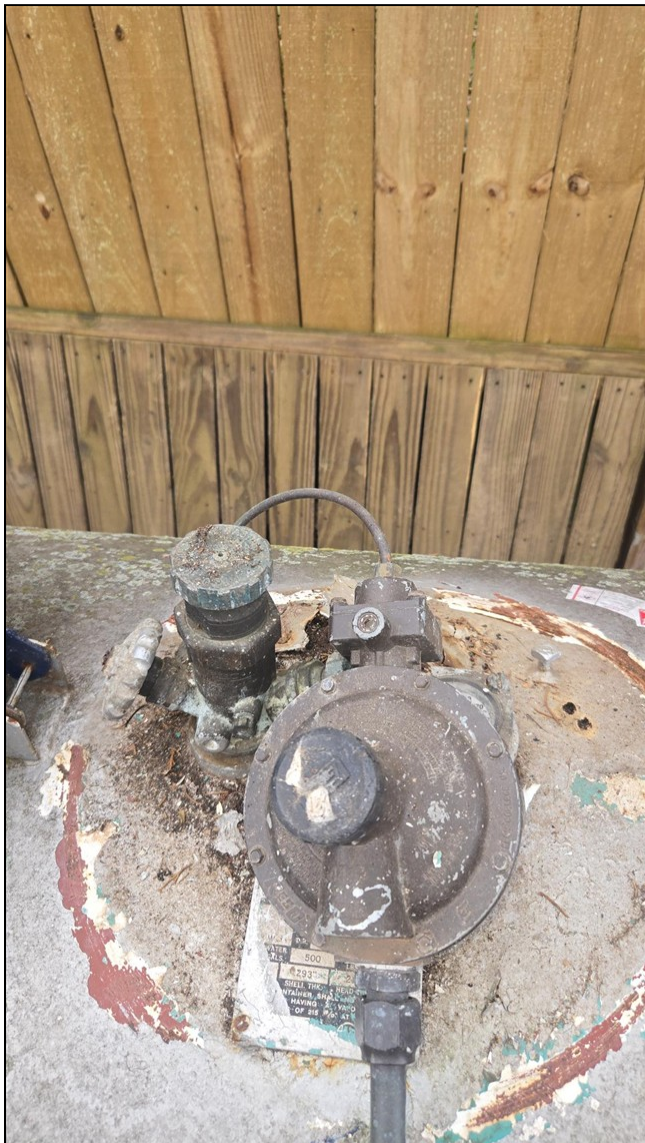
5.4 Item 1(Picture) The tank pop off valves should be serviced by the tank provider. The main gas shut-off valve is located at the propane tank. The tank was 57% full at the time of the inspection.

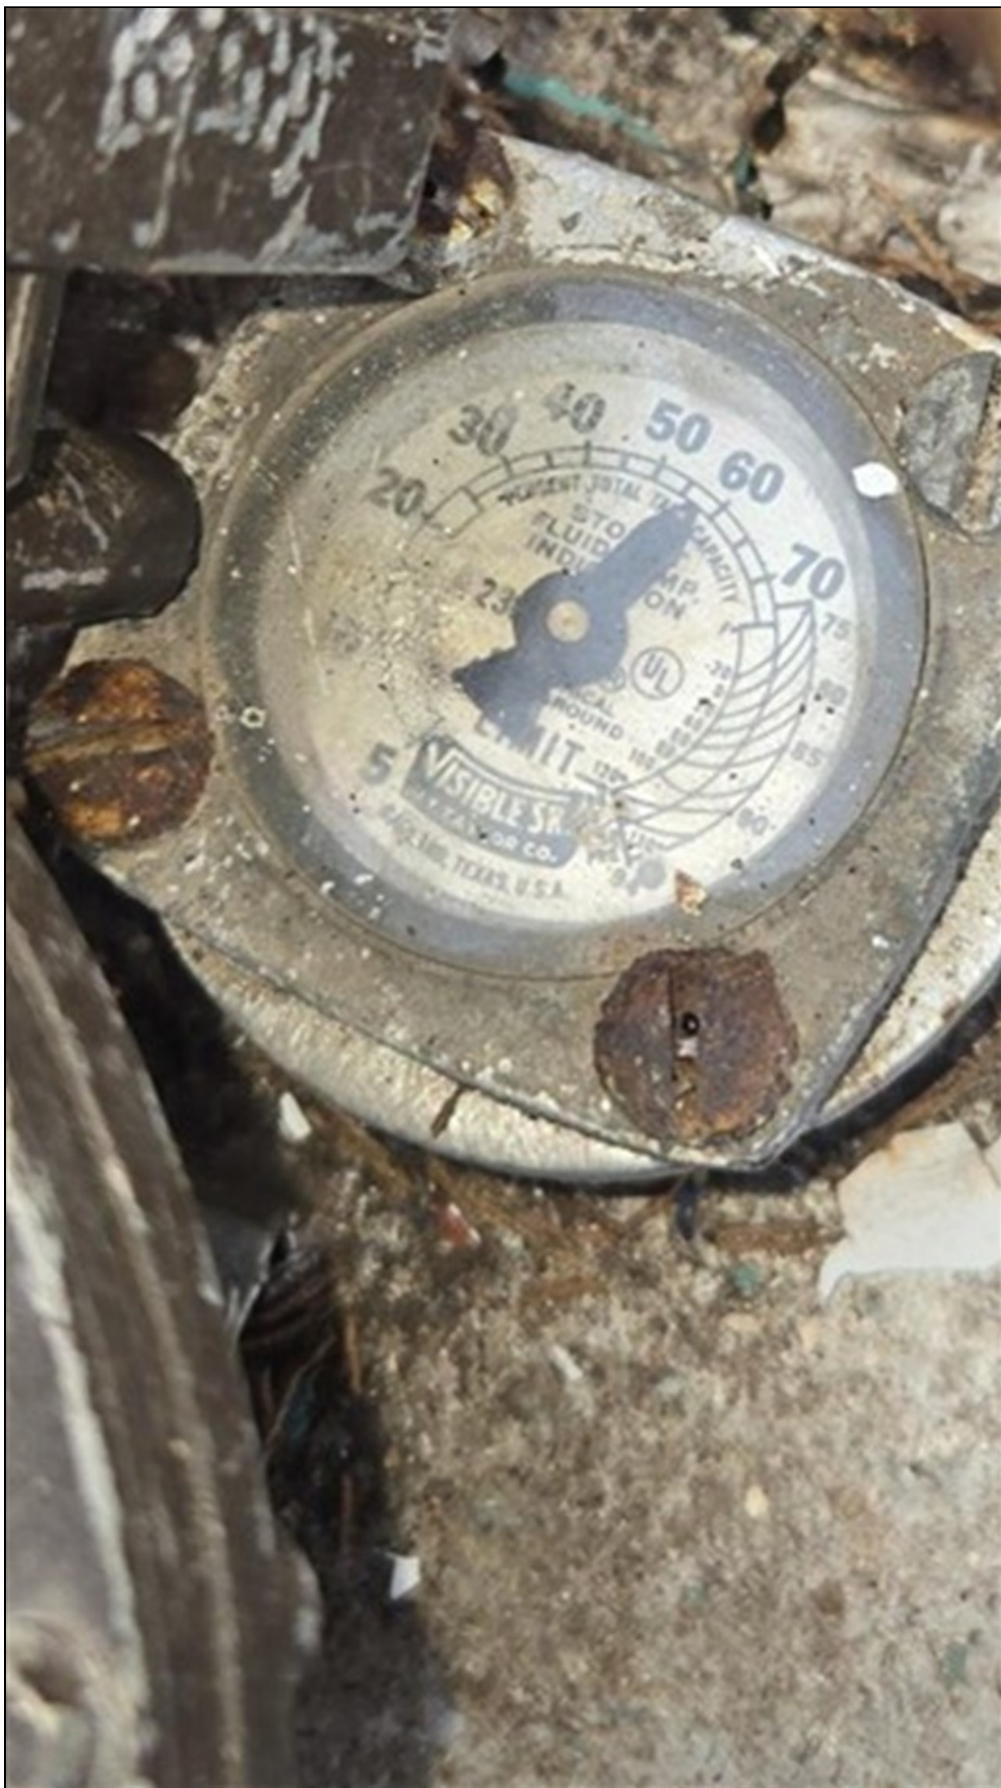
5.4 Item 2(Picture) The tank pop off valves should be serviced by the tank provider. The main gas shut-off valve is located at the propane tank. The tank was 57% full at the time of the inspection.

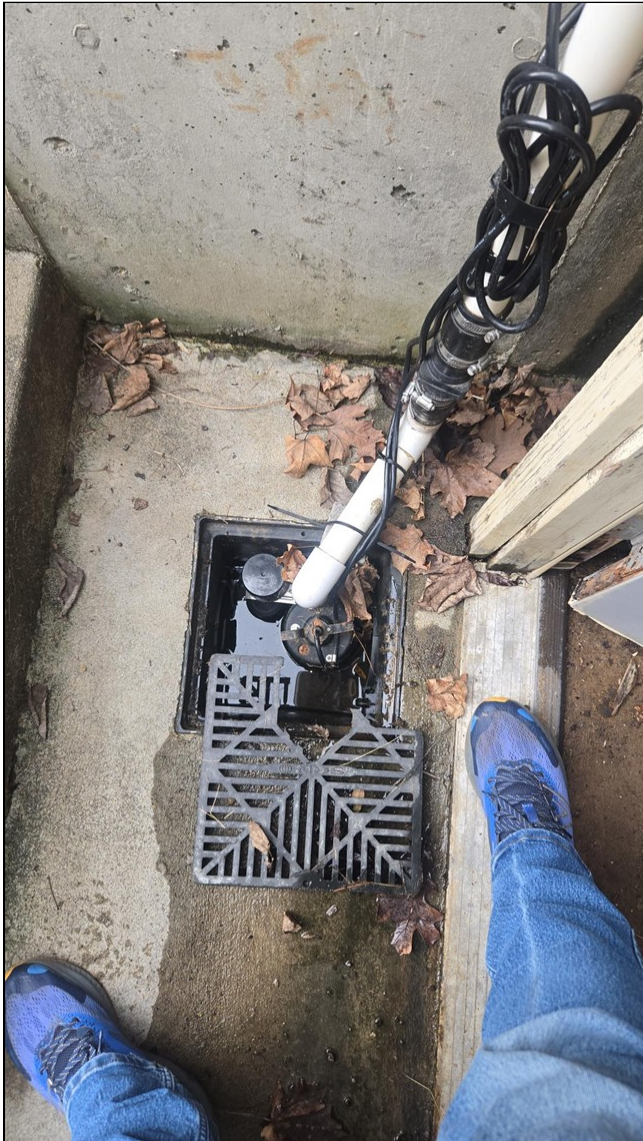
5.5 Item 1(Picture) The sump at the bottom of the basement stairwell was operable at the time of the inspection.

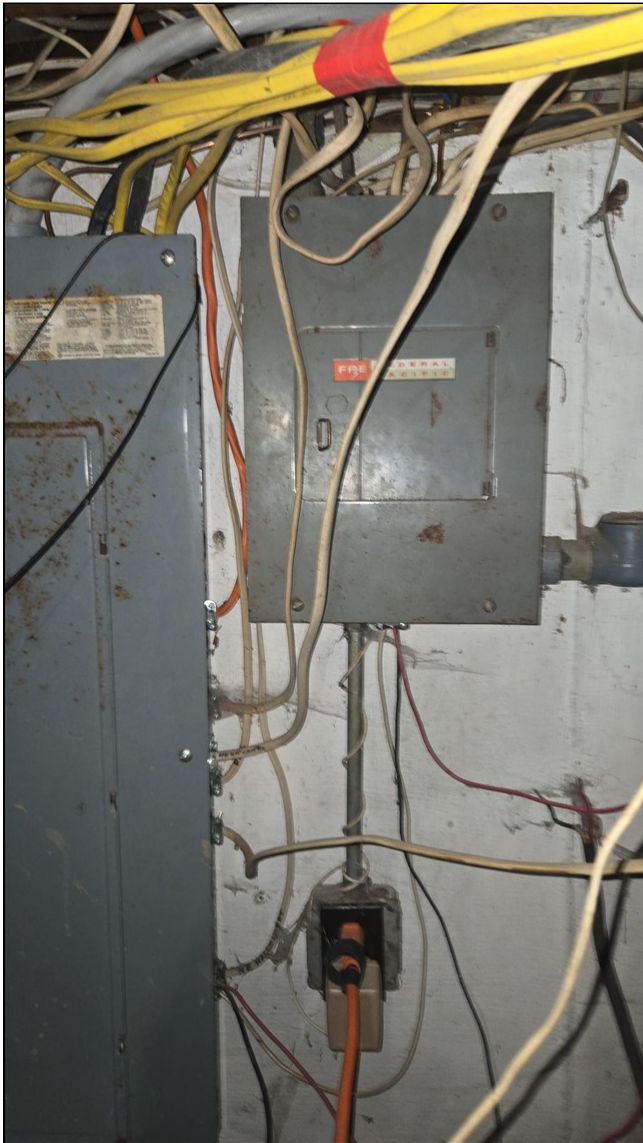
6.1 Item 1(Picture) It was unsafe for me to open the electrical panels because there were loose wires that could cause problems. I did not fully inspect the electrical system. There was loose, unprotected, or temporary wiring noticed. A qualified electrical contractor should find and fix any and all National Electrical Code deficiencies.

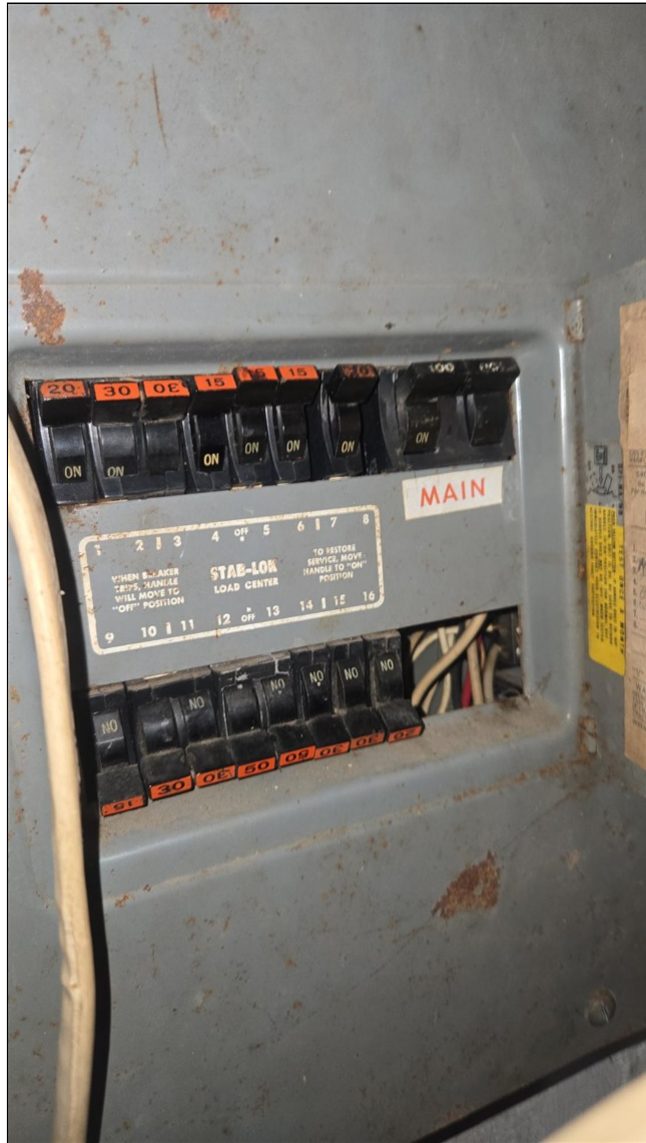
6.1 Item 2(Picture) Open breaker spaces could allow accidental contact with energized parts. A qualified electrical contractor should find and fix any and all National Electrical Code deficiencies.

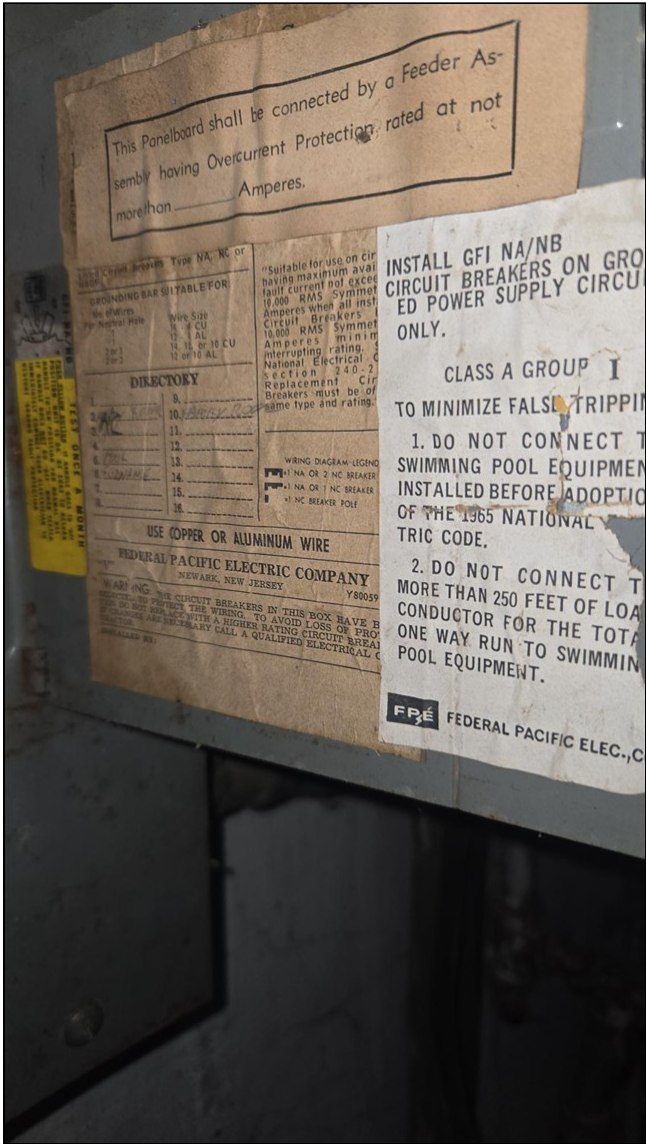
6.1 Item 3(Picture) Breakers not labeled. A qualified electrical contractor should find and fix any and all National Electrical Code deficiencies.

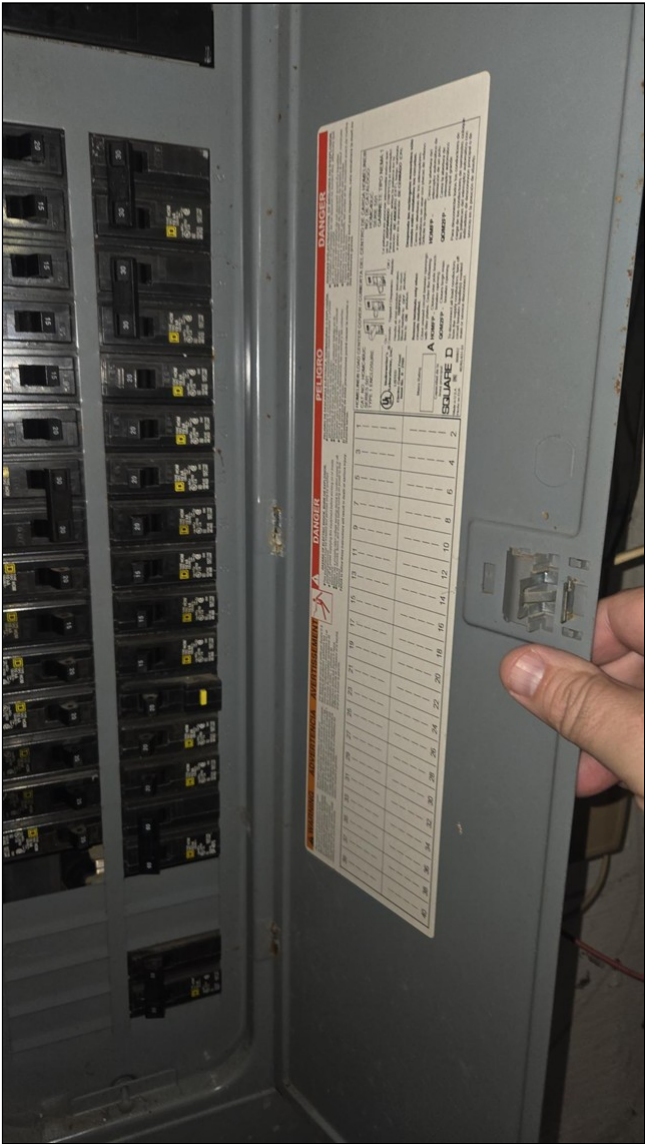
6.1 Item 4(Picture) Breakers not labeled. A qualified electrical contractor should find and fix any and all National Electrical Code deficiencies.

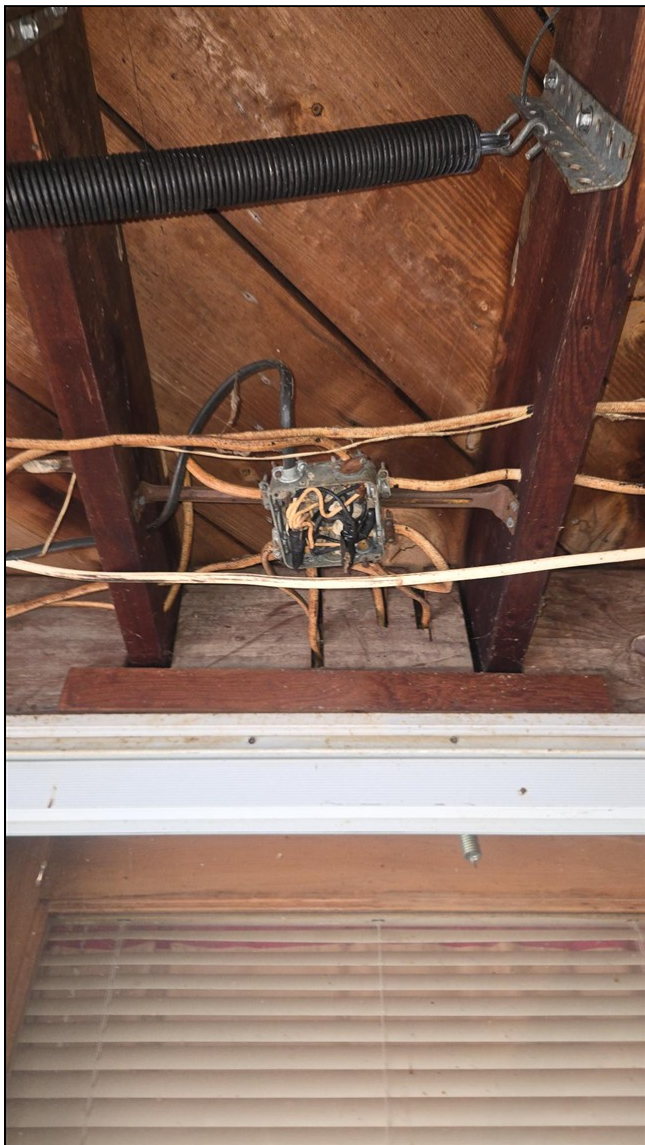
6.3 Item 1(Picture) Open and overloaded splice boxes - A qualified electrical contractor should find and fix any and all National Electrical Code deficiencies.

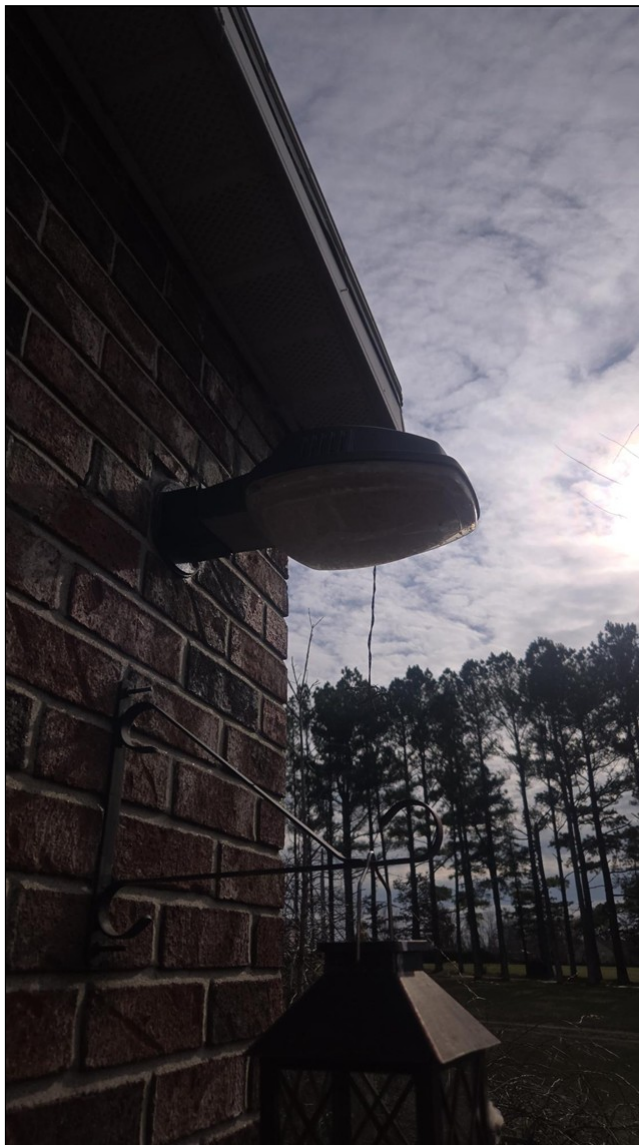
6.3 Item 2(Picture) Inoperable exterior lights - A qualified electrical contractor should find and fix any and all National Electrical Code deficiencies.

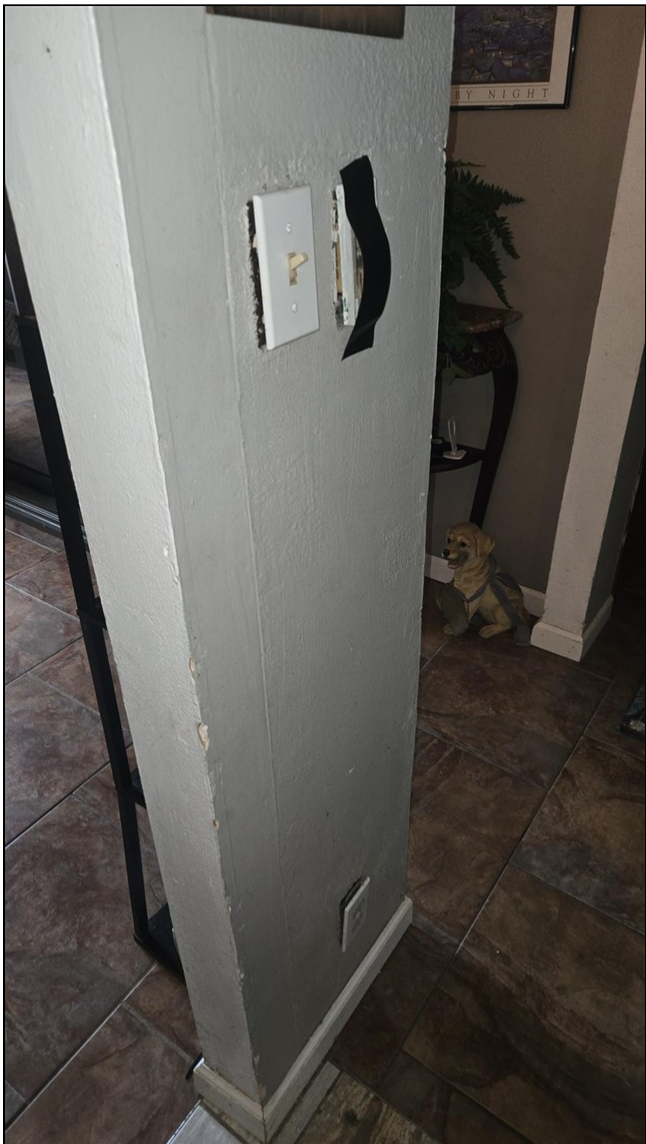
6.3 Item 3(Picture) Outlets and switches should all be replaced and properly installed. A qualified electrical contractor should find and fix any and all National Electrical Code deficiencies.

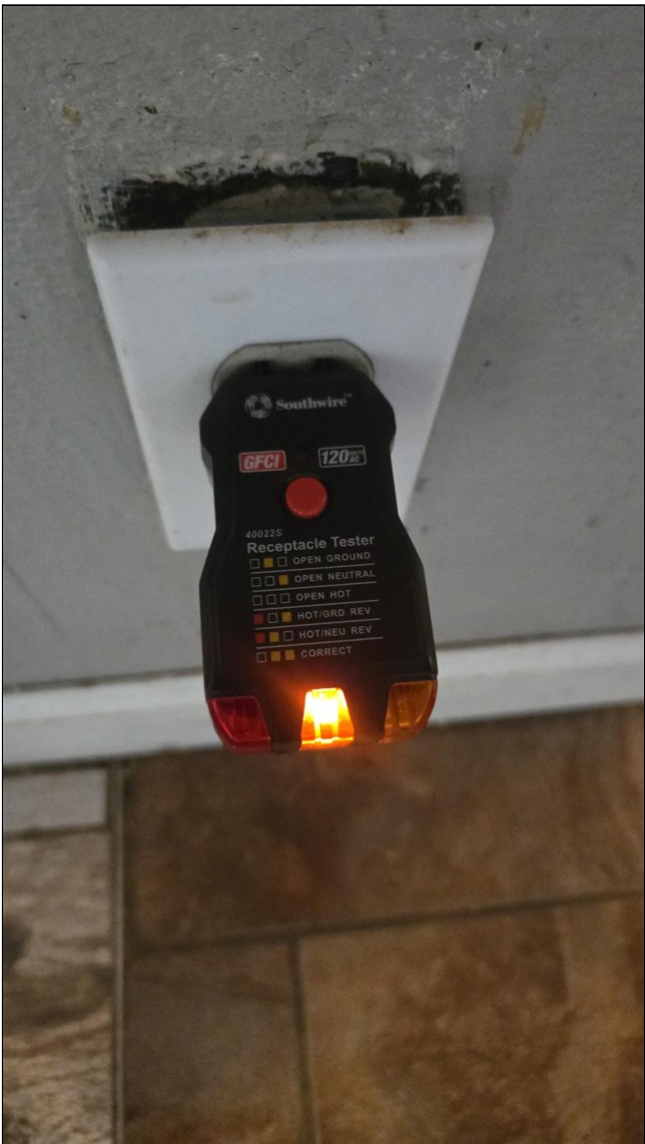
6.3 Item 4(Picture) Ungrounded outlets throughout the house. A qualified electrical contractor should find and fix any and all National Electrical Code deficiencies.

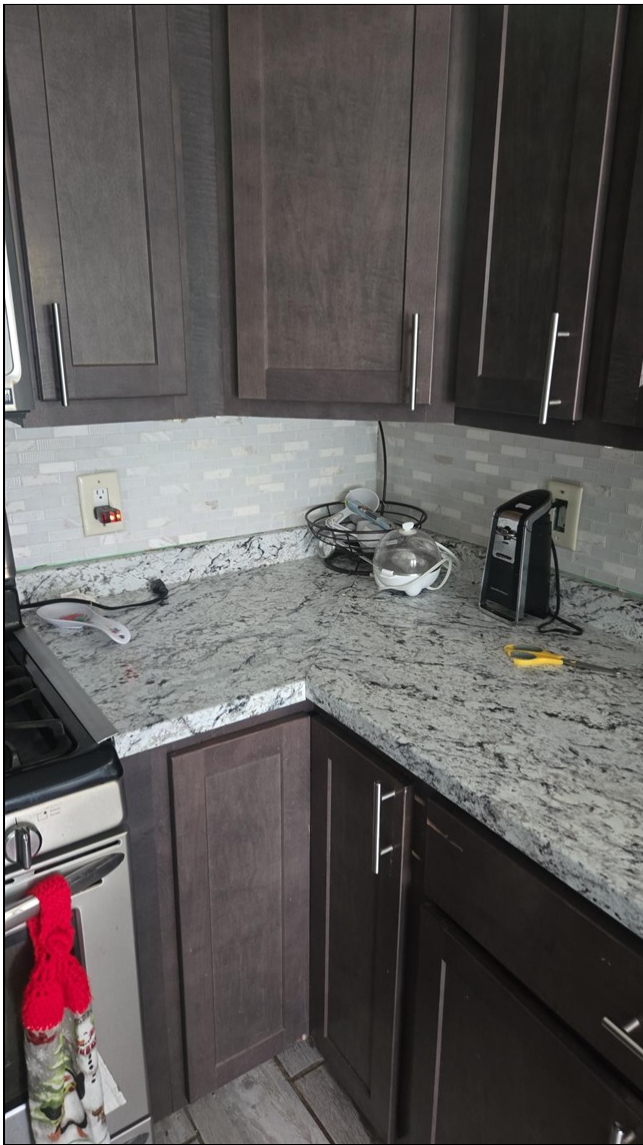
6.4 Item 1(Picture) Not GFCI protected. GFCI outlets should be located: at least one on the front exterior of the house, at least one on the rear exterior of the house, all exterior outlets, all outbuilding outlets, all unfinished spaces, all outlets above the countertop in the kitchen, all bathroom outlets (at least one above the sink/vanity), and all laundry room outlets...This home did not have all of the GFCI's in the correct places. A qualified electrical contractor should find and fix any and all NEC deficiencies.

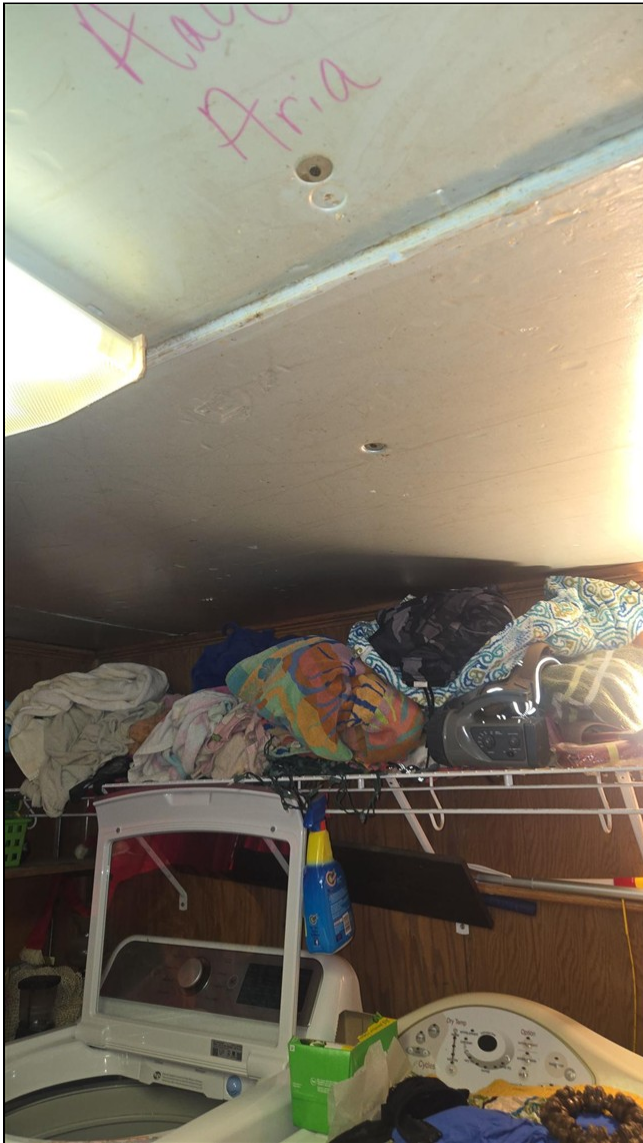
7.0 Item 1(Picture) There was not a finished ceiling in the laundry room. This ceiling should be removed and the wood rafters should be inspected in this area prior to finishing this ceiling. There may be hidden water damage in this area.

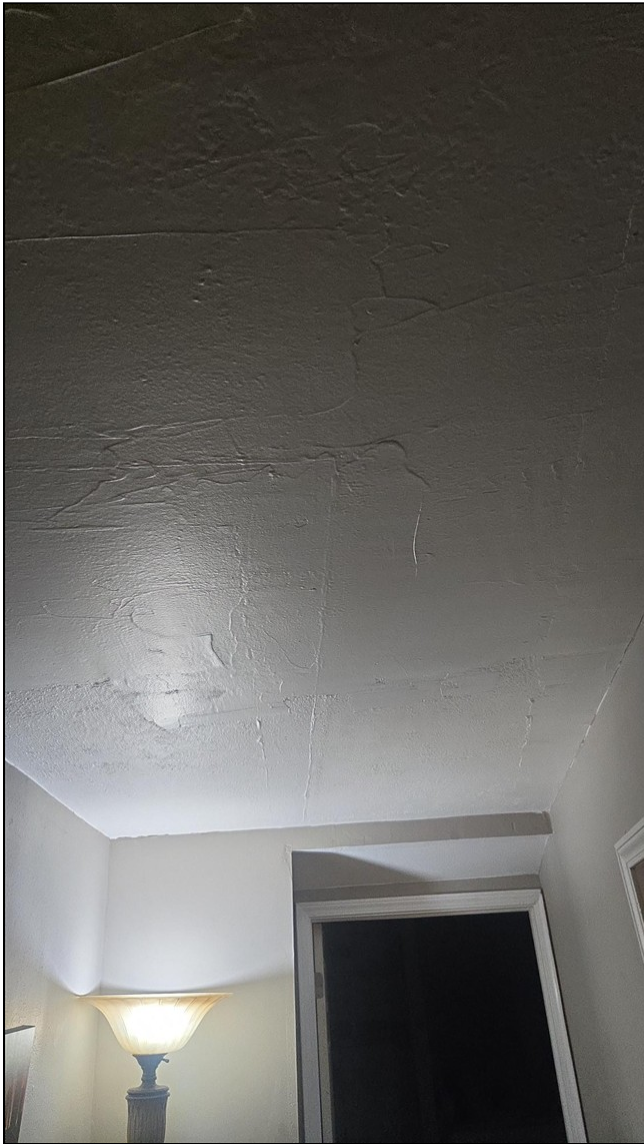
7.0 Item 3(Picture) There were some scuffs, scrapes, cracks, and inconsistent texture noticed throughout the house.

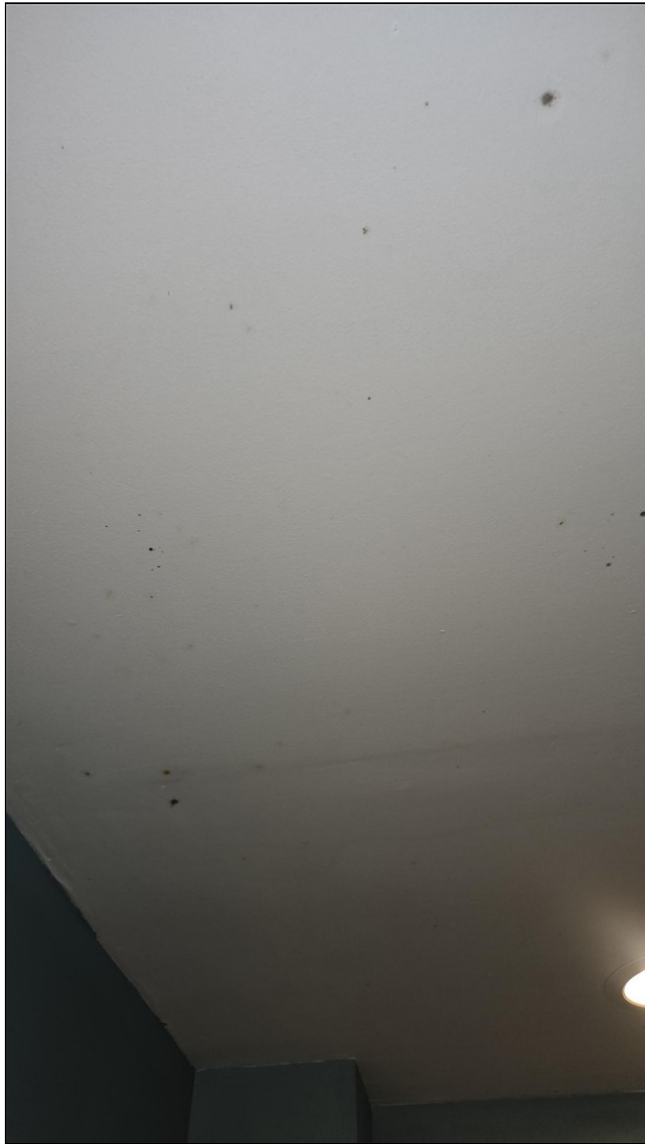
7.0 Item 4(Picture) MoldThere were some scuffs, scrapes, cracks, and inconsistent texture noticed throughout the house.

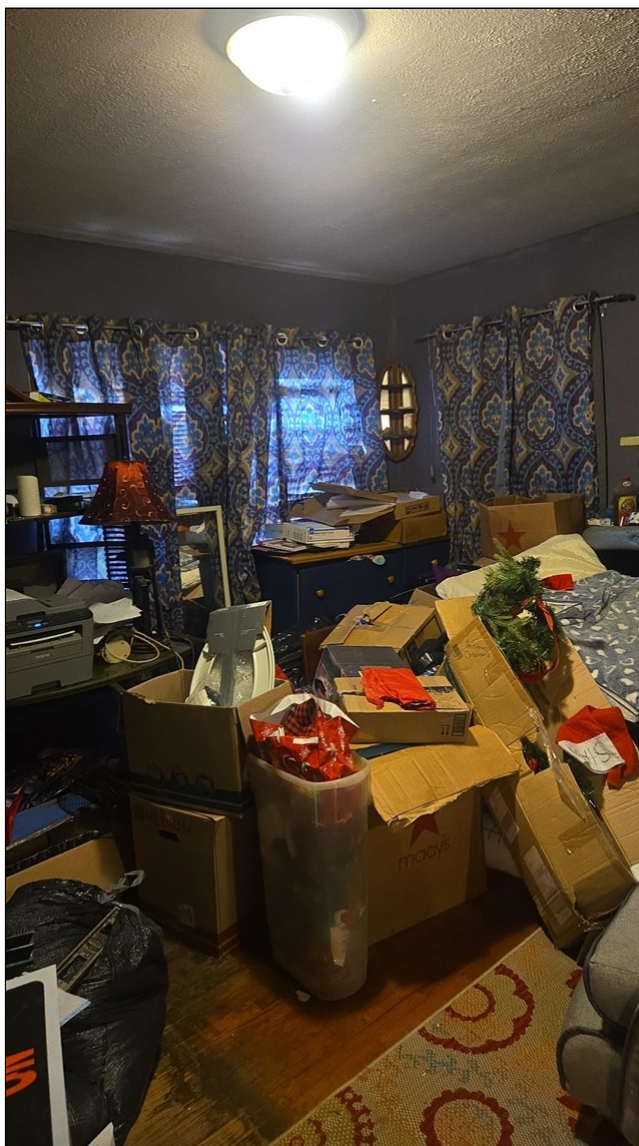
7.1 Item 2(Picture) The occupant and occupants belongings limited the inspection.

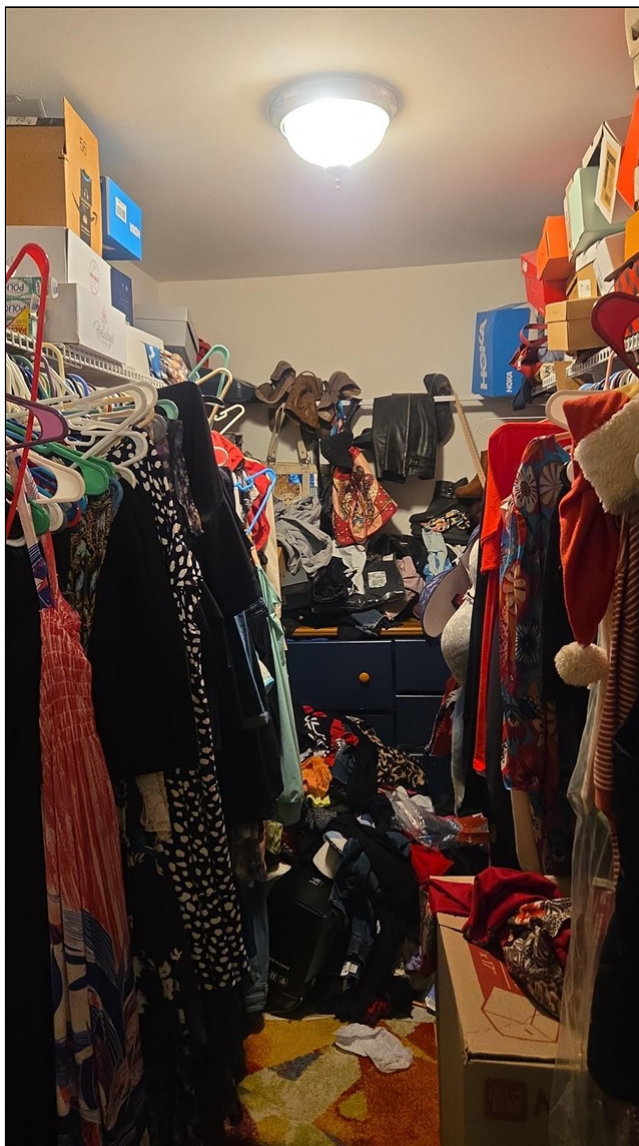
7.1 Item 4(Picture) The occupant and occupants belongings limited the inspection.

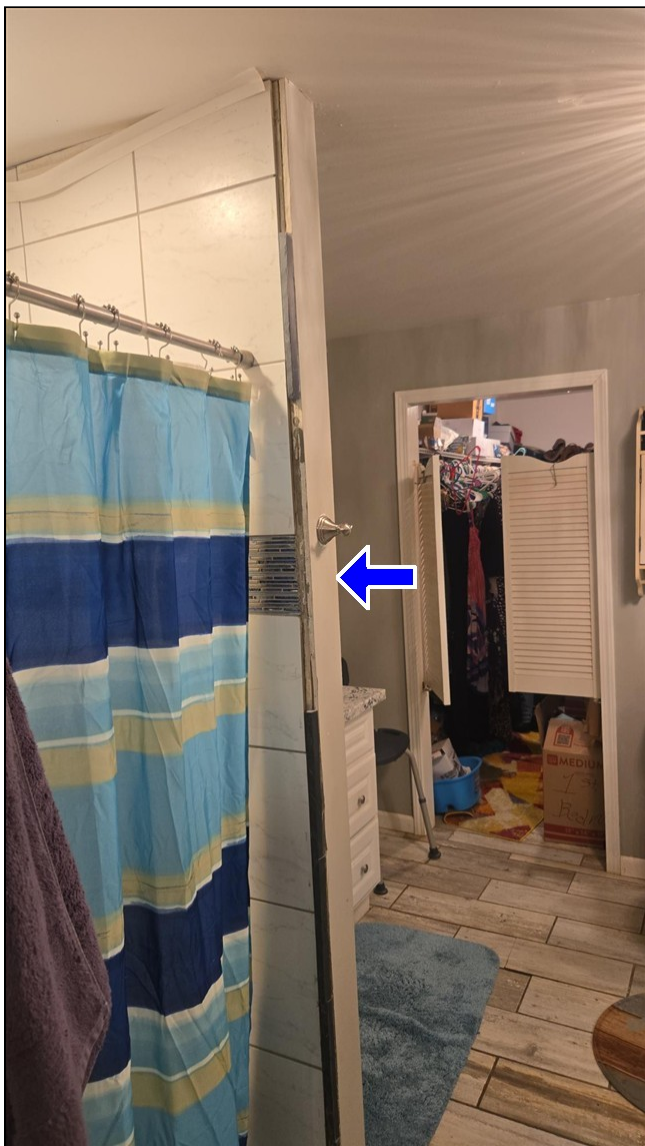
7.1 Item 5(Picture) The master bathroom shower wall looked like it may have some major rot and water damage behind the wall. This wall should be torn down to the studs and inspected.
