Inspection Report

4700 Turley Mill Rd, Farmington, MO 63640, USA

A-Team Consulting and Contracting

Date: 1/2/2025	Time:	Report ID: 2025010202
Property: Address	Customer: NAME	Real Estate Professional:

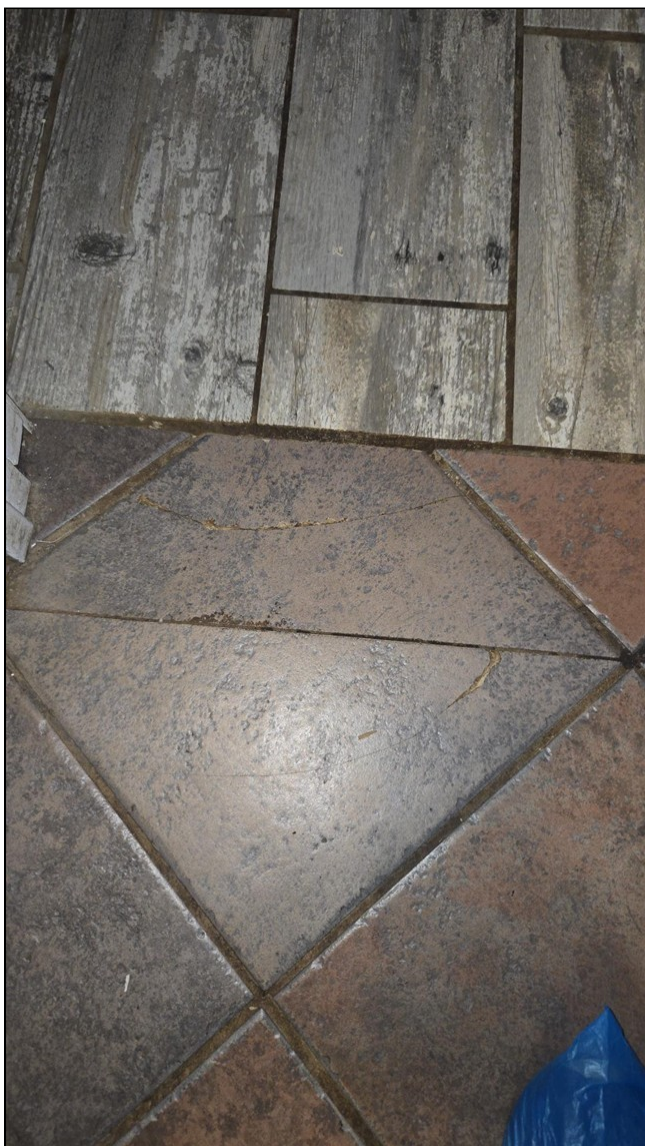
7.2 Item 1(Picture) There was cracked tile and grout throughout the house. Some of the cracked tile and grout appeared to be from structural movement and you should expect to make structural repairs to the subflooring and floor joists in some, but not all areas.

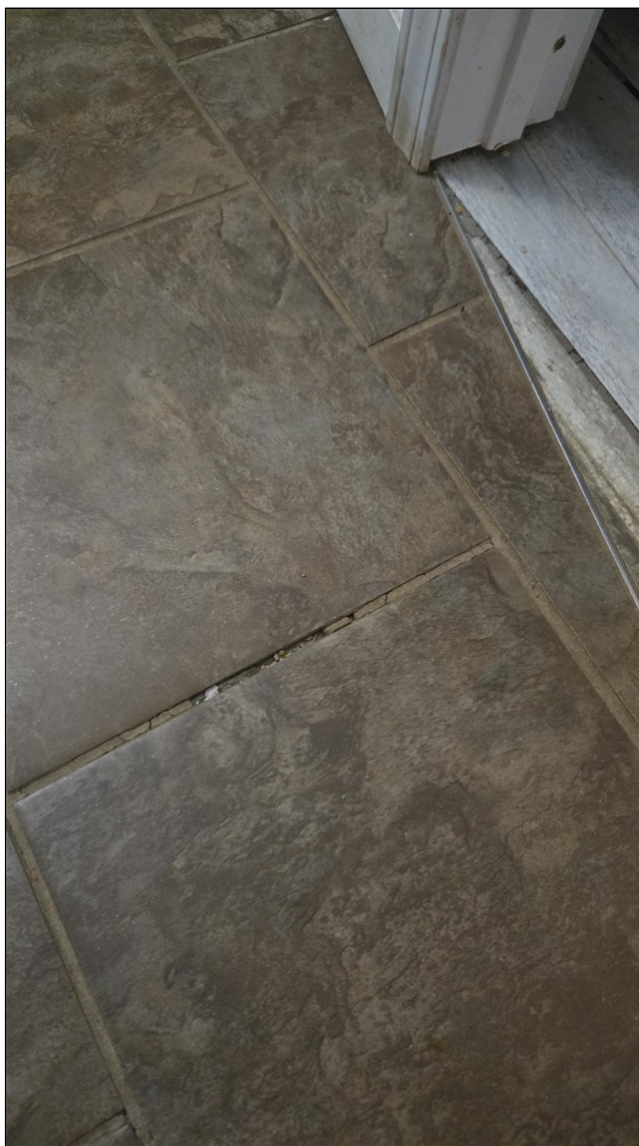
7.2 Item 2(Picture) There was cracked tile and grout throughout the house. Some of the cracked tile and grout appeared to be from structural movement and you should expect to make structural repairs to the subflooring and floor joists in some, but not all areas.

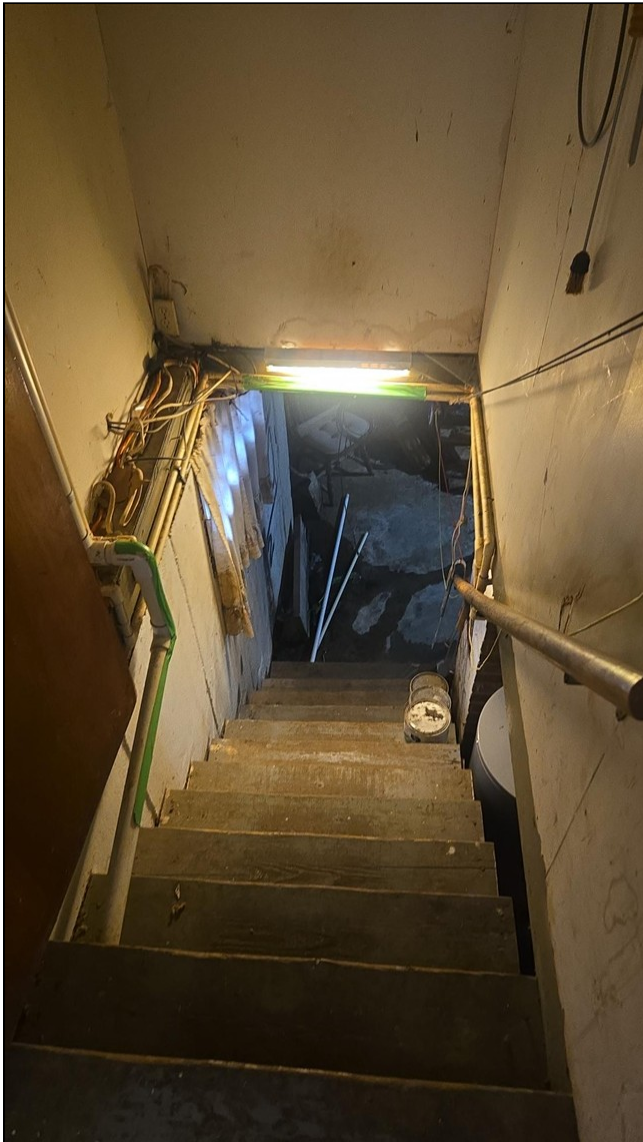
7.3 Item 1(Picture) The stairs were too steep. Stairs should be no steeper than 7" riser on 11" tread depth. The stairs were leaning/unlevel. A qualified contractor should repair the stairs to code requirements. There was low overhead clearance. The overhead clearance over the stairwell should be 6'8" or more and was not. The stairwell should be rebuilt. There were open risers. Open risers can be a safety hazard for small children whom might stick their heads in the riser gap. These should be closed with a board to prevent injury. A qualified contractor should complete all work.

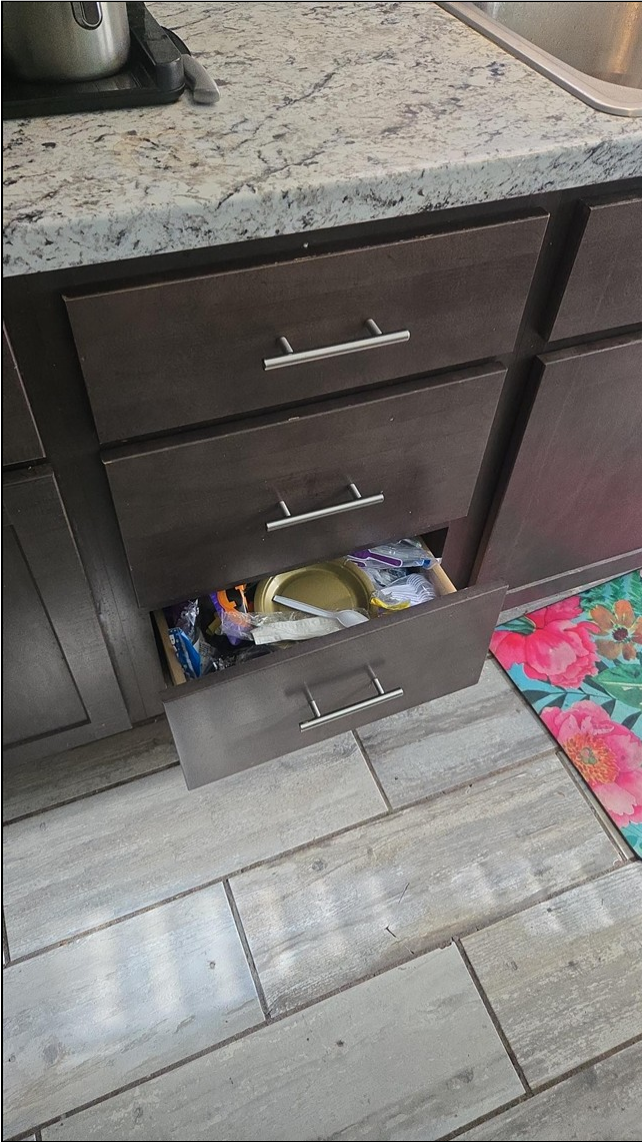
7.4 Item 1(Picture) There was a drawer in the kitchen that required repairs.

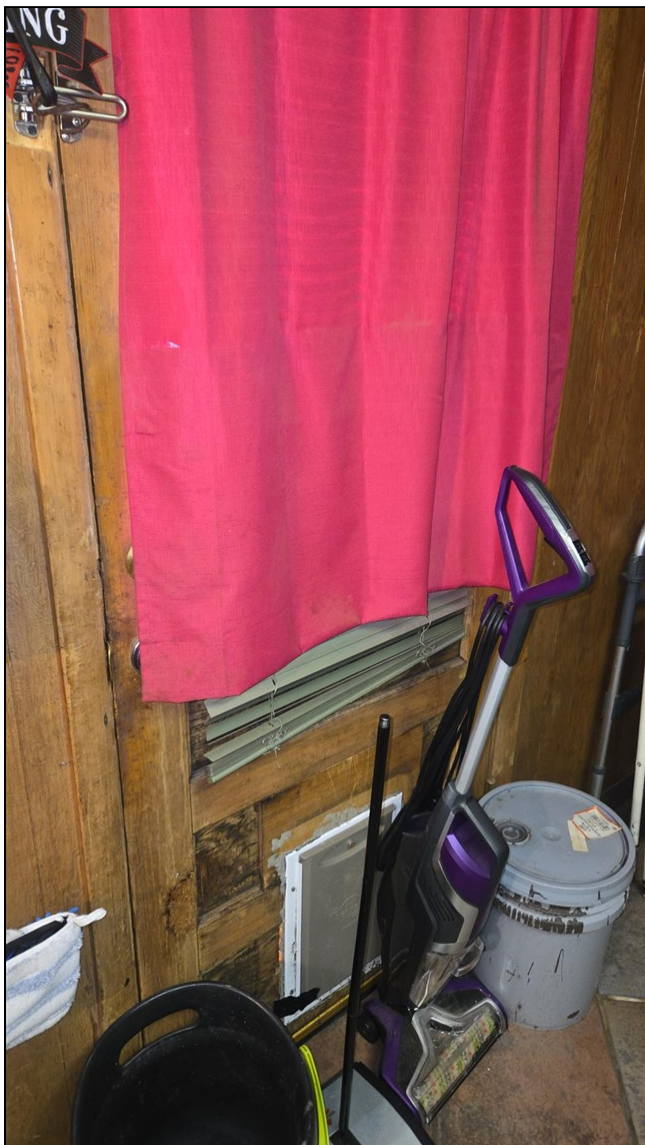
7.5 Item 1(Picture) There were some damaged doors that should be repaired or replaced. Some doorways were blocked and the door could not be fully inspected.

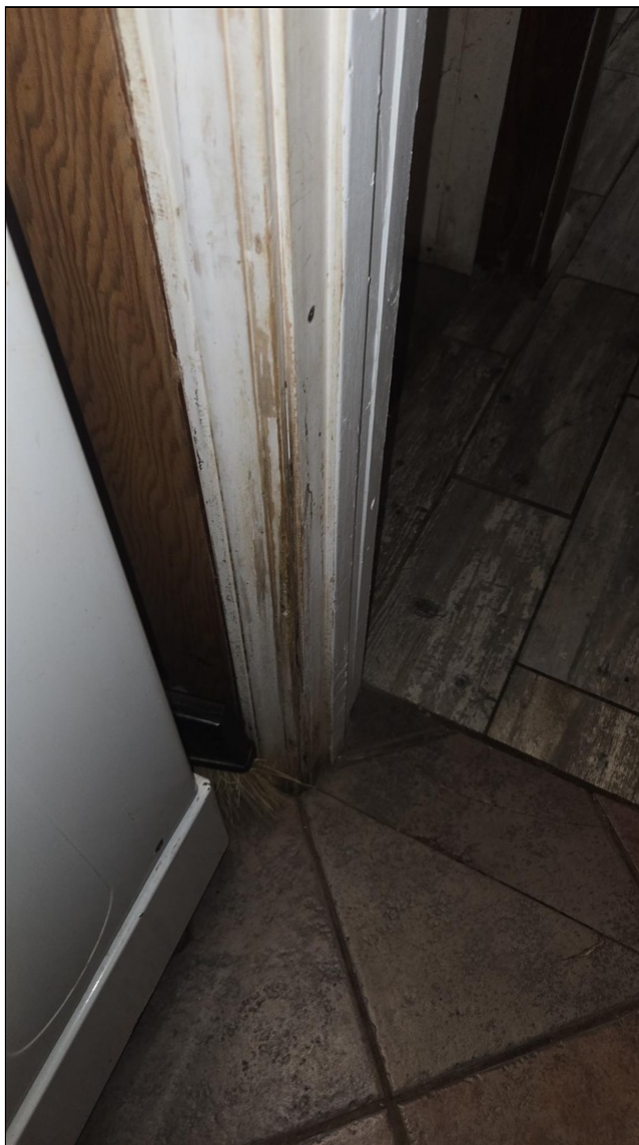
7.5 Item 2(Picture) There were some damaged doors that should be repaired or replaced.

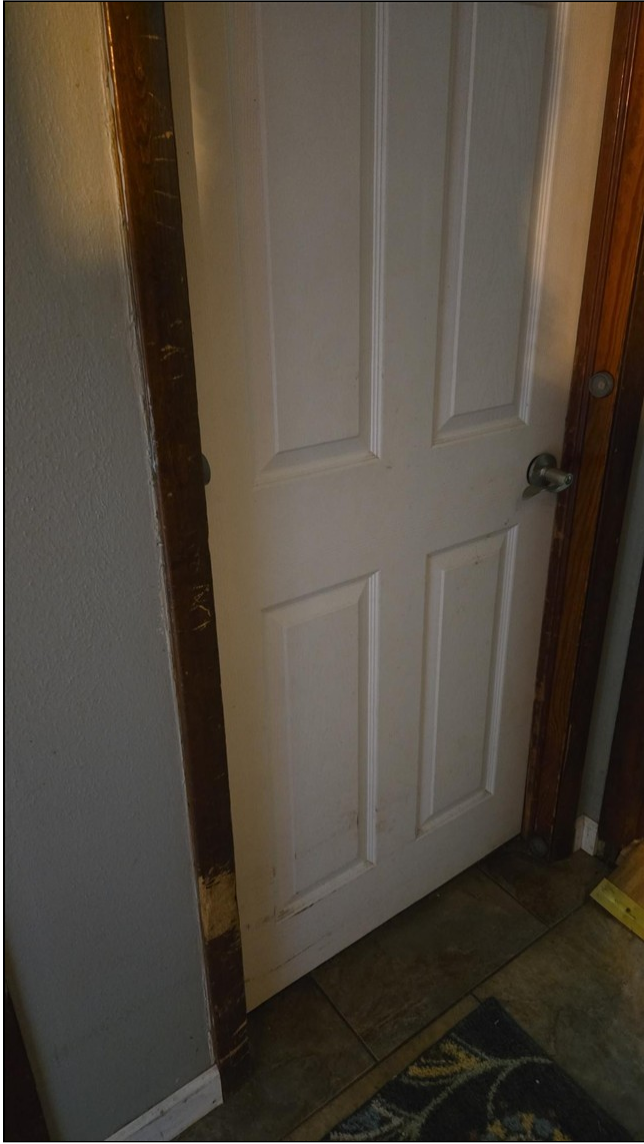
7.5 Item 3(Picture) There were some damaged doors that should be repaired or replaced.

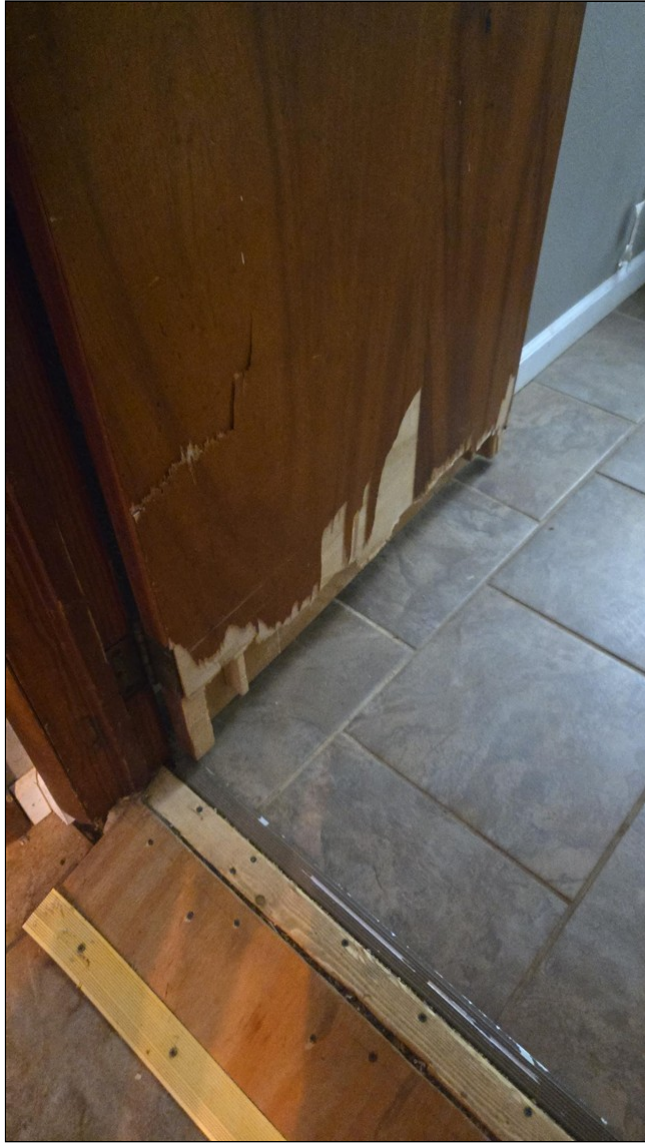
7.5 Item 4(Picture) There were some damaged doors that should be repaired or replaced.

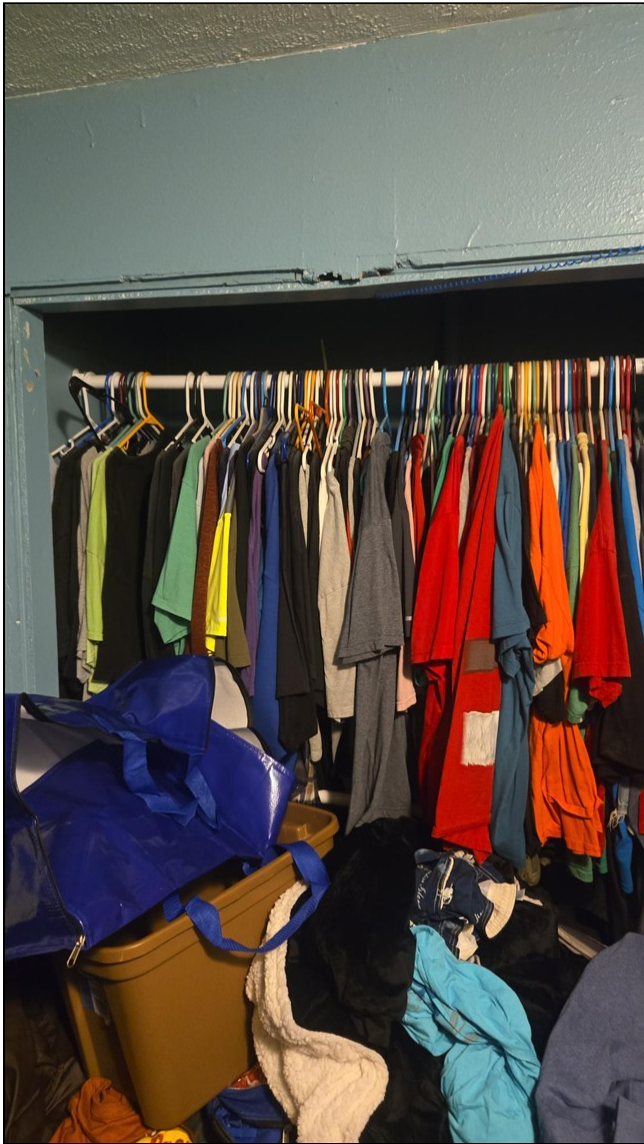
7.5 Item 5(Picture) Missing closet door.

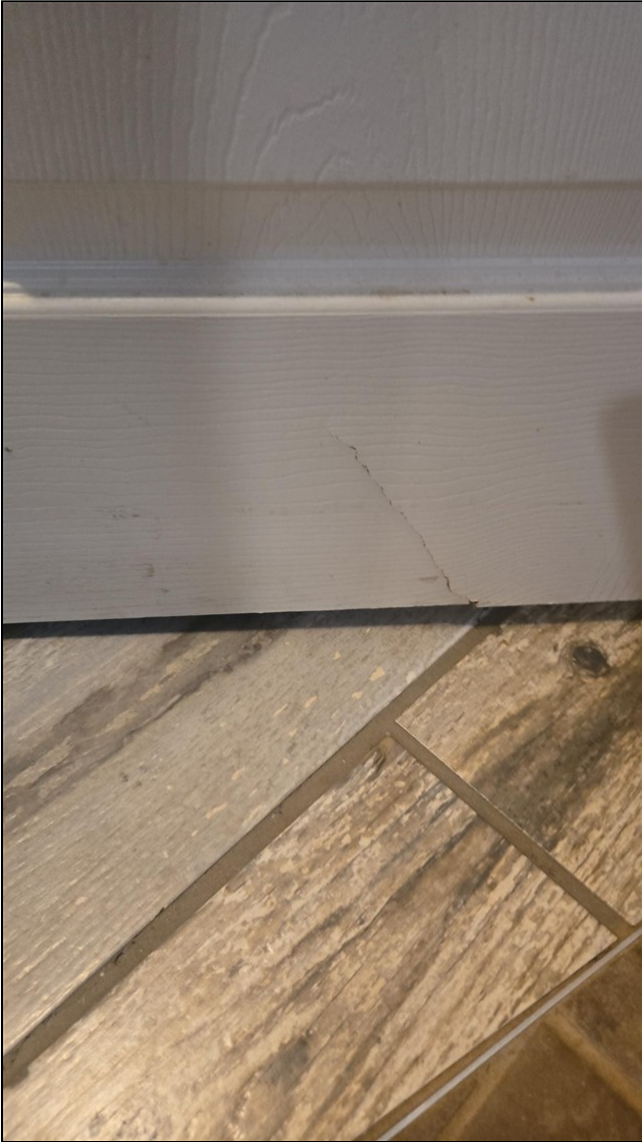
7.5 Item 7(Picture) Cracked door.

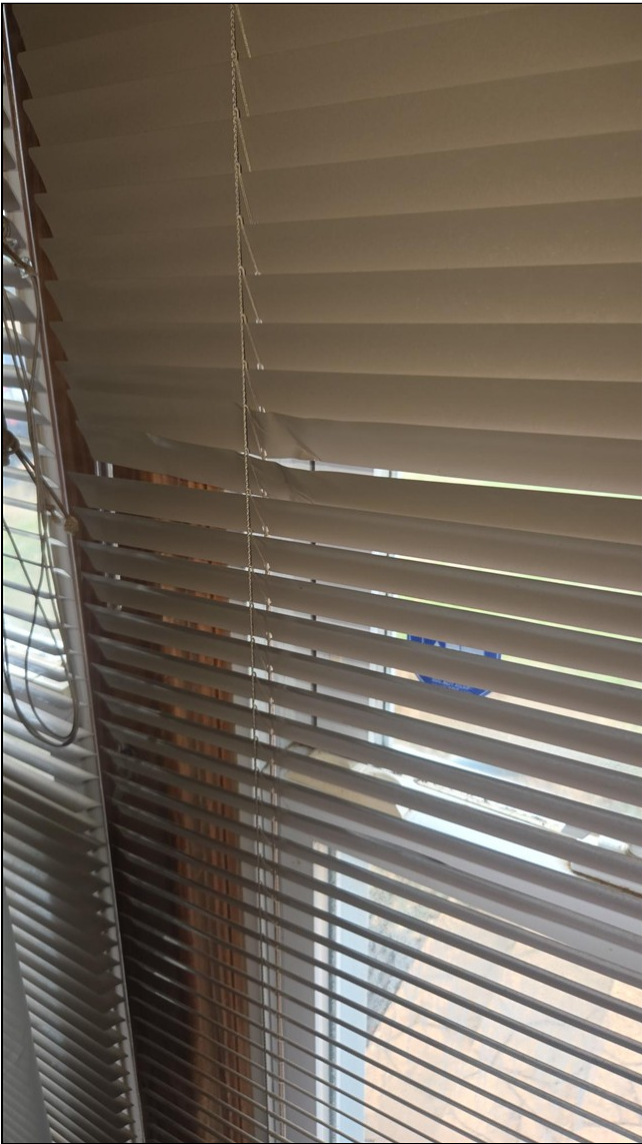
7.6 Item 1(Picture) The blinds were old, brittle, and hard to open/close.

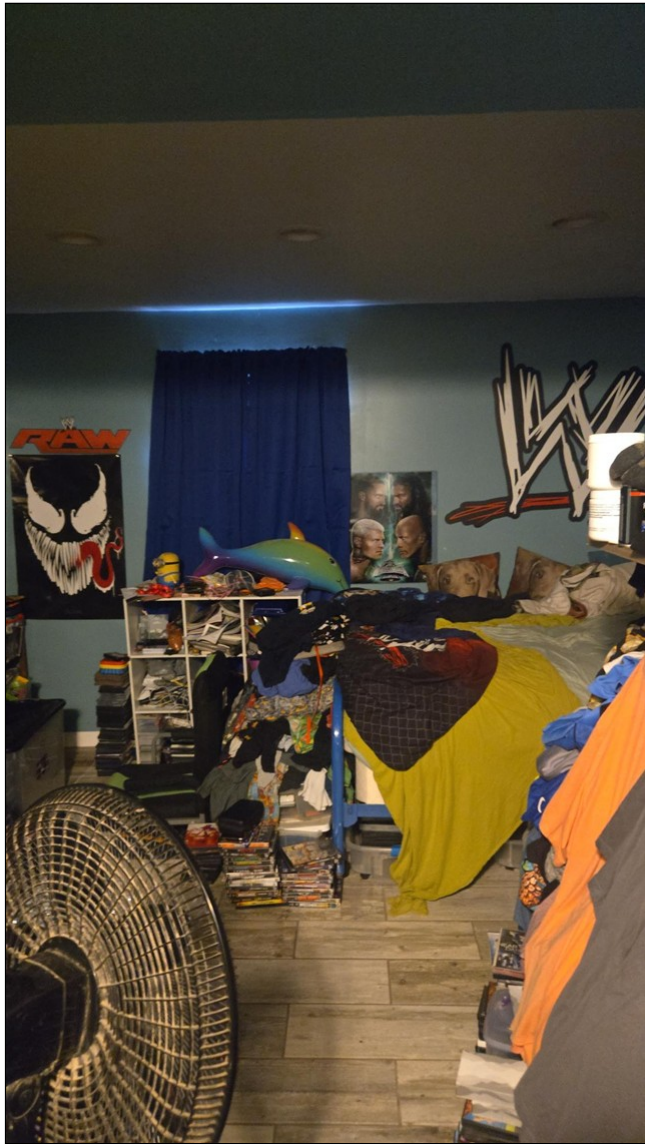
7.6 Item 2(Picture) Many windows were inaccessible and were not inspected.

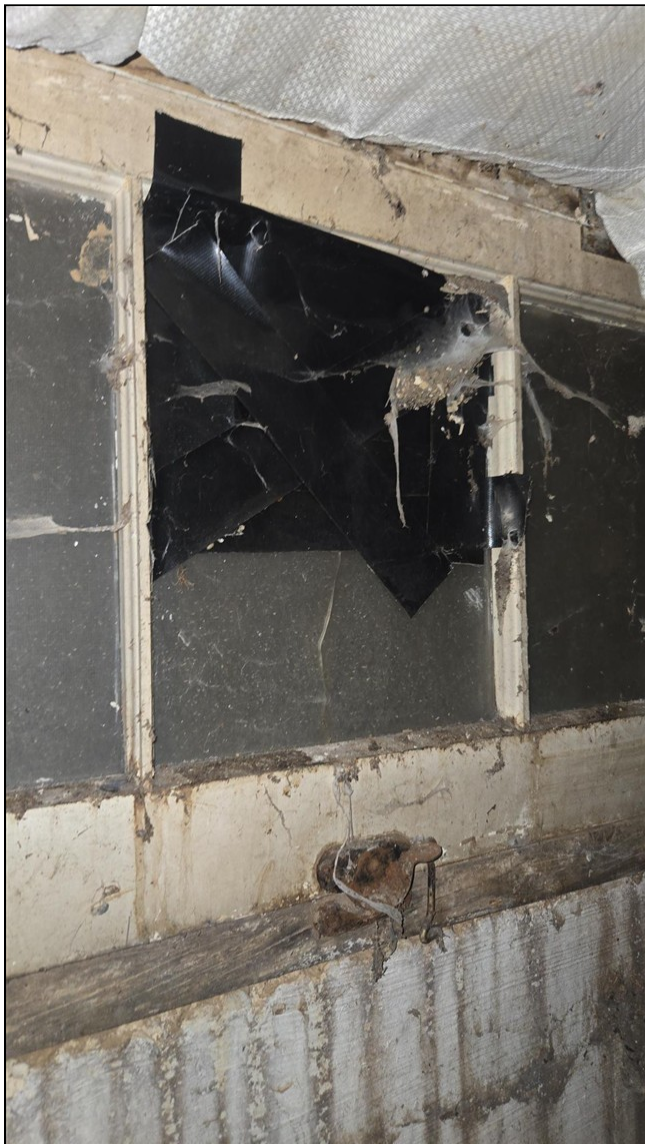
7.6 Item 3(Picture) Broken basement crawlspace entrance.

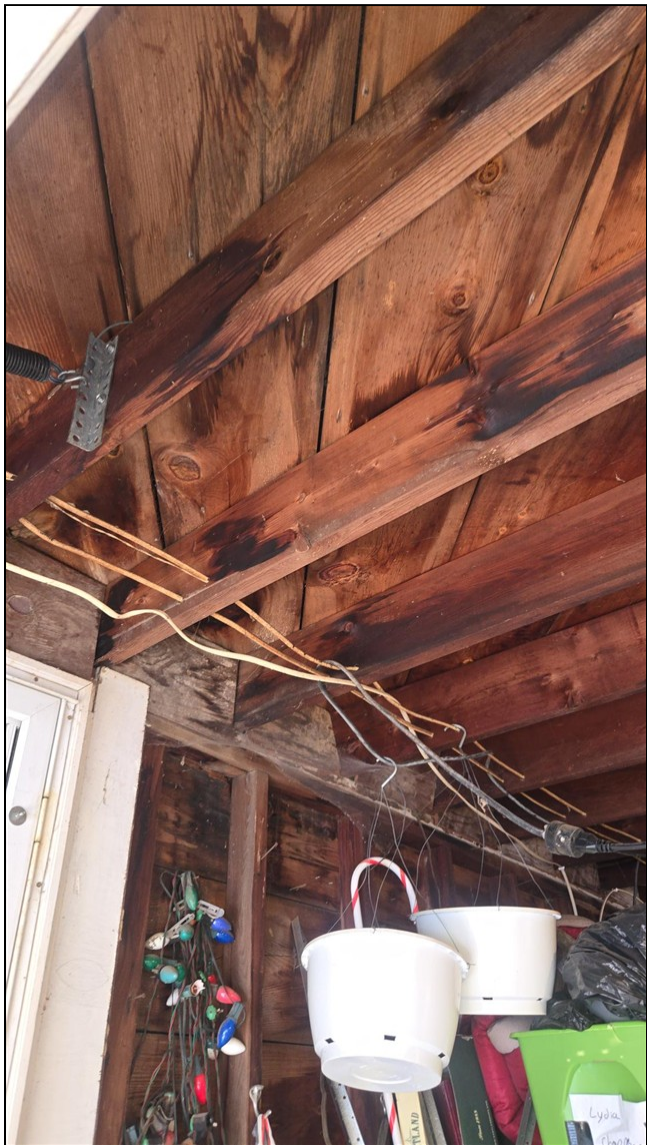
8.0 Item 1(Picture) The garage ceiling should be covered with 5/8" or thicker type-x fire resistant drywall to provide fire protection to the occupancy in the event of a garage fire.

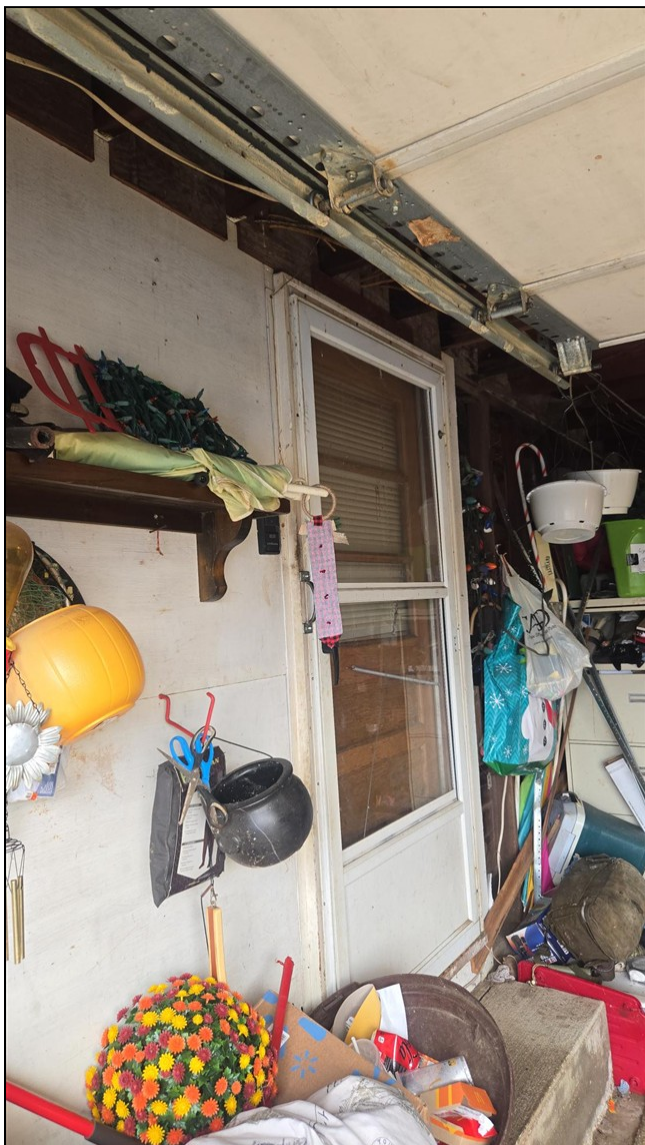
8.1 Item 1(Picture) The garage wall should be covered with ½” or thicker type-x fire resistant drywall to provide fire protection to the occupancy in the event of a garage fire.

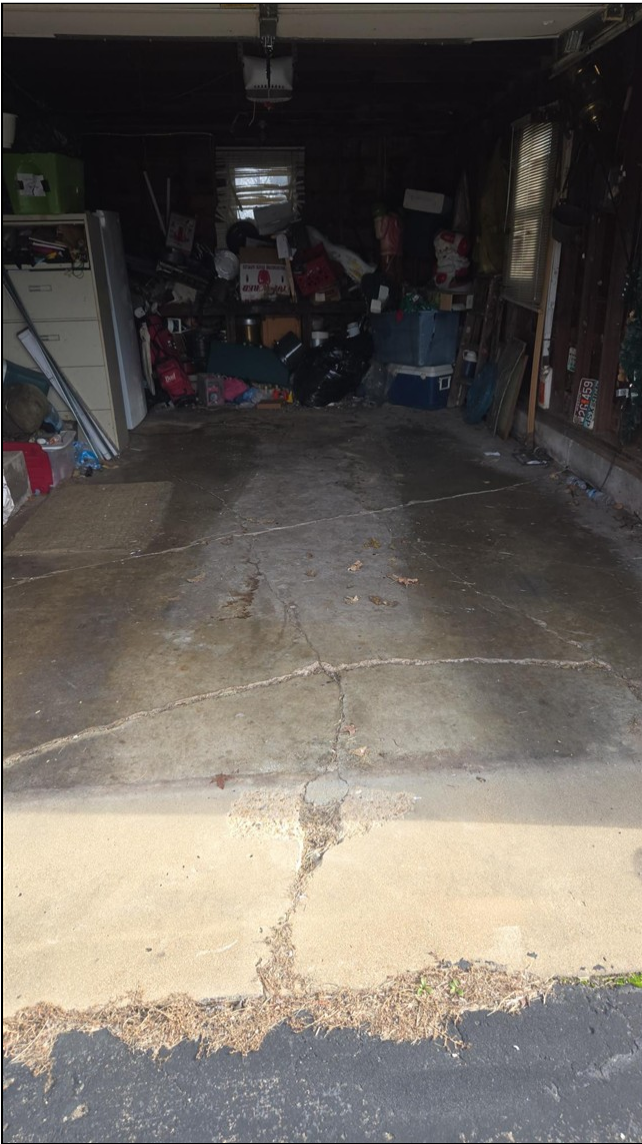
8.2 Item 1(Picture)

8.2 The garage floor was cracked in several places and may be a floating slab.

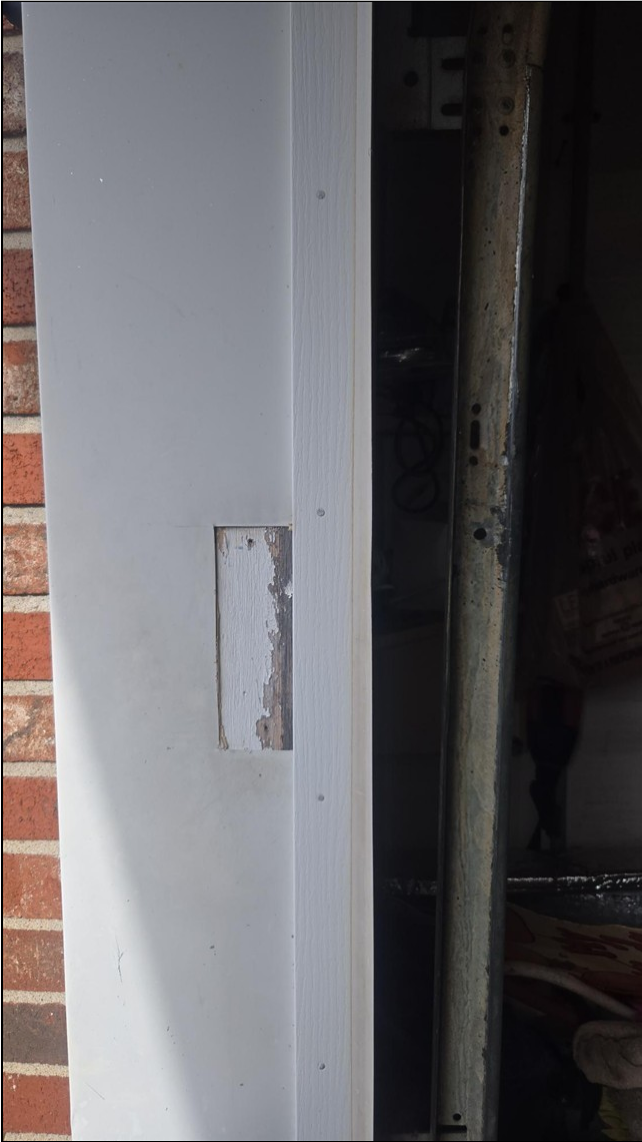
8.3 Item 1(Picture) The garage door fascia required repairs.

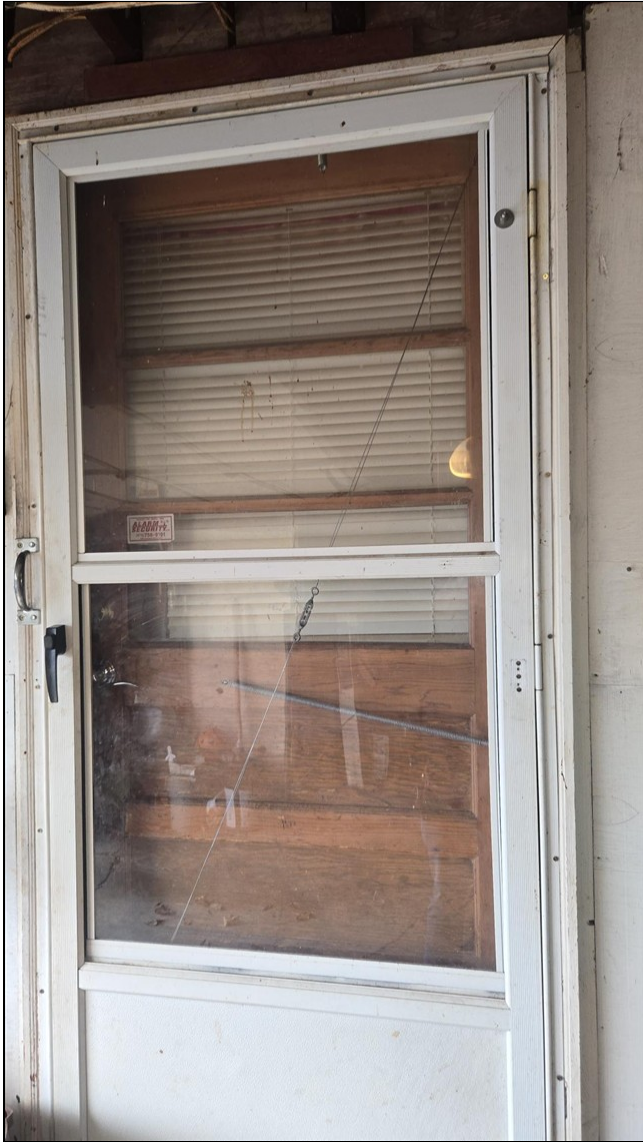
8.4 Item 1(Picture) The occupant door to the house from the garage should be a fire resistant door. "Other openings between the garage and the residence shall be equipped with solid wood doors not less than 1-3/8" (35 mm) in thickness, solid- or honeycomb-core steel doors not less than 1-3/8" (35 mm) thick, or 20-minute fire-rated doors." The door should be replaced with a fire resistant door by a qualified contractor.

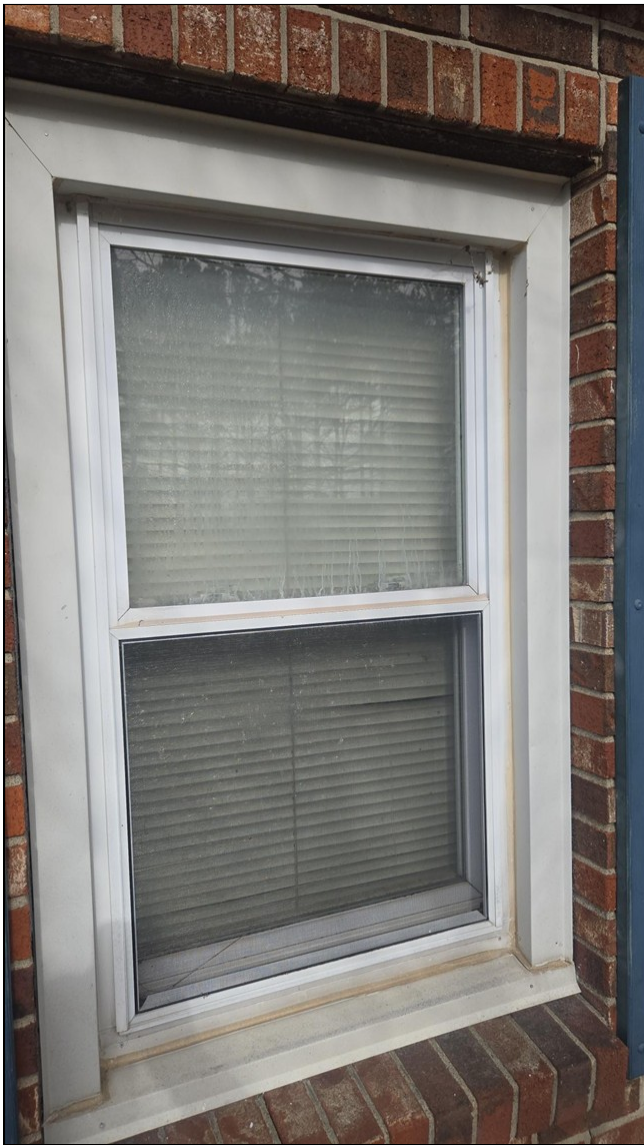
8.6 Item 1(Picture) Broken thermal seals present as sometimes milky residue between the panes of glass and or condensation in between the thermal panes. Broken thermal seals allow moisture vapor to enter the window between the thermal panes and make the window less efficient from a thermal energy perspective. The windows should be cleaned; any and all broken thermal seals should be found and fixed by a qualified contractor.

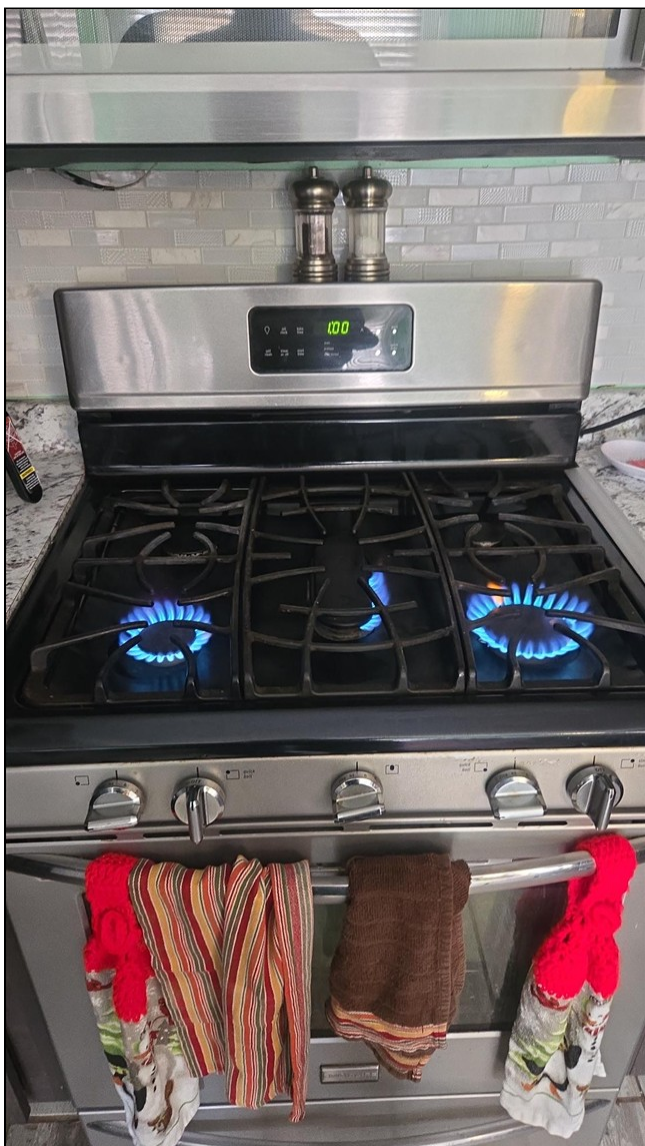
9.1 Item 1(Picture) The stove and oven required repairs. The burners should be cleaned or replaced. CO detectors should be located in every sleeping room of the house and in the basement. CO detectors should be located within 2' of the floor. All detectors more than 10 years old should be replaced

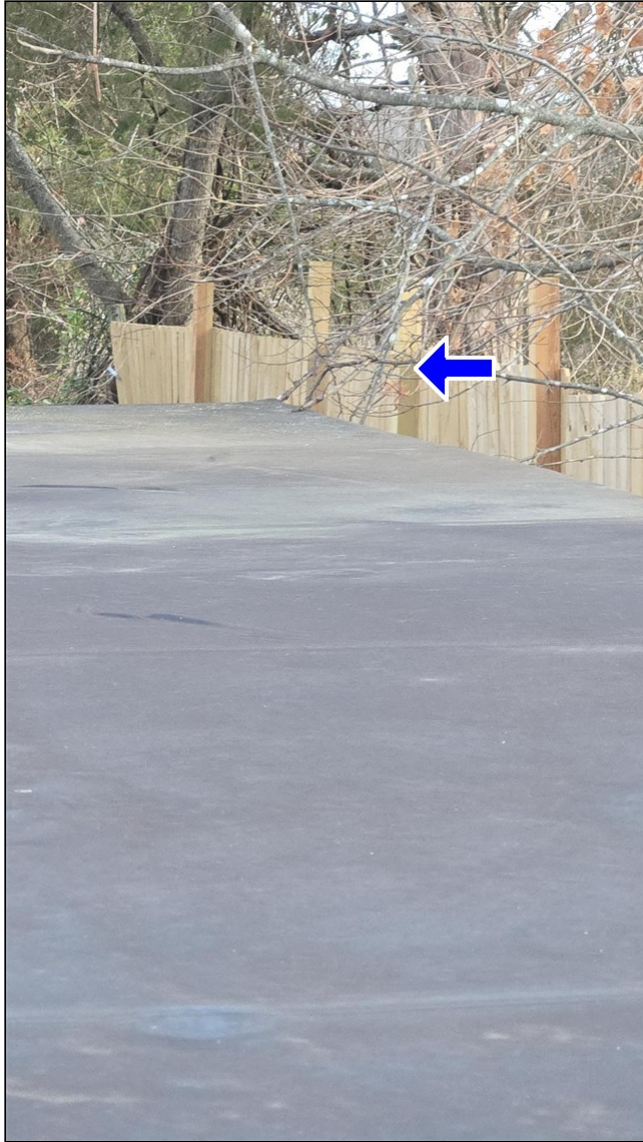
1.0 Item 1(Picture) Tree branches should be cut back 6' outside of the perimeter of the home plumb to the sky. Tree branches that are closer to the home than that may cause sudden damage and leaking.

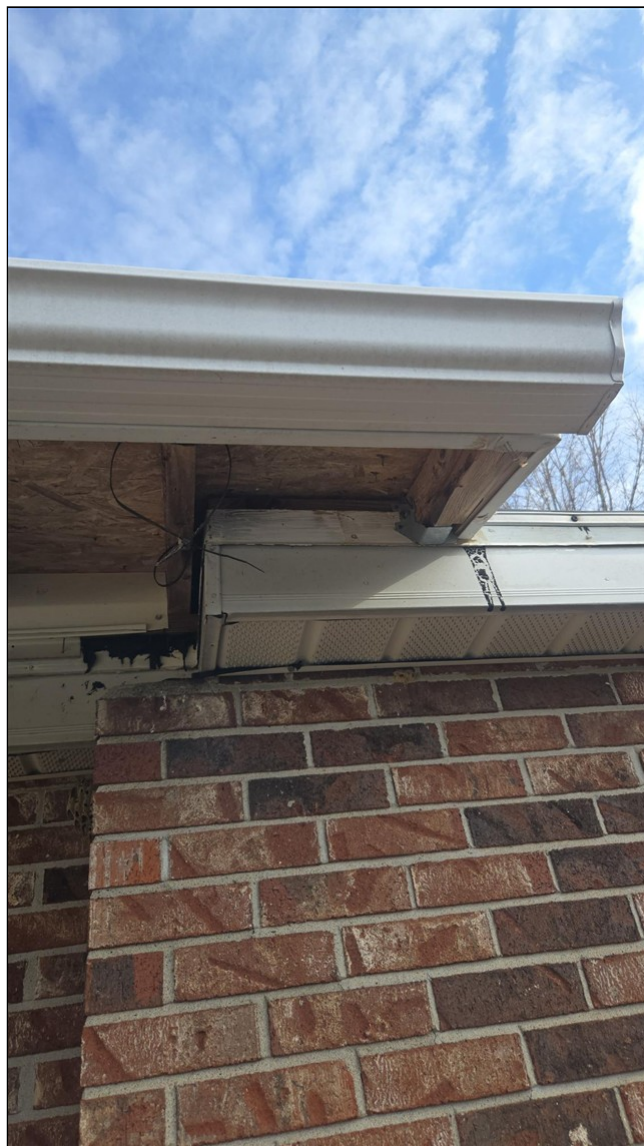
1.1 Item 2(Picture) The flashing on the roof between the flat roof and the house was missing and did not look appropriate. This is an unusual situation and it should be repaired by a qualified roofer. This situation may cause leaks and there may be hidden water damage in this area.

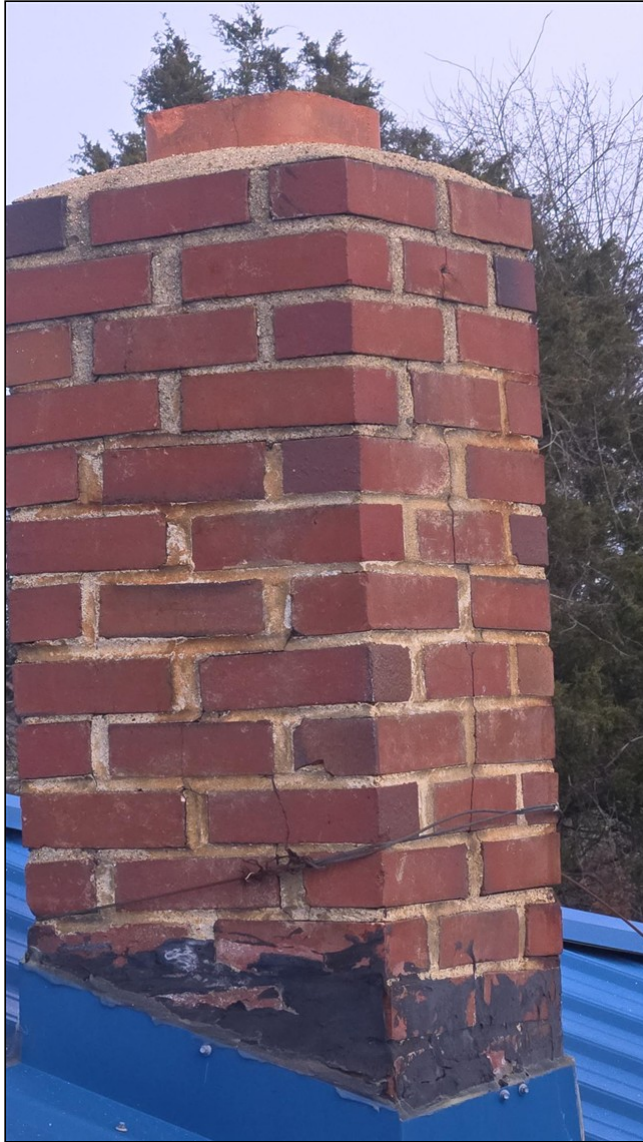
1.2 Item 1(Picture) The flue was cracked. The chimney required tuck pointing. The chimney flashing was not properly installed and should be regularly sealed or replaced. A qualified roofing contractor should repair any and all problem areas of this roof. The flue cap were not installed and flue caps should be installed by a qualified contractor. Flue caps prevent birds and rain from entering the flue and causing the flue to become blocked trapping carbon monoxide in the home. A flue cap should be installed by a qualified contractor. The flue should be swept and repaired by a licensed chimney sweep, prior to the first use and annually thereafter. Masonry repair and tuck pointing is required on the property. Maintaining the mortar is integral to maintaining the asset. All mortar should be cement based.

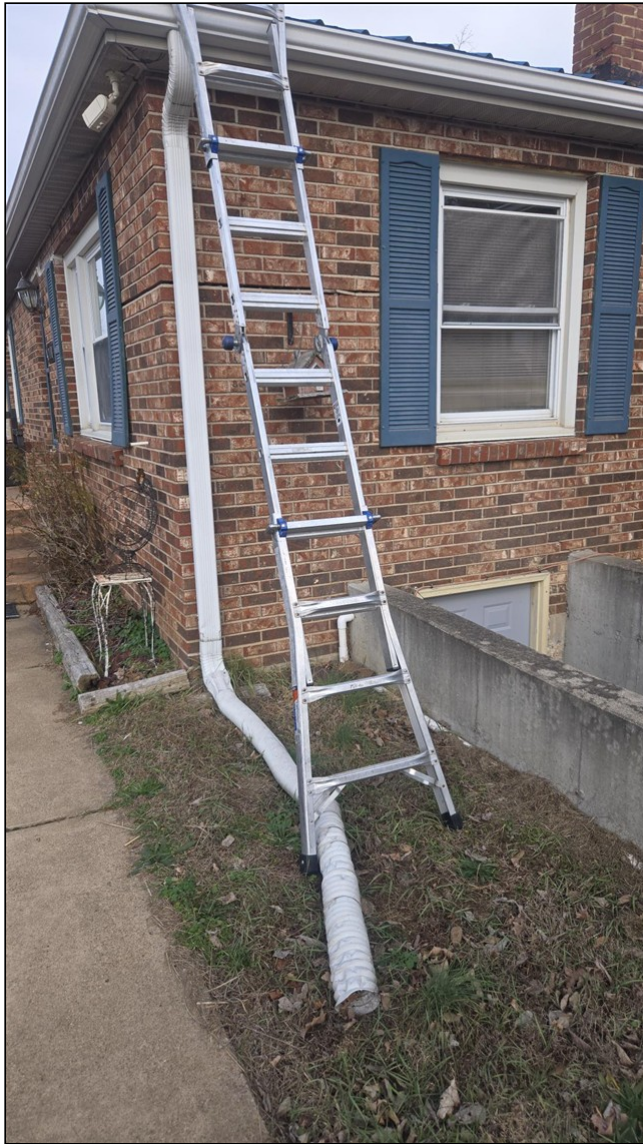
1.3 Item 1(Picture) Gutters should be provided with down spouts and downspout drains that discharge to daylight at least 10' outside of the perimeter of the house. Water should never be allowed to pool, puddle, or run within 10' of the perimeter of the home. The roof was missing some guttering. All roofs should be provided with gutters, downspouts, and drains.

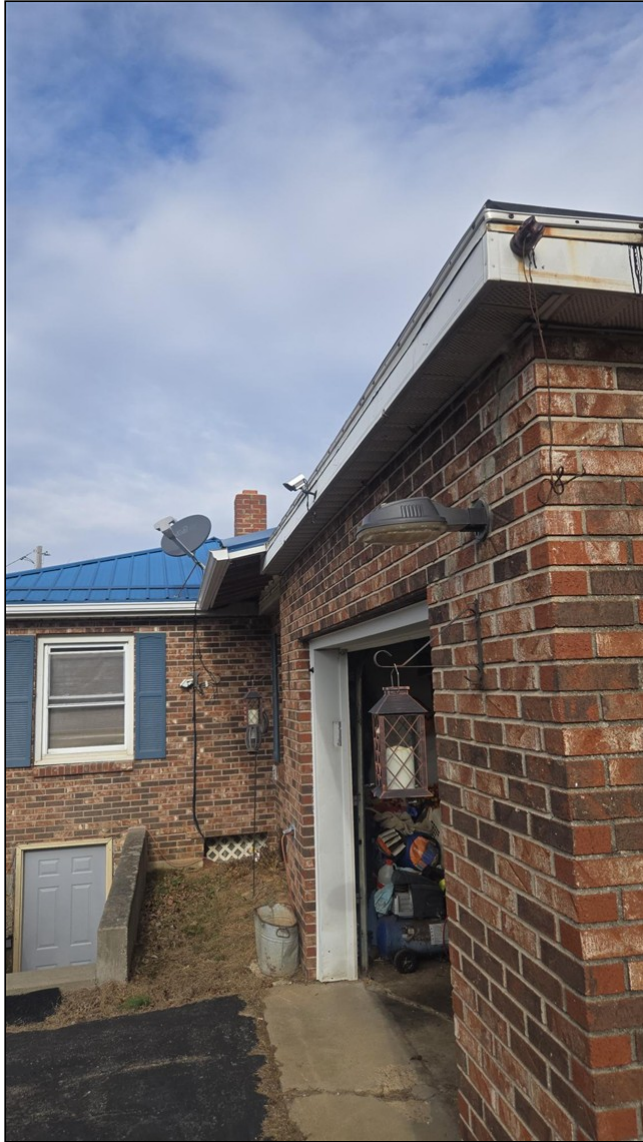
1.3 Item 3(Picture) The gutters were missing. The downspouts were missing. The downspout drains were missing. Some drains did not have an identifiable outlet. Gutters should be provided with down spouts and downspout drains that discharge to daylight at least 10' outside of the perimeter of the house. Water should never be allowed to pool, puddle, or run within 10' of the perimeter of the home. The roof was missing some guttering. All roofs should be provided with gutters, downspouts, and drains.

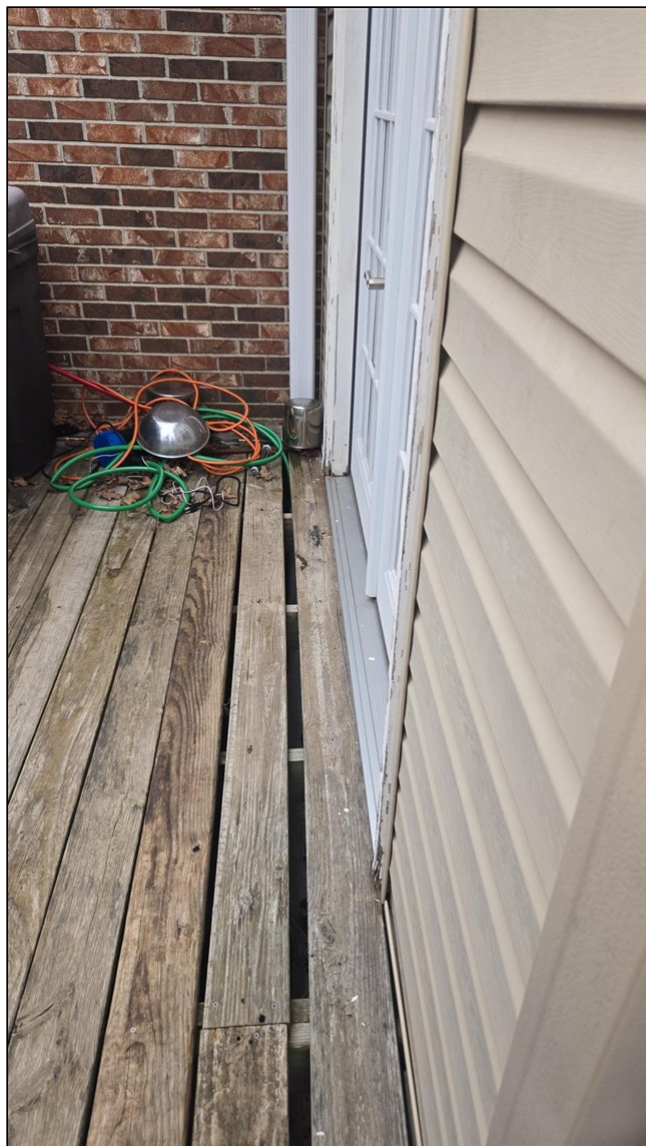
1.3 Item 5(Picture) This basement was actively wet.Improving the surface drainage and downspout drains around the house will increase the likelihood of a dry basement. The basement was dry at the time of the inspection. InterNACHI estimates that over 80% of wet basement issues are from water that is within 10' of the perimeter of the house.

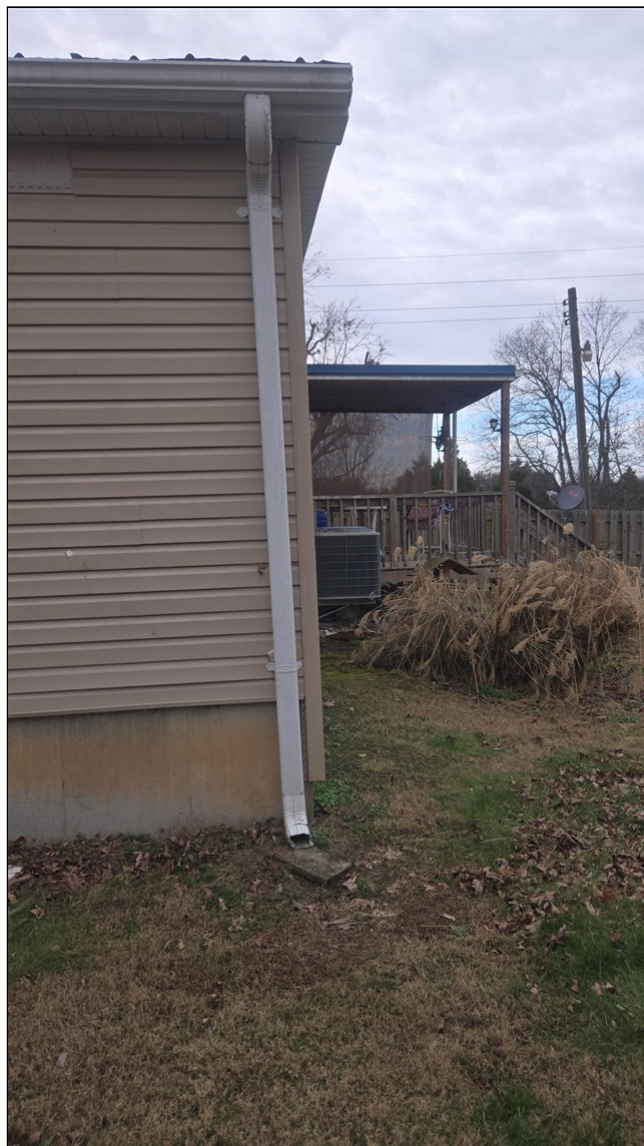
1.3 Item 6(Picture) This basement was actively wet.Improving the surface drainage and downspout drains around the house will increase the likelihood of a dry basement. The basement was dry at the time of the inspection. InterNACHI estimates that over 80% of wet basement issues are from water that is within 10' of the perimeter of the house.

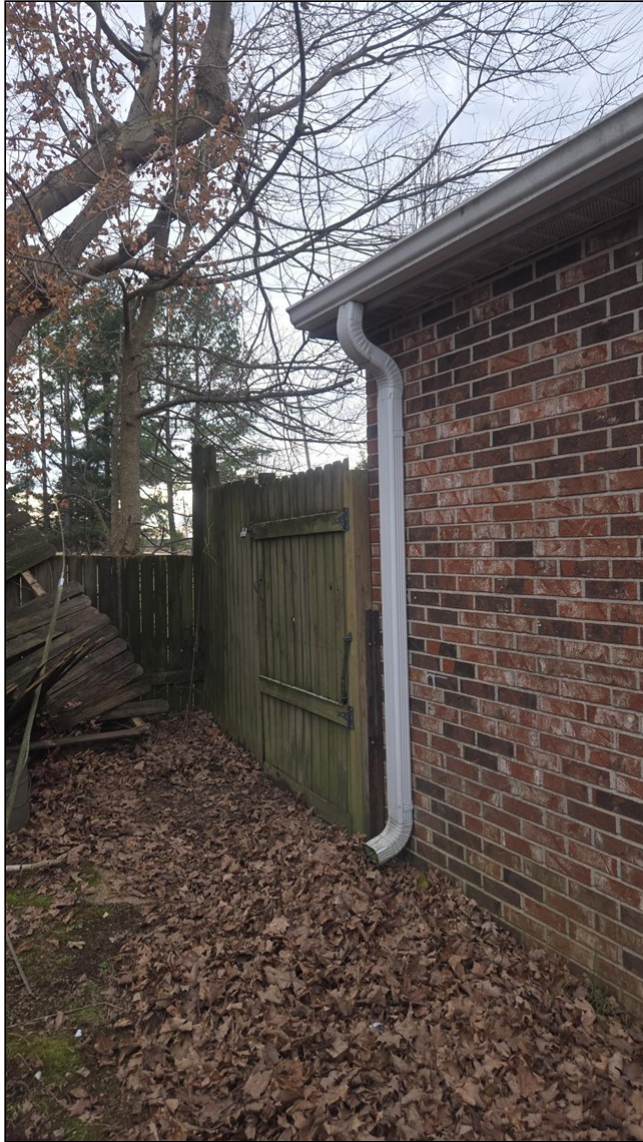
1.3 Item 7(Picture) This basement was actively wet. Improving the surface drainage and downspout drains around the house will increase the likelihood of a dry basement. The basement was dry at the time of the inspection. InterNACHI estimates that over 80% of wet basement issues are from water that is within 10' of the perimeter of the house.
