Inspection Report

4700 Turley Mill Rd, Farmington, MO 63640, USA

A-Team Consulting and Contracting

Date: 1/2/2025	Time:	Report ID: 2025010202
Property: Address	Customer: NAME	Real Estate Professional:

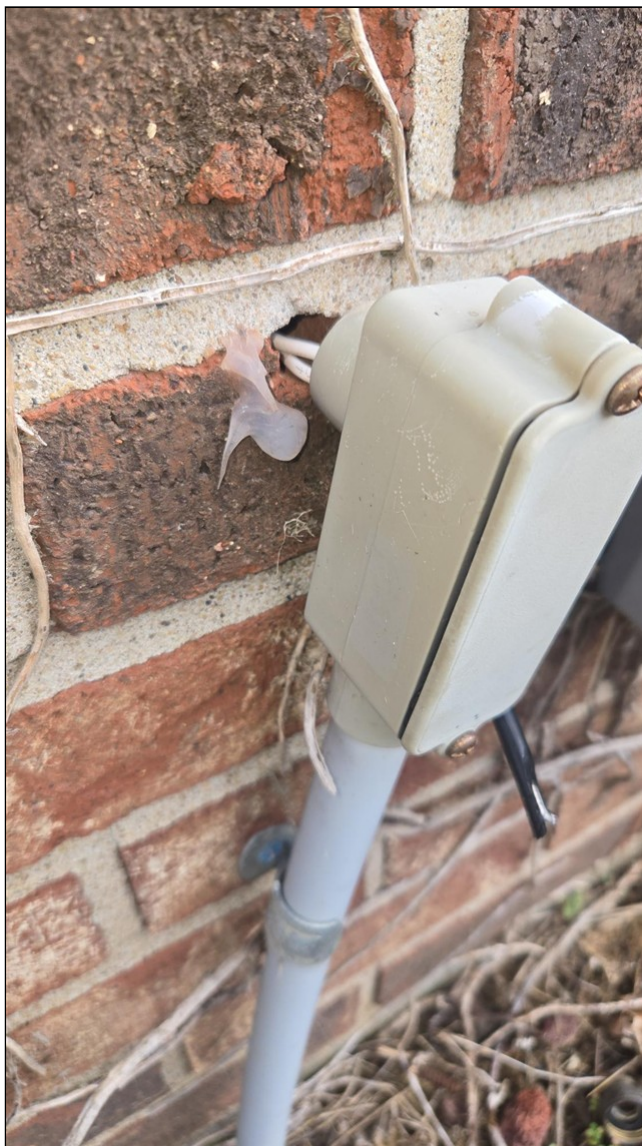
2.0 Item 2(Picture) Any and all holes should be sealed. This conduit should be repaired by a licensed electrical contractor.

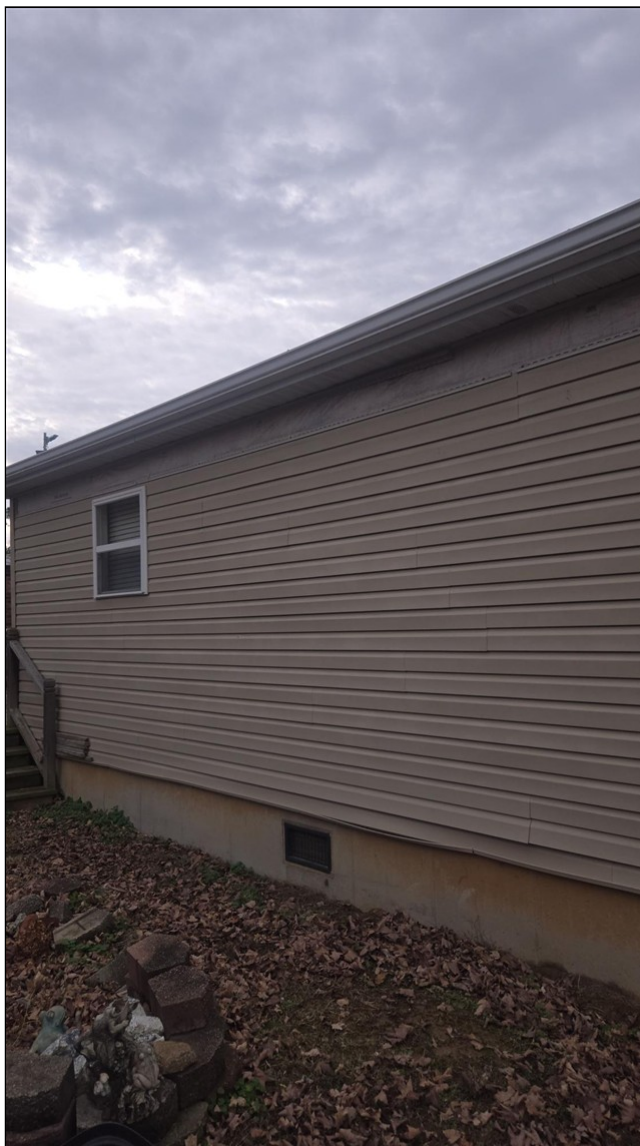
2.0 Item 4(Picture) There was missing siding noticed and the OSB exterior wall sheathing was not protected with a house wrap. The siding should be completely removed. The osb exterior walls should be provided with house wrap and the siding should be reinstalled.

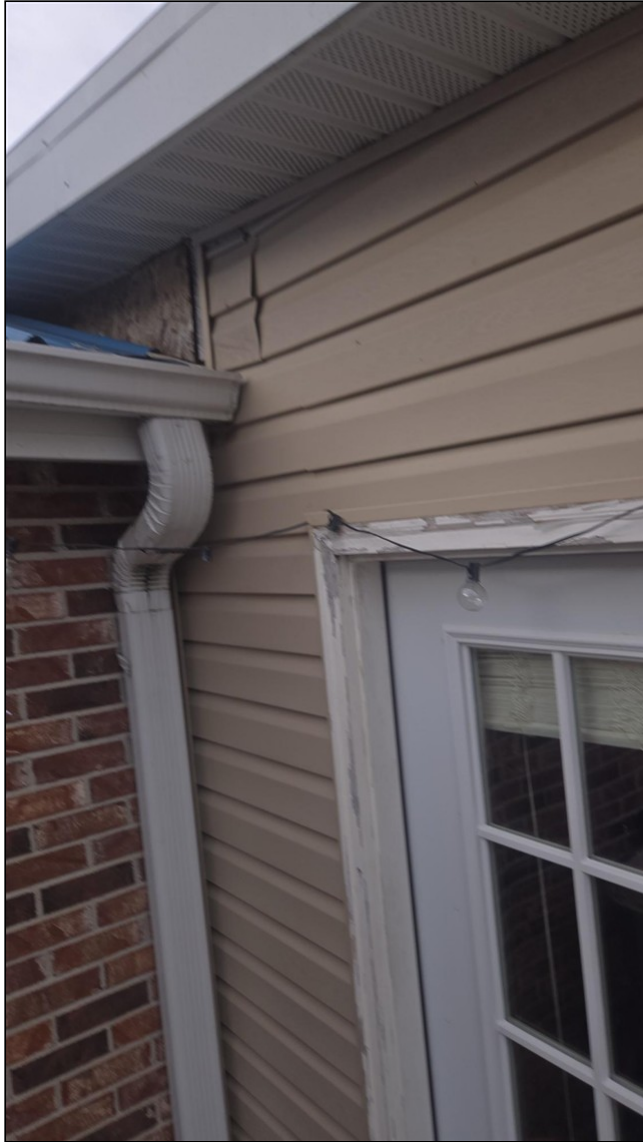
2.0 Item 5(Picture) There was missing siding noticed and the OSB exterior wall sheathing was not protected with a house wrap. The siding should be completely removed. The osb exterior walls should be provided with house wrap and the siding should be reinstalled.

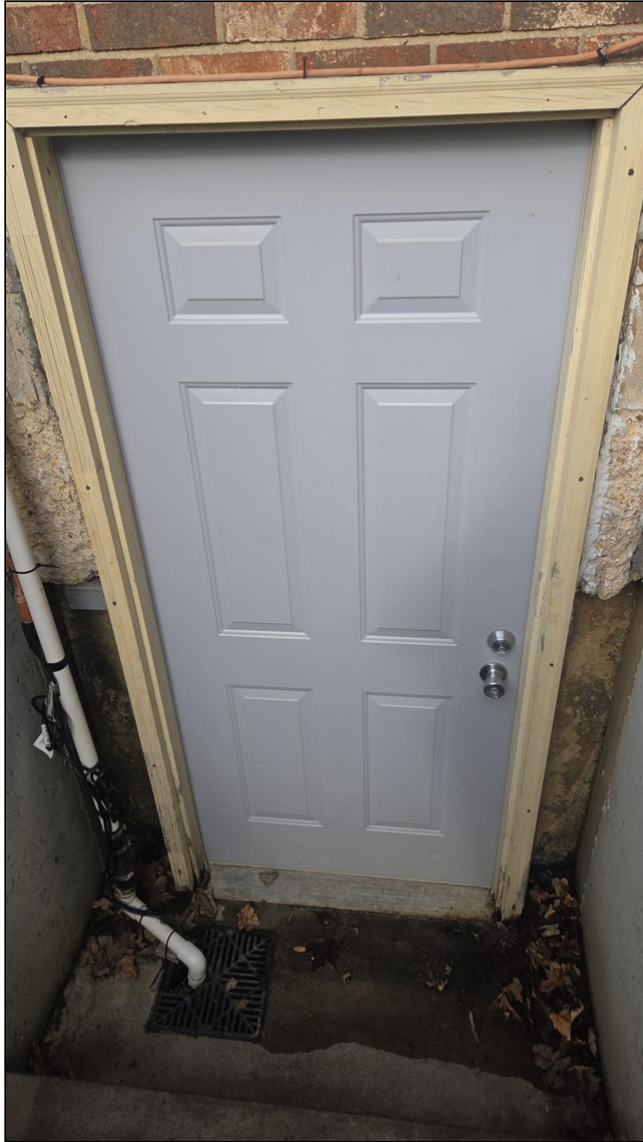
2.1 Item 1(Picture) There was bare wood and rotted wood noticed. There was exposed wood and metal. Exposed materials degrade faster than painted materials. A qualified contractor should repaint, stain, or seal any and all exposed materials. Painting of bare metal/wood is a minimum housing standard requirement.

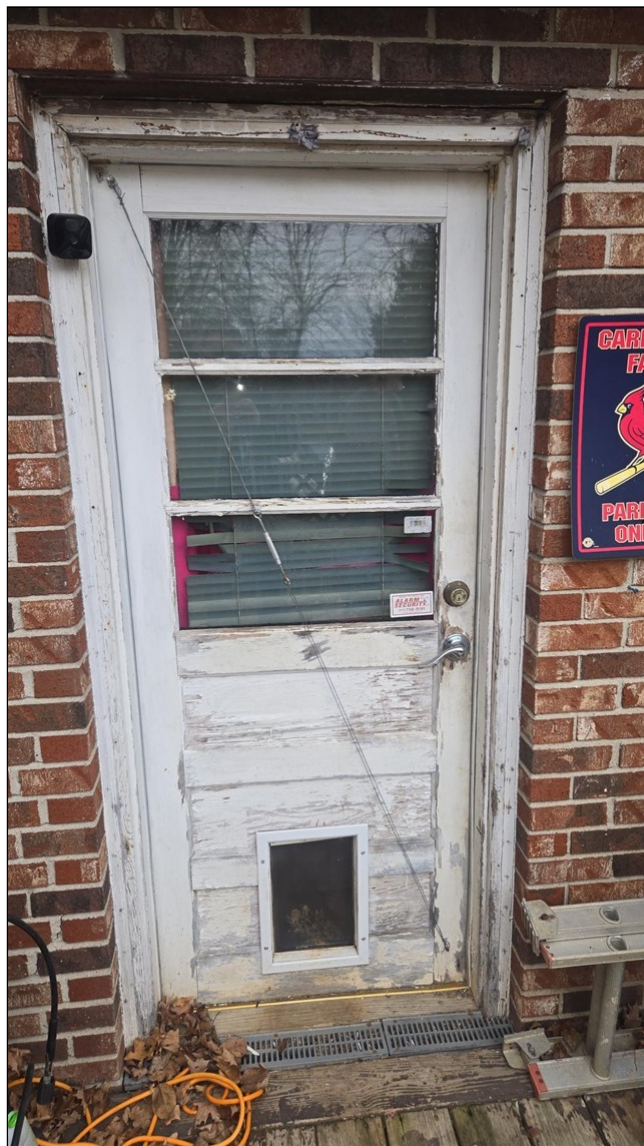
2.1 Item 4(Picture) There was bare wood and rotted wood noticed. There was exposed wood and metal. Exposed materials degrade faster than painted materials. A qualified contractor should repaint, stain, or seal any and all exposed materials. Painting of bare metal/wood is a minimum housing standard requirement.

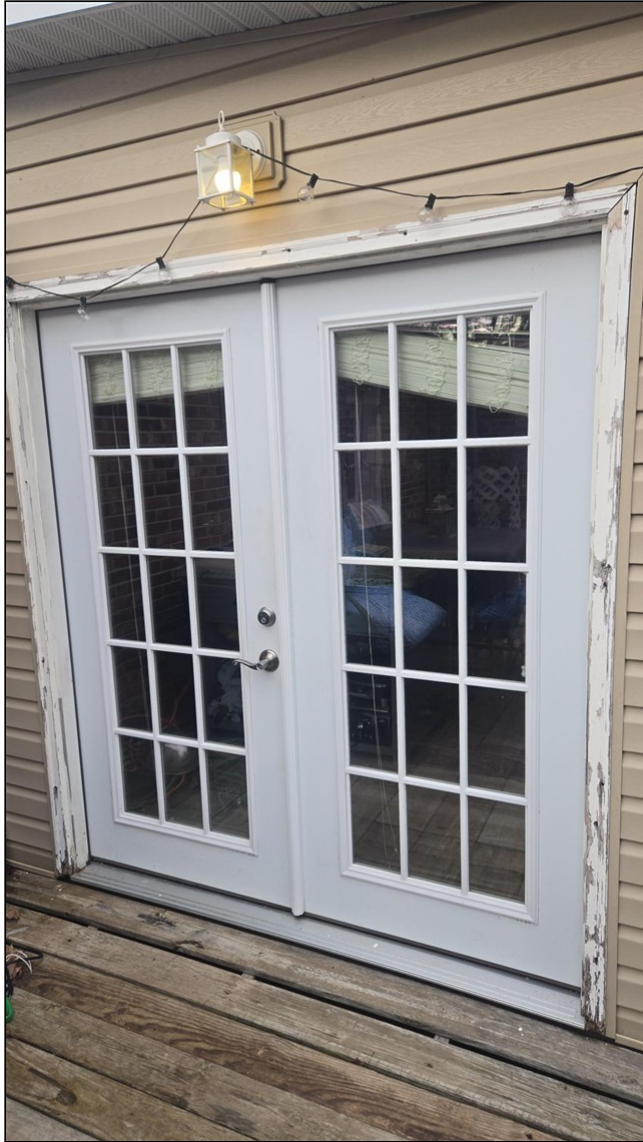
2.1 Item 5(Picture) There was bare wood and rotted wood noticed. There was exposed wood and metal. Exposed materials degrade faster than painted materials. A qualified contractor should repaint, stain, or seal any and all exposed materials. Painting of bare metal/wood is a minimum housing standard requirement.

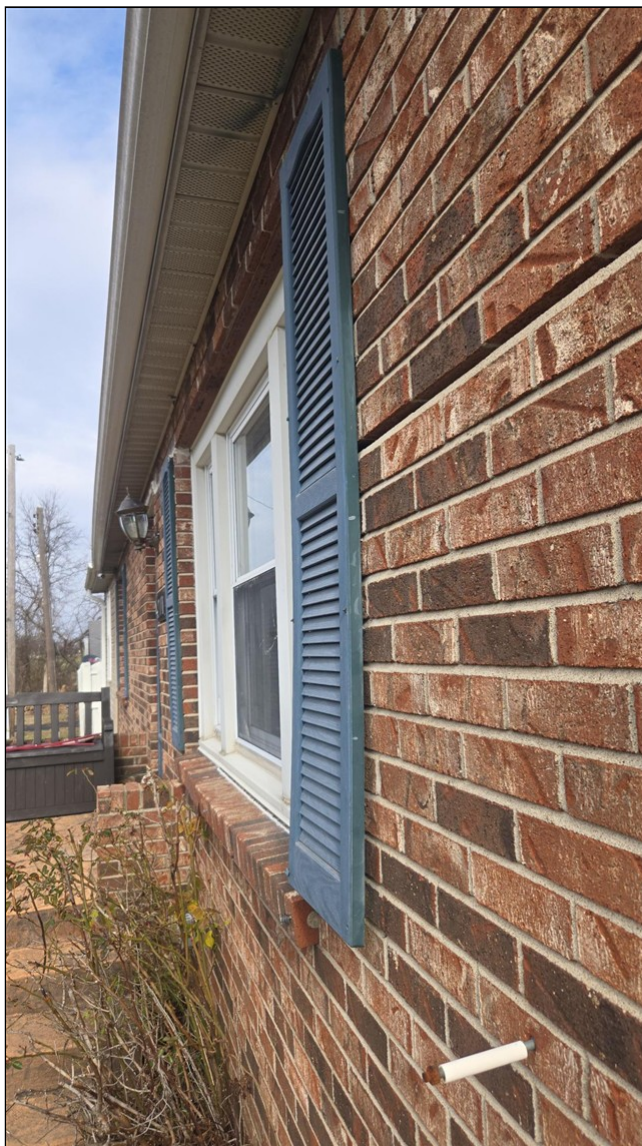
2.2 Item 2(Picture) Loose shutter - There was at least one loose shutter.

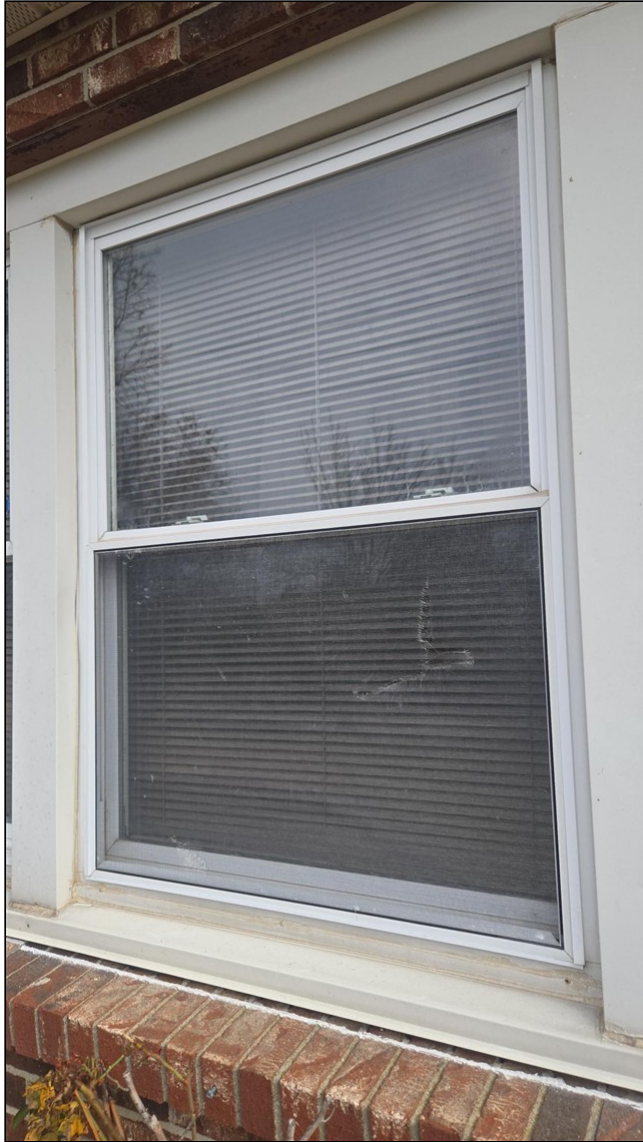
2.2 Item 3(Picture) Broken thermal seals - Dirty windows may appear to be windows with broken thermal panes. Broken thermal seals present as sometimes milky residue between the panes of glass and or condensation in between the thermal panes. Broken thermal seals allow moisture vapor to enter the window between the thermal panes and make the window less efficient from a thermal energy perspective. The windows should be cleaned; any and all broken thermal seals should be found and fixed by a qualified contractor.

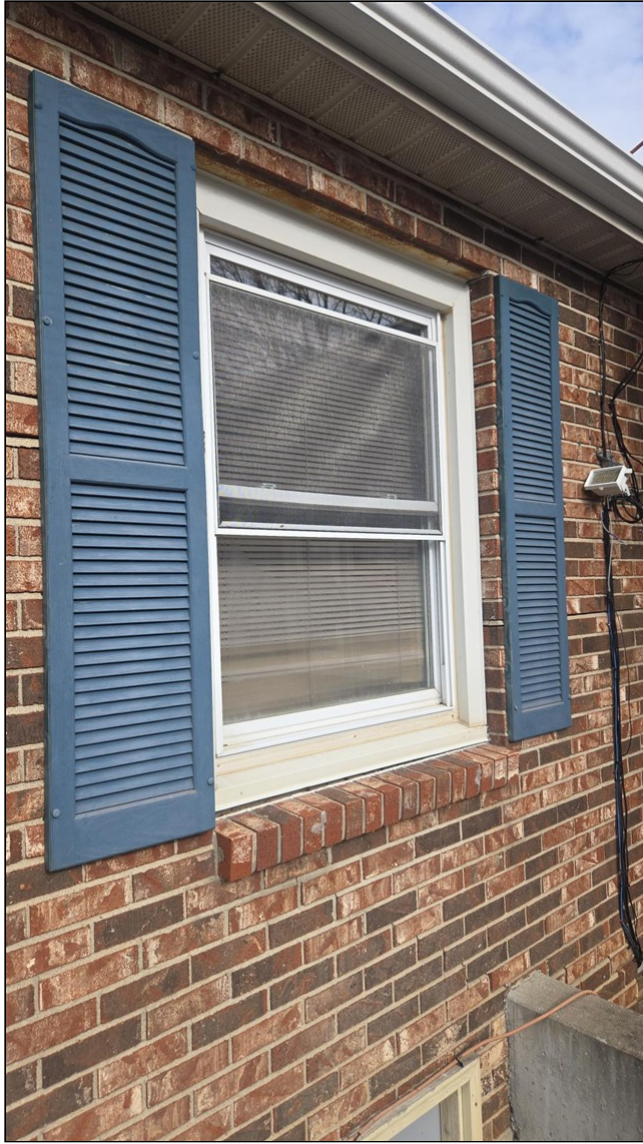
2.2 Item 5(Picture) Broken thermal seals - Dirty windows may appear to be windows with broken thermal panes. Broken thermal seals present as sometimes milky residue between the panes of glass and or condensation in between the thermal panes. Broken thermal seals allow moisture vapor to enter the window between the thermal panes and make the window less efficient from a thermal energy perspective. The windows should be cleaned; any and all broken thermal seals should be found and fixed by a qualified contractor.

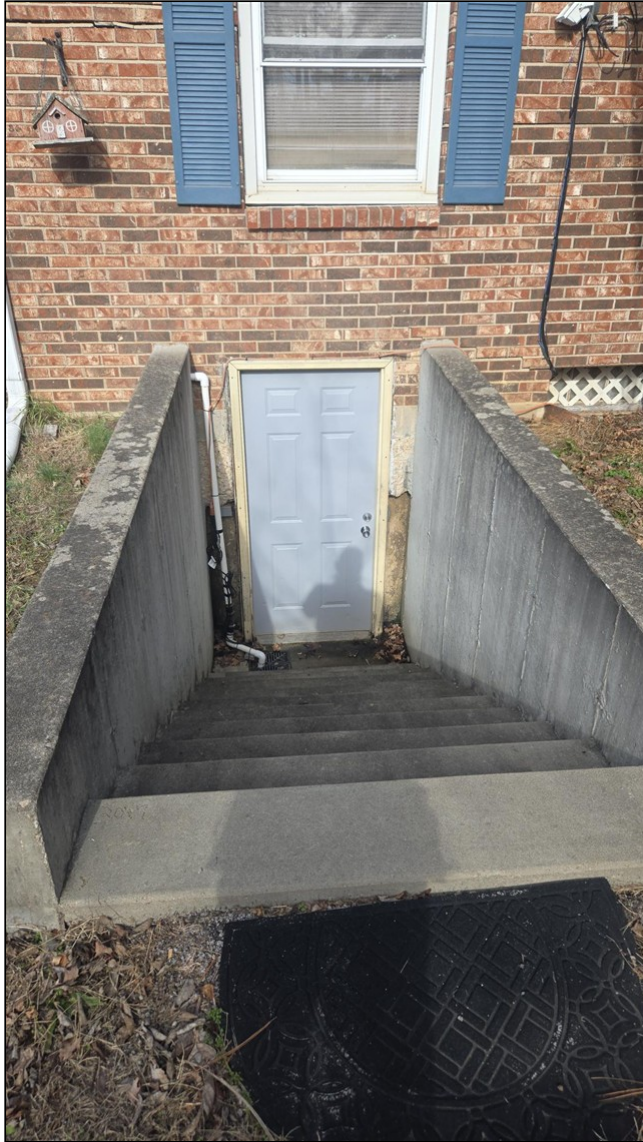
2.3 Item 1(Picture) Missing handrail. Handrails should be designed to handle 300# of force applied in any direction. Handrails should also be graspable by wrapping a hand completely around the handrail to help prevent slips, trips, and falls. Every stairwell with 4 risers or more should have a handrail. A qualified contractor should repair the handrails that don't meet those requirements.

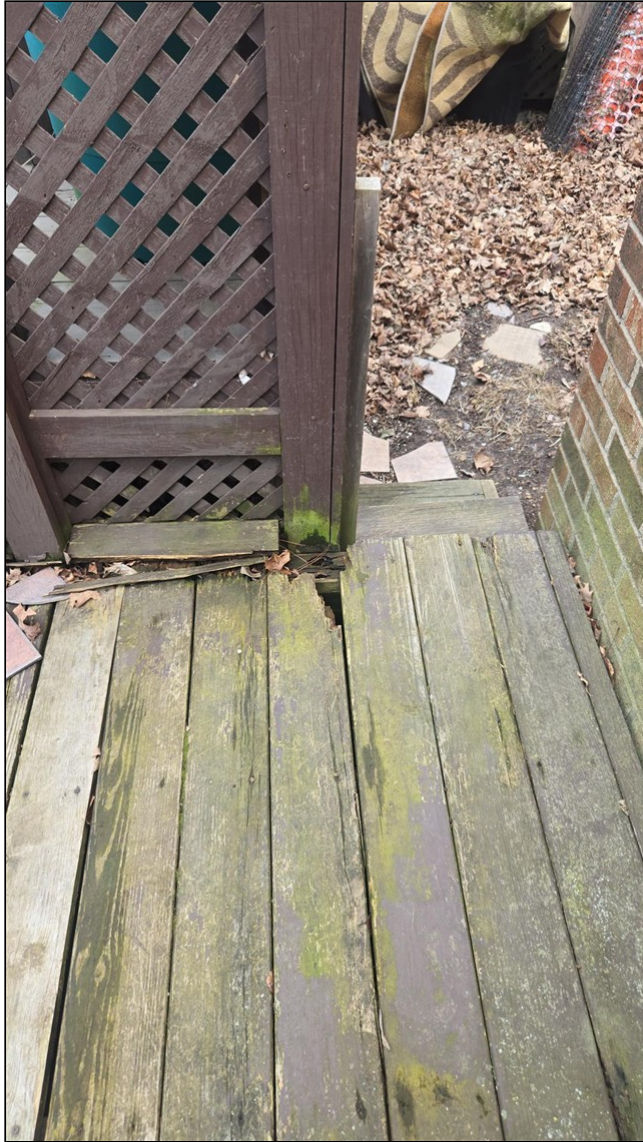
2.3 Item 3(Picture) Rotted wood noticed. There was bare wood and rotted wood noticed. There was exposed wood and metal. Exposed materials degrade faster than painted materials. A qualified contractor should repaint, stain, or seal any and all exposed materials. Painting of bare metal/wood is a minimum housing standard requirement.

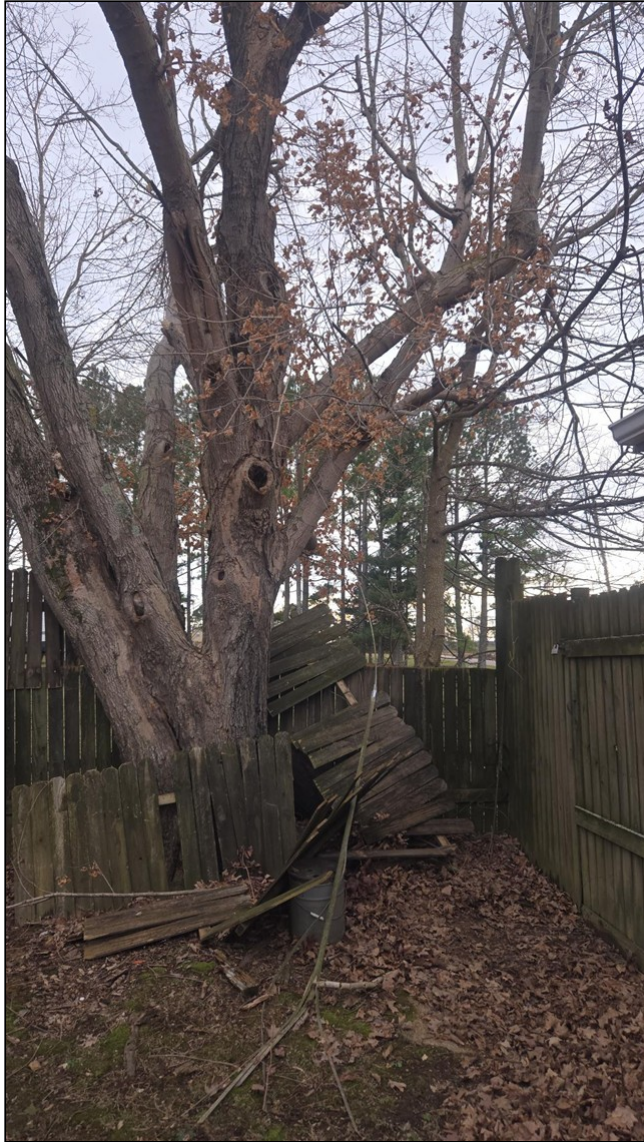
2.4 Item 1(Picture) All trees within 15' of the house should be completely removed because the roots may damage the foundation and the branches may damage the home.

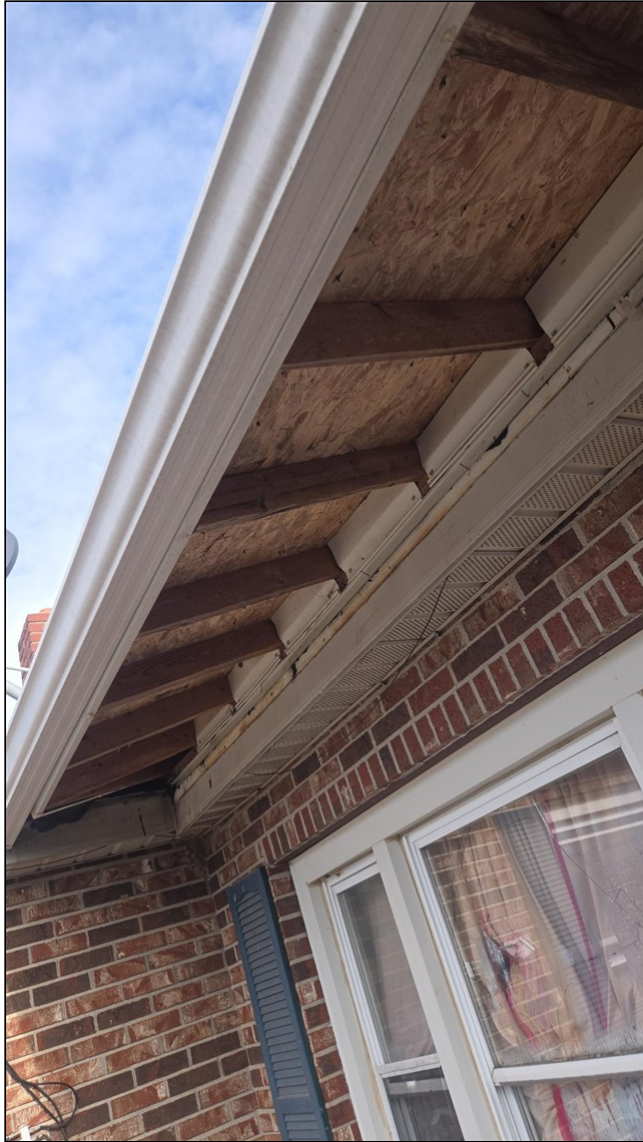
2.5 Item 1(Picture) There was missing soffit noticed.

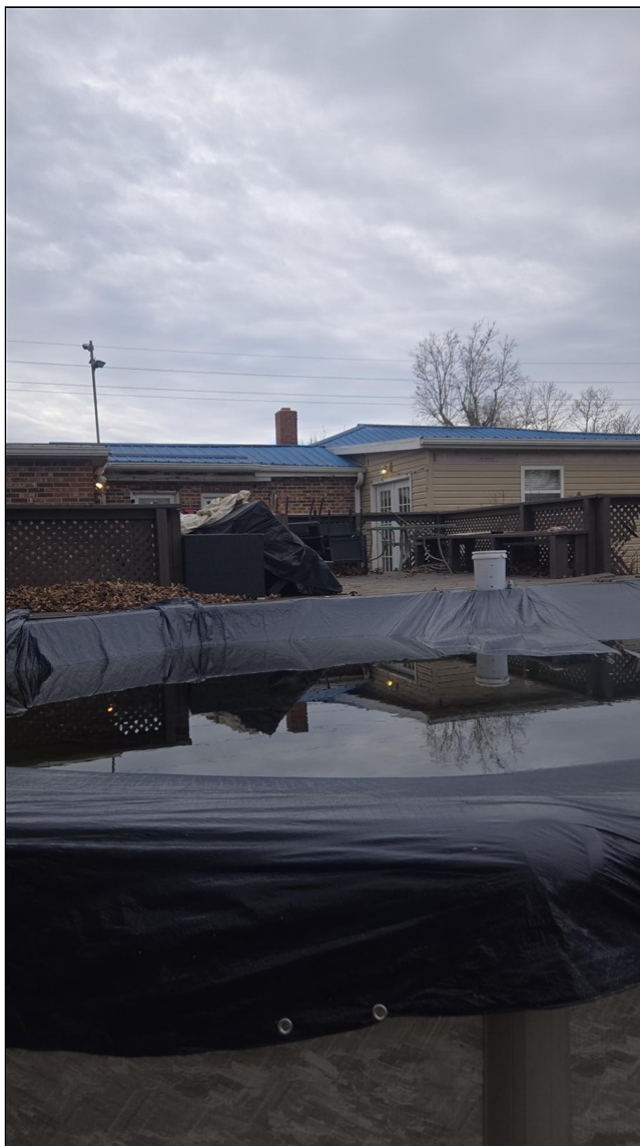
2.6 Item 2(Picture) The pool was closed for winter and could not be fully inspected.

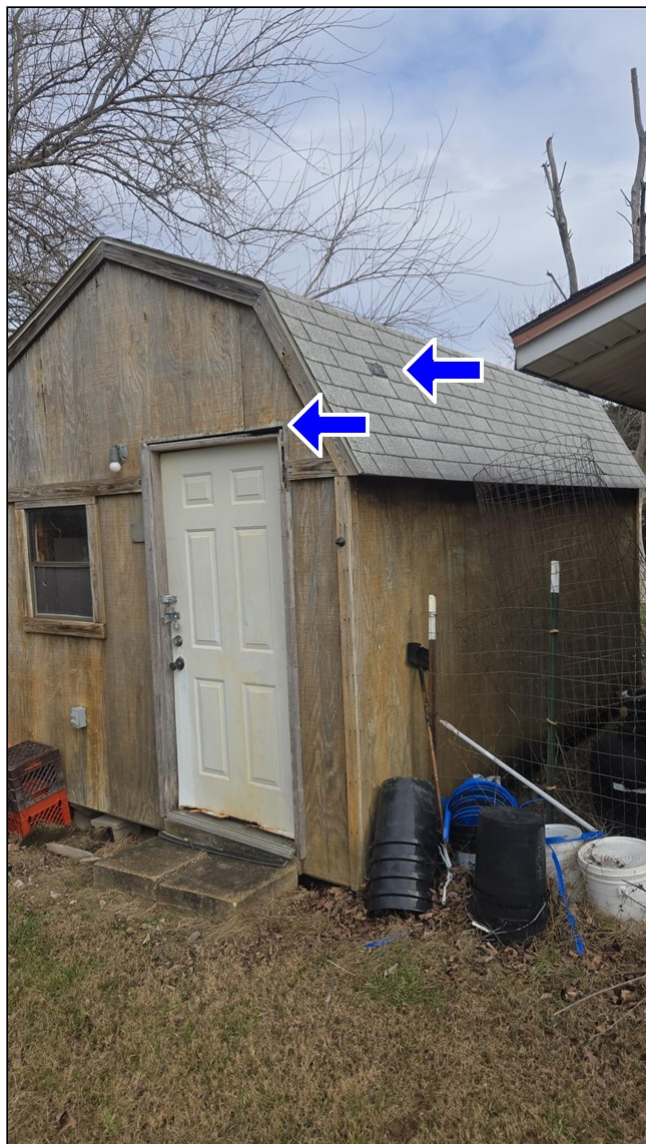
2.7 Item 1(Picture) There was exposed wood and metal. Exposed materials degrade faster than painted materials. A qualified contractor should repaint, stain, or seal any and all exposed materials. Painting of bare metal/wood is a minimum housing standard requirement.

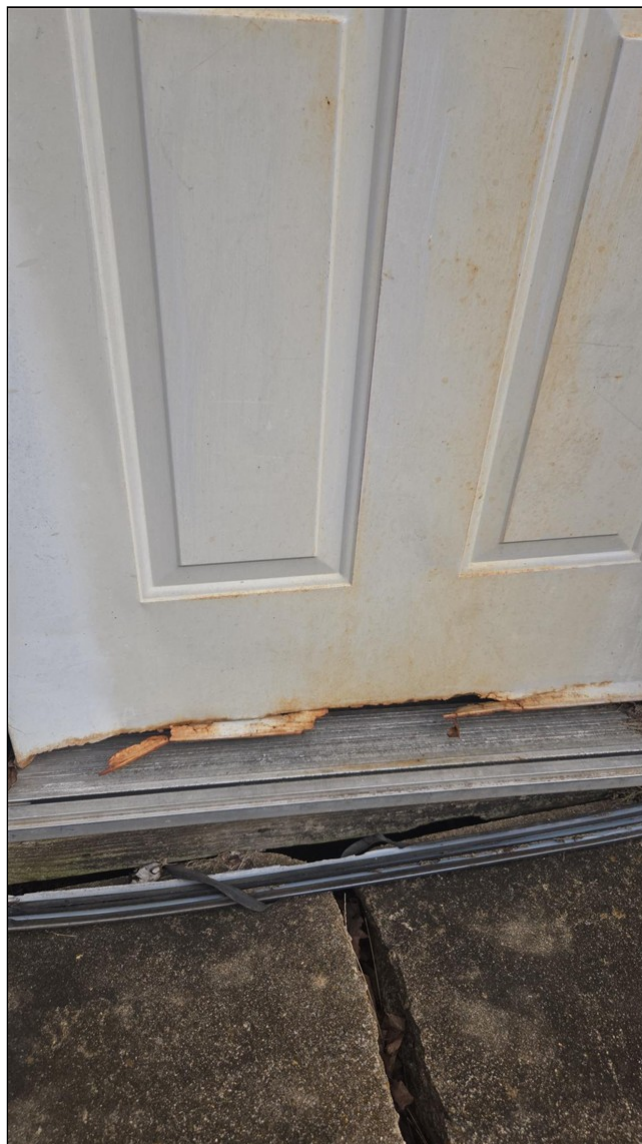
2.7 Item 2(Picture) Rusty door

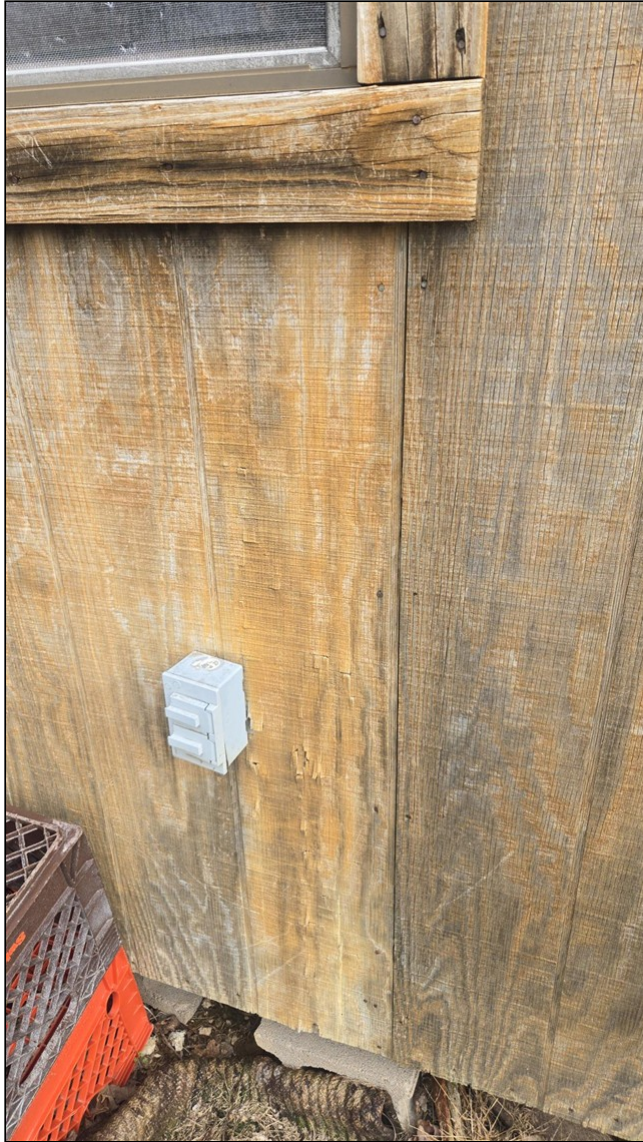
2.7 Item 3(Picture) Bare wood. Not GFCI protected. Outbuilding electrical systems do not meet National Electrical code guidelines. A licensed electrical contractor should bring all of the buildings and the pool area up to modern standards.

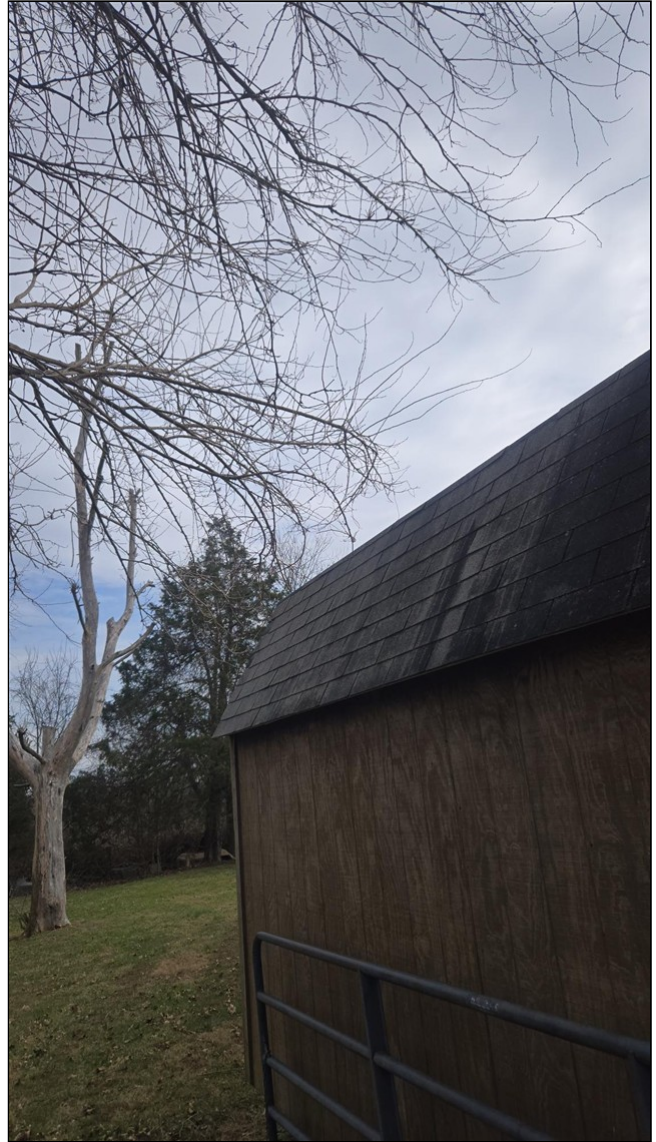
2.7 Item 4(Picture) Tree branches over outbuilding roof.

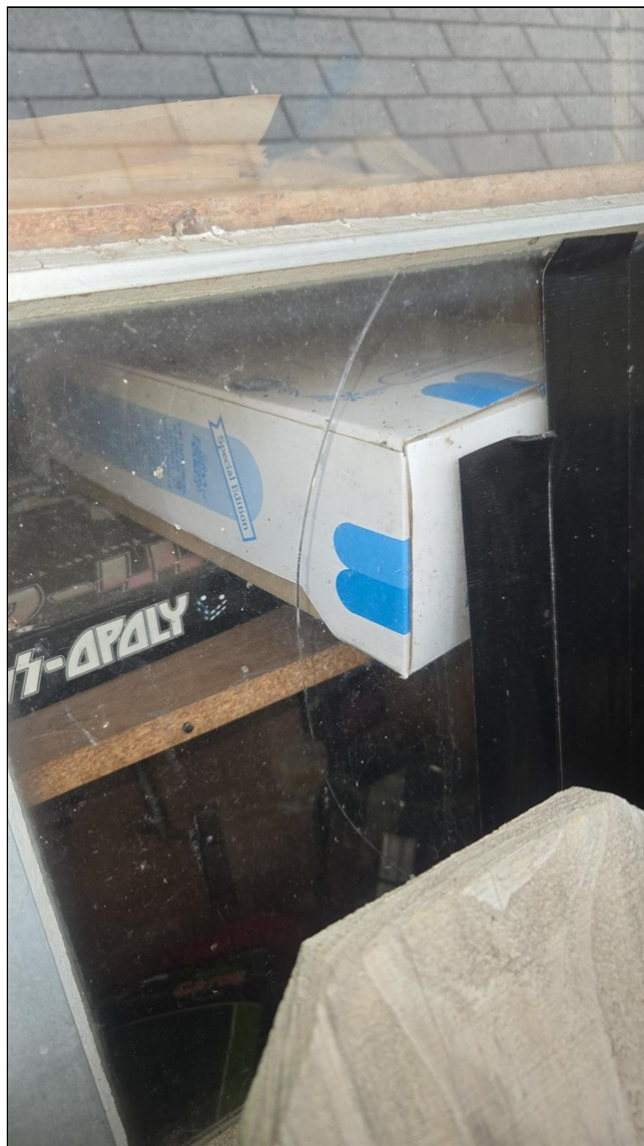
2.7 Item 6(Picture) There was at least one broken window; any and all broken windows should be found and replaced by a qualified contractor. Minimum housing standards require all windows to be whole; exterior windows should open, close, latch, and lock. A qualified contractor should find and fix any and all broken or damaged windows.

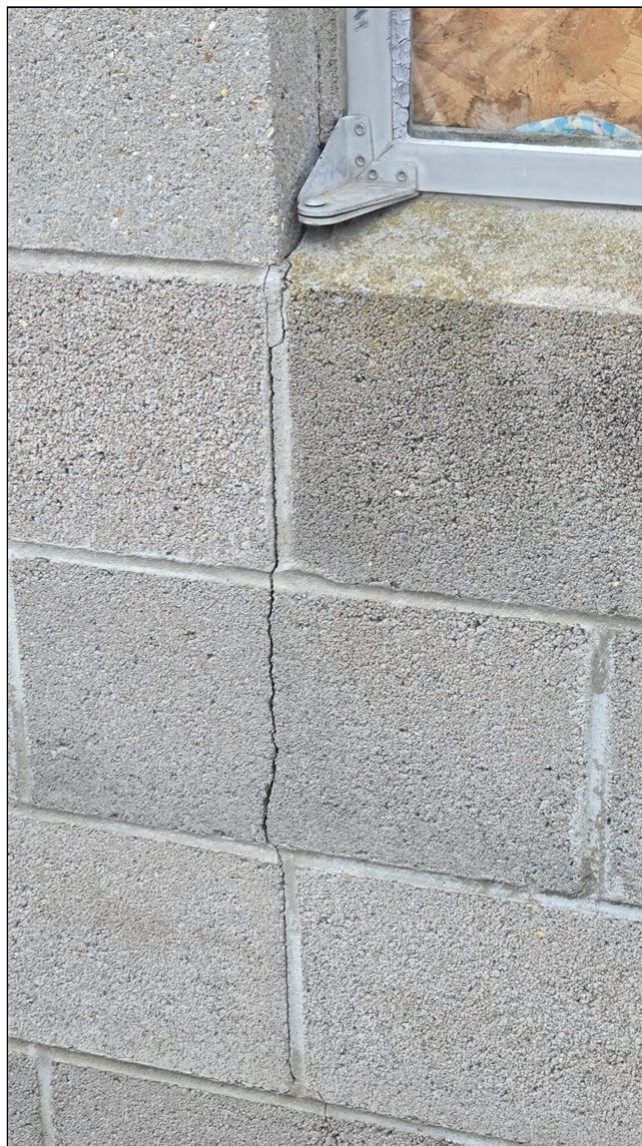
2.7 Item 8(Picture) Masonry repairs required to outbuilding.

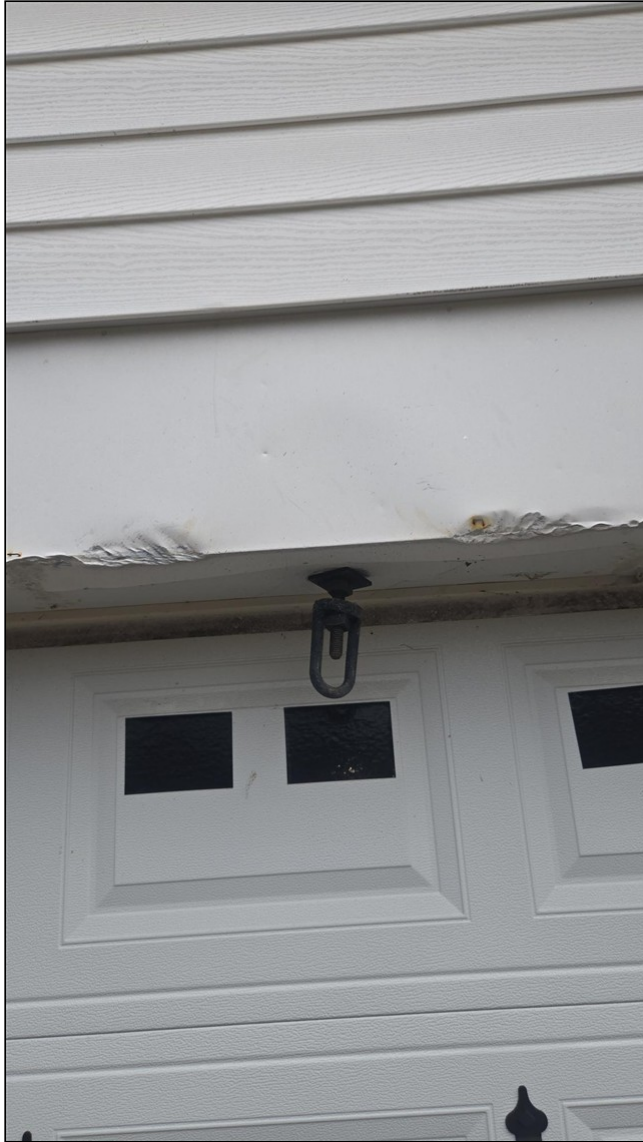
2.7 Item 9(Picture) Damaged outbuilding fascia.

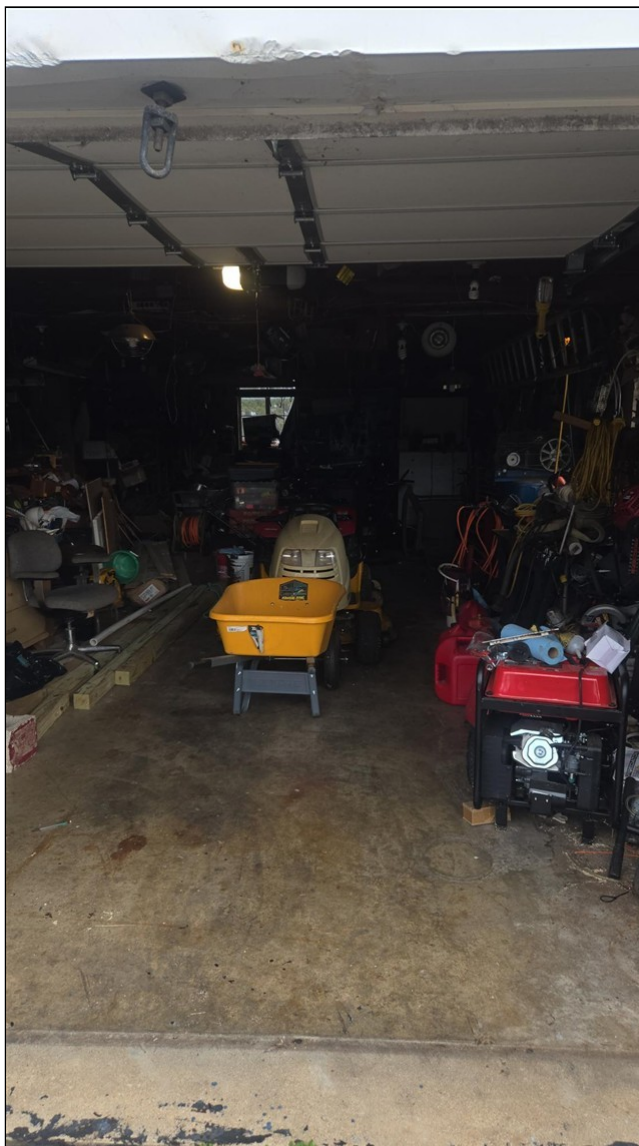
2.7 Item 12(Picture) Inspection limited by seller and seller possessions.

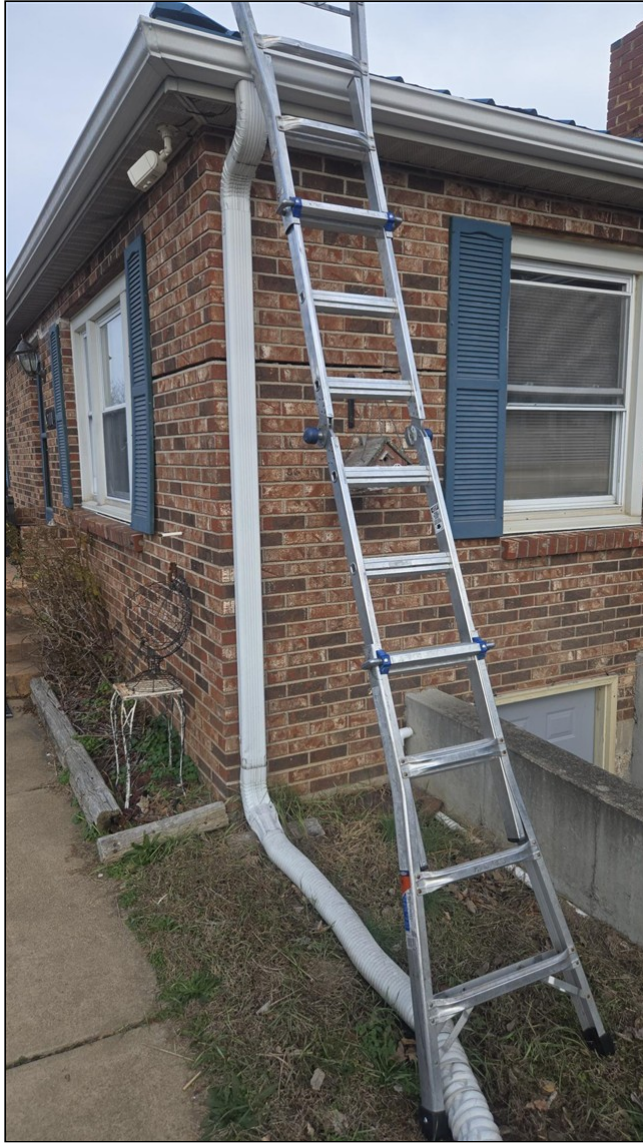
3.0 Item 1(Picture) The exterior brick veneer had subsided because of excessively wet conditions near the foundation of the veneer and removal of foundational support near the basement walk-out door. This is a structural issue for the veneer only and could be repaired in several ways. Scoping repairs is beyond the scope of the inspection. The brick veneer should be repaired to prevent water damage to the exterior wall envelope.

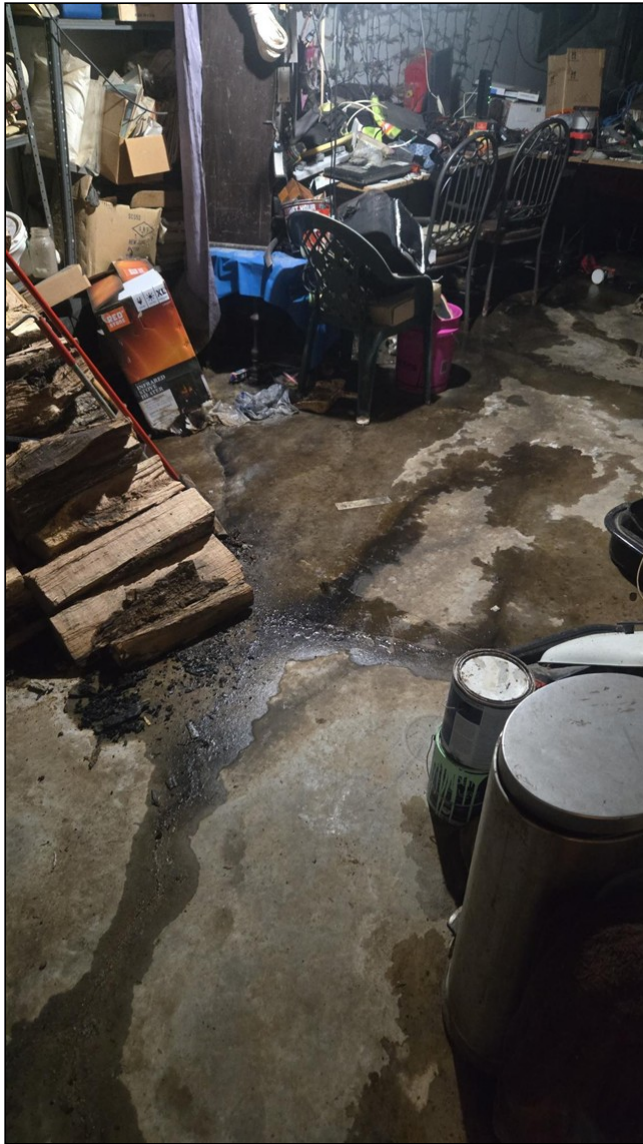
3.0 Item 3(Picture) The basement was wet at the time of the inspection. This appeared to be from hydrostatic pressure and may be due to a combination of circumstances. Based on the floor staining and the seller's description of the septic tank lid as metal, I suspect that most of this water is from a failed septic tank that is leaking near the foundation of the home and putting hydrostatic pressure on the concrete. Additional factors that may be contributing to this condition include improper downspout drainage and surface drainage around the home. I recommend that the septic tank is completely replaced and that the downspouts are installed into separate downspout drains that drain to daylight near the road ditch. Hydrostatic pressure may cause catastrophic damage to the foundation and this situation should be repaired as soon as practical.

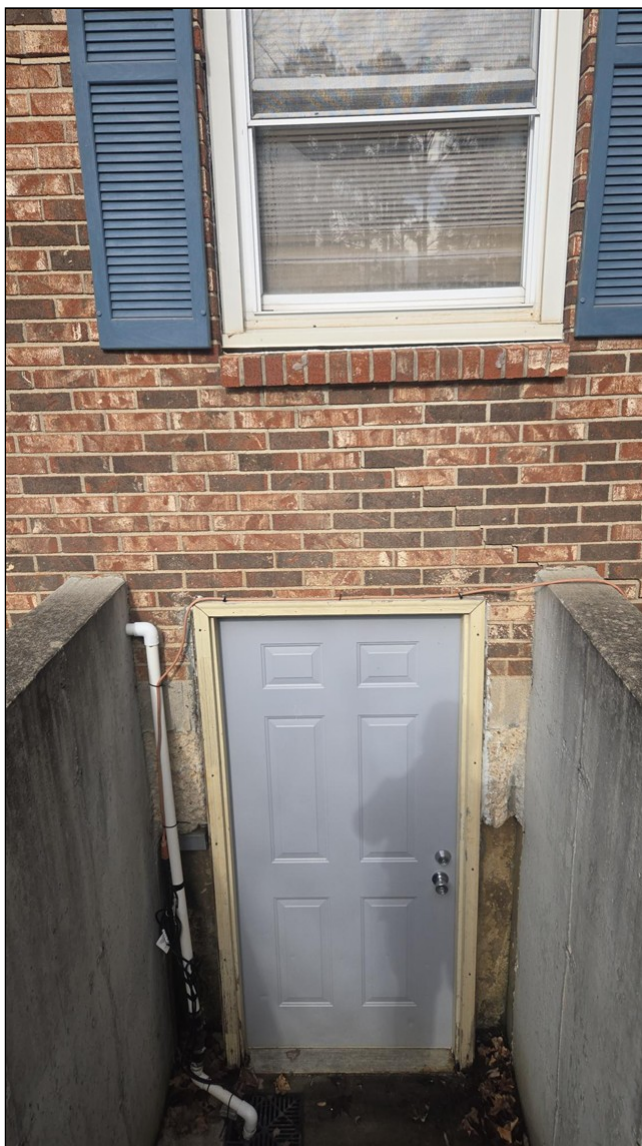
3.1 Item 2(Picture) The brick veneer required immediate repairs.

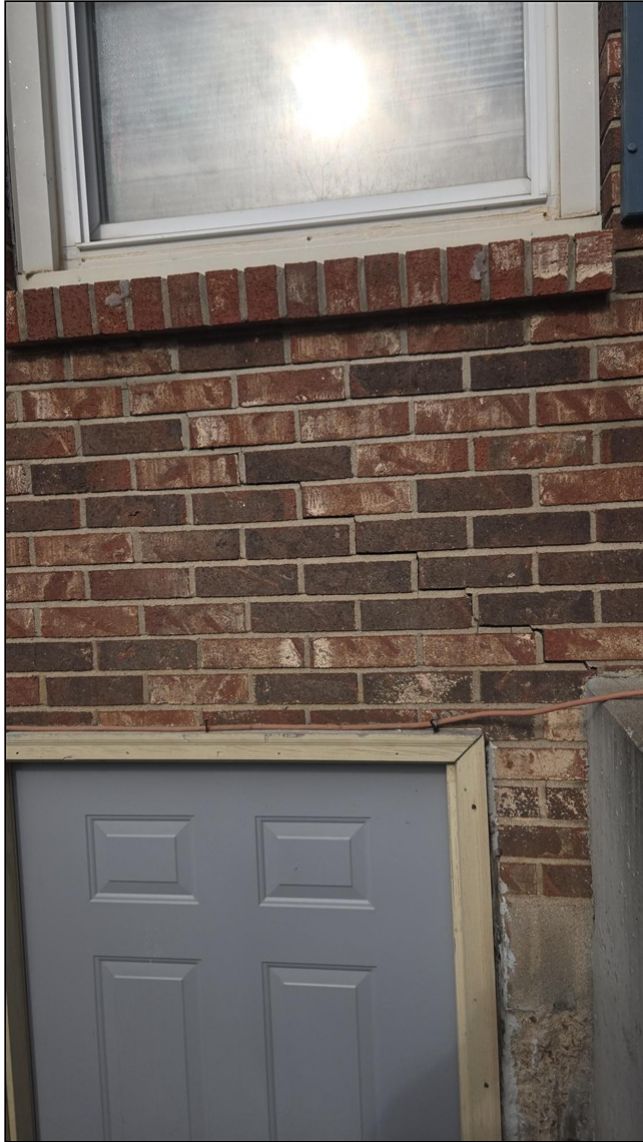
3.1 Item 3(Picture) The brick veneer required immediate repairs.

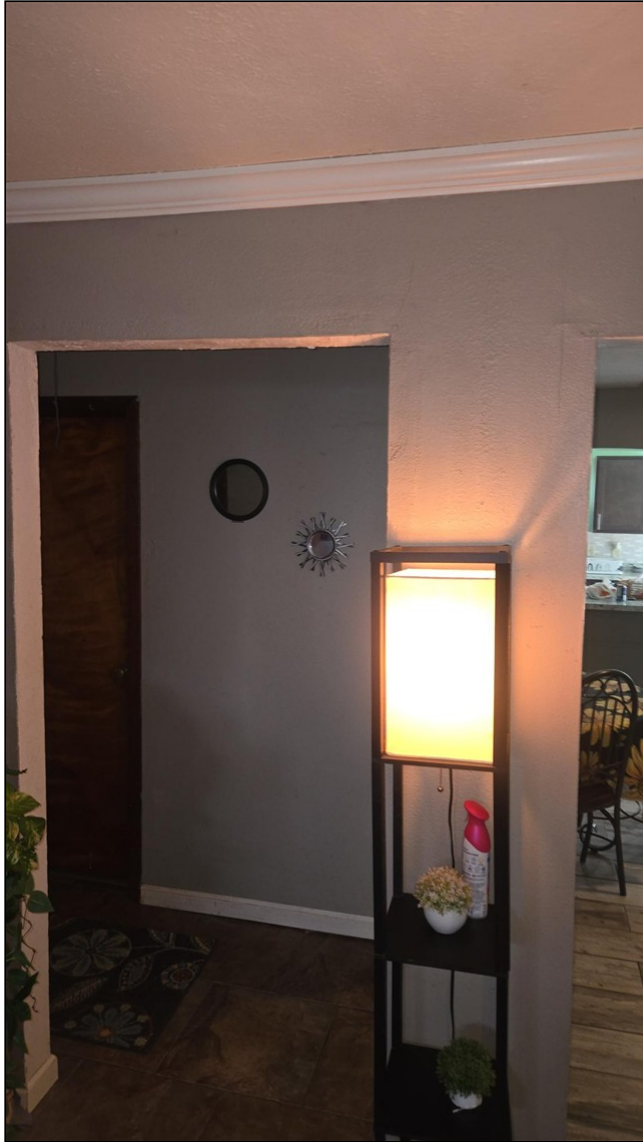
3.1 Item 5(Picture) There was visible structural movement due to termite damage and a sagging main beam. The main beam of the house should be replaced.

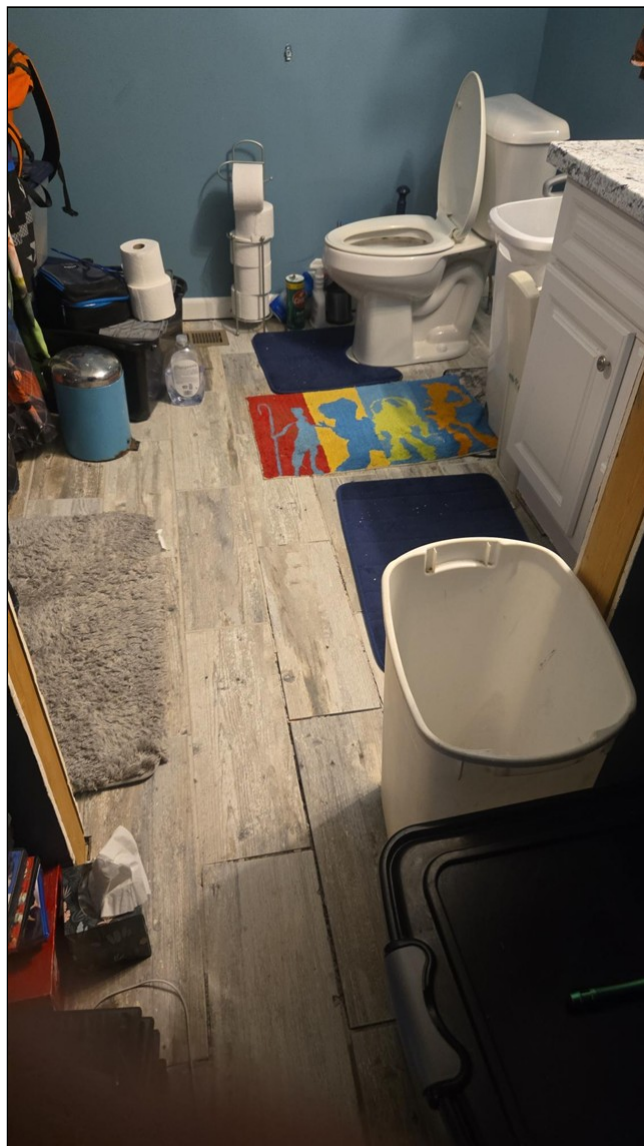
3.3 Item 2(Picture) Some areas of the home were inaccessible at the time of the inspection. We were unable to inspect the crawlspace or attic area. There was noticeable deflection in the floors in some areas and I expect that there are some floor joists that require repairs.
