Inspection Report

4700 Turley Mill Rd, Farmington, MO 63640, USA

A-Team Consulting and Contracting

Date: 1/2/2025	Time:	Report ID: 2025010202
Property: Address	Customer: NAME	Real Estate Professional:

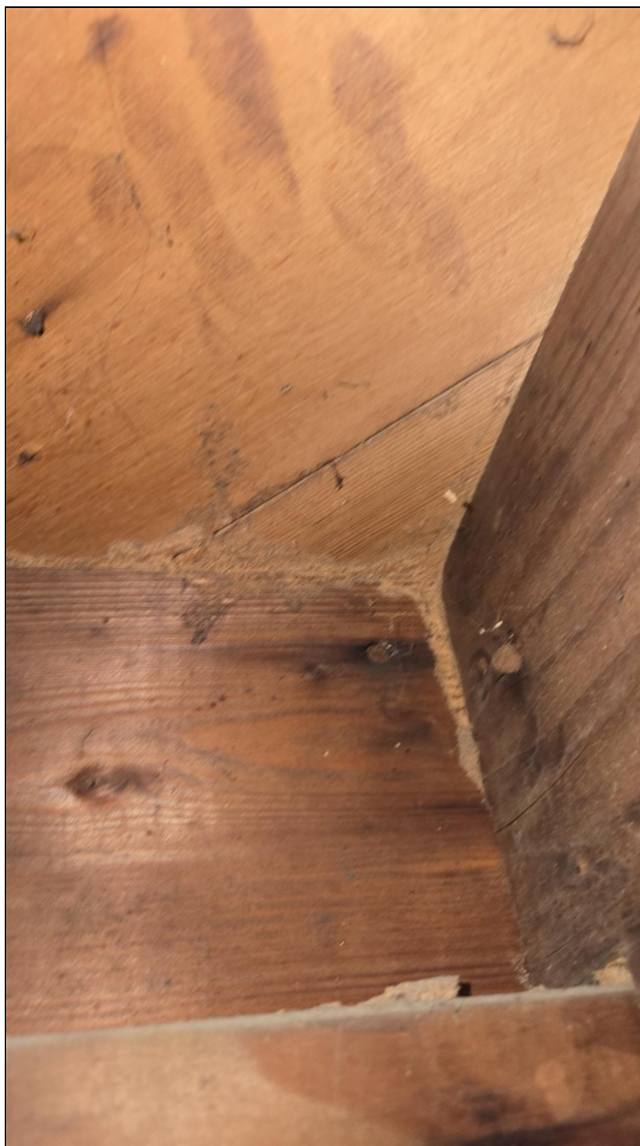
3.3 Item 4(Picture) Floor joist termite damage noticed. There was noticeable deflection in the floors in some areas and I expect that there are some floor joists that require repairs. Evidence of termites and some termite damage was found. Some termite damage may be hidden. We recommend termite treatment. Any and all termite damaged wood should be repaired or replaced. A qualified contractor should repair or replace any and all damaged, cracked, or buckled floor joists. The floor joists should be sistered with a continuous board that is the same size as width as the existing floor joist and the same length as the existing floor joist. The sistered floor joist should be bearing on the sill plate on one side and bearing on the beam on the otherside. The sistered floor joist should be #6 screwed or 6d nailed to the old floor joist on an eschelon pattern with 6" offset between the fasteners. The fasteners should alternate between top and bottom of the floor joist. The fasteners should not be located less than 2" from the outside edge of the board. The sistered board should be installed crown facing up.

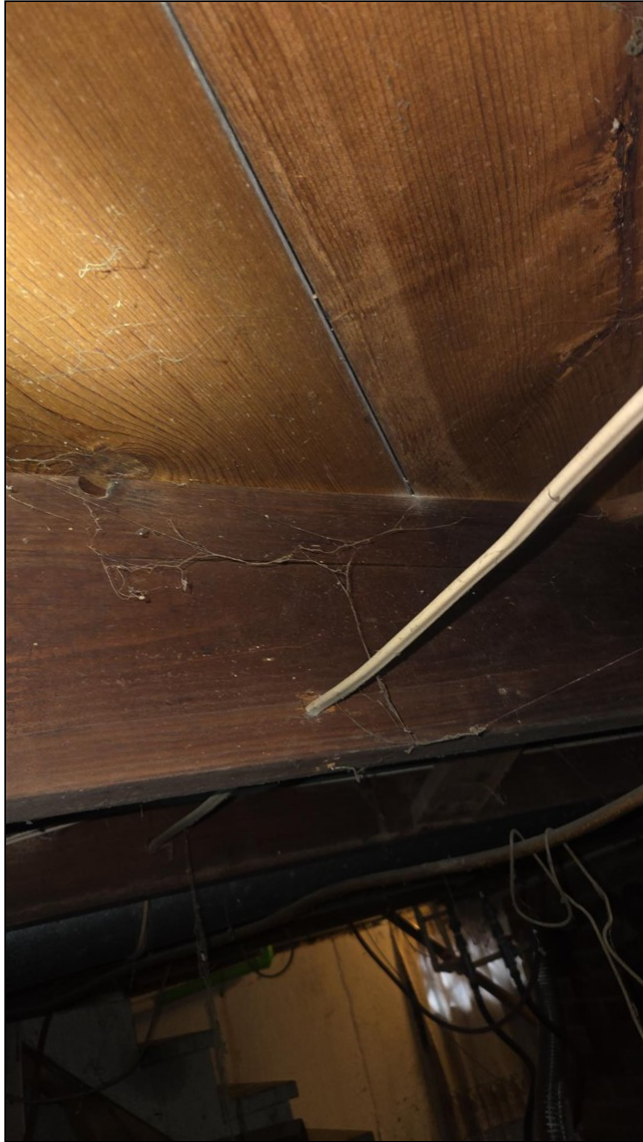
3.3 Item 5(Picture) There was noticeable deflection in the floors in some areas and I expect that there are some floor joists that require repairs. Evidence of termites and some termite damage was found. Some termite damage may be hidden. We recommend termite treatment. Any and all termite damaged wood should be repaired or replaced. A qualified contractor should repair or replace any and all damaged, cracked, or buckled floor joists. The floor joists should be sistered with a continuous board that is the same size as width as the existing floor joist and the same length as the existing floor joist. The sistered floor joist should be bearing on the sill plate on one side and bearing on the beam on the otherside. The sistered floor joist should be #6 screwed or 6d nailed to the old floor joist on an eschelon pattern with 6" offset between the fasteners. The fasteners should alternate between top and bottom of the floor joist. The fasteners should not be located less than 2" from the outside edge of the board. The sistered board should be installed crown facing up.

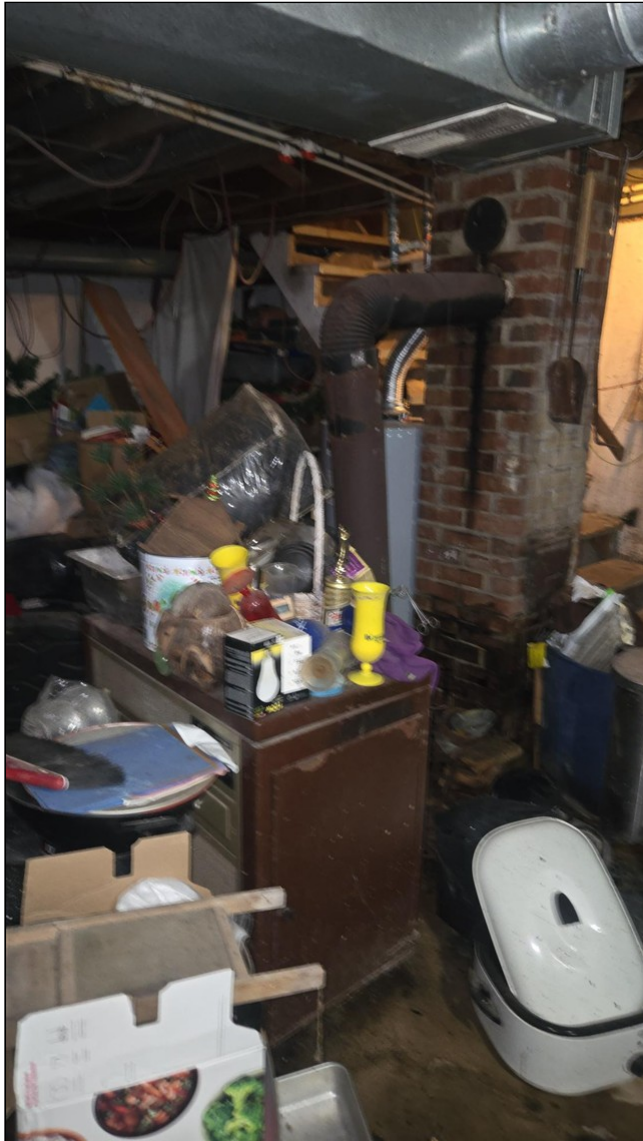
4.5 Item 1(Picture) The wood stove is beyond the scope of the inspection and blocked by the occupants belongings. InterNACHI always recommends that the flue is swept by a licensed chimney sweep, prior to the first use and annually thereafter. The wood stove should be inspected and repaired by a licensed chimney sweep.

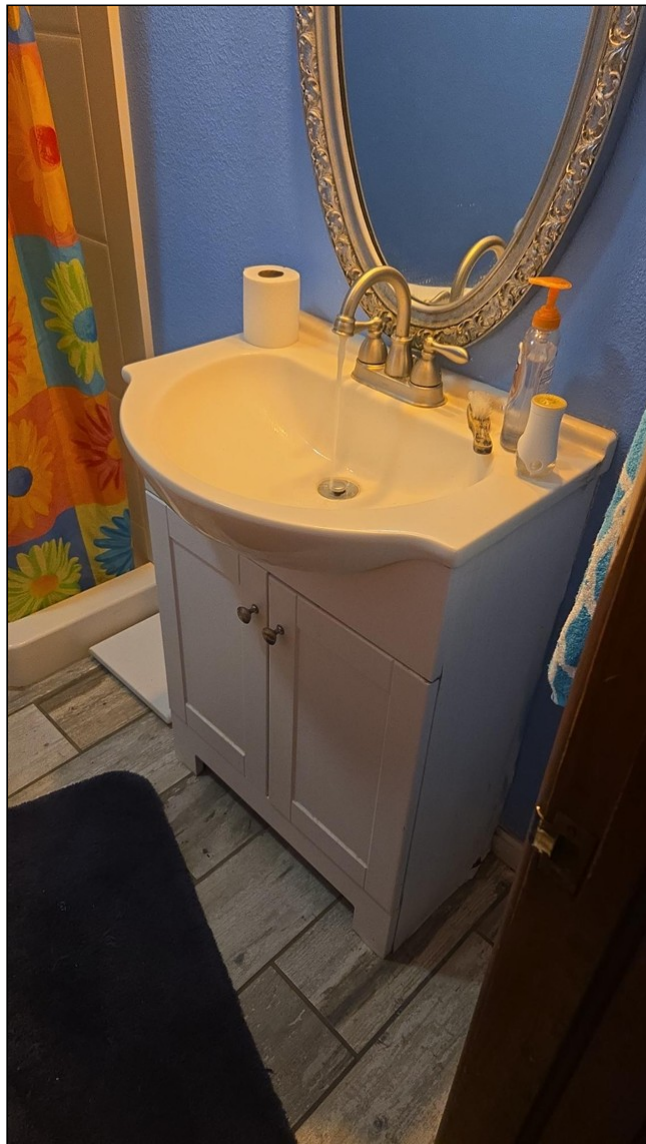
5.0 Item 1(Picture) There was a sewer gas smell notice in this bathroom. A plumbing vent may be clogged or something in this bathroom may not be vented properly. A qualified plumbing contractor should find and fix any and all plumbing issues. . After any plumbing work the plumber should pressure check and leak check all the pipes.

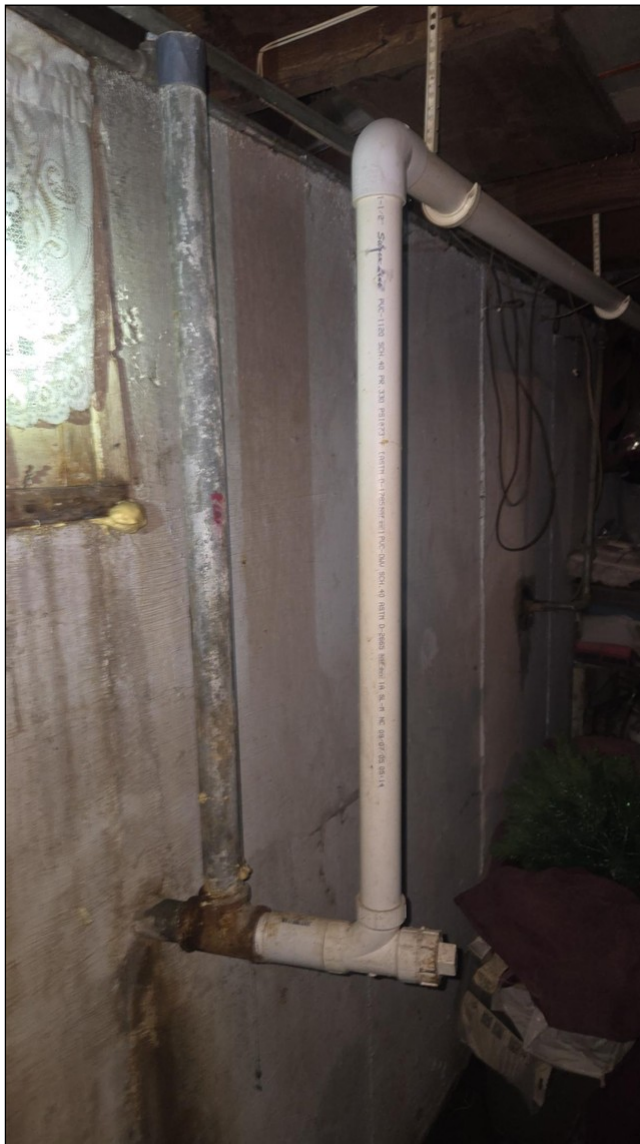
5.0 Item 2(Picture) Plumbing vents into the basement improperly...I recommend that a sewer lateral locator service is hired to trace all sewer line and floor drains that leave the basement prior to making any septic system inspections or repairs.

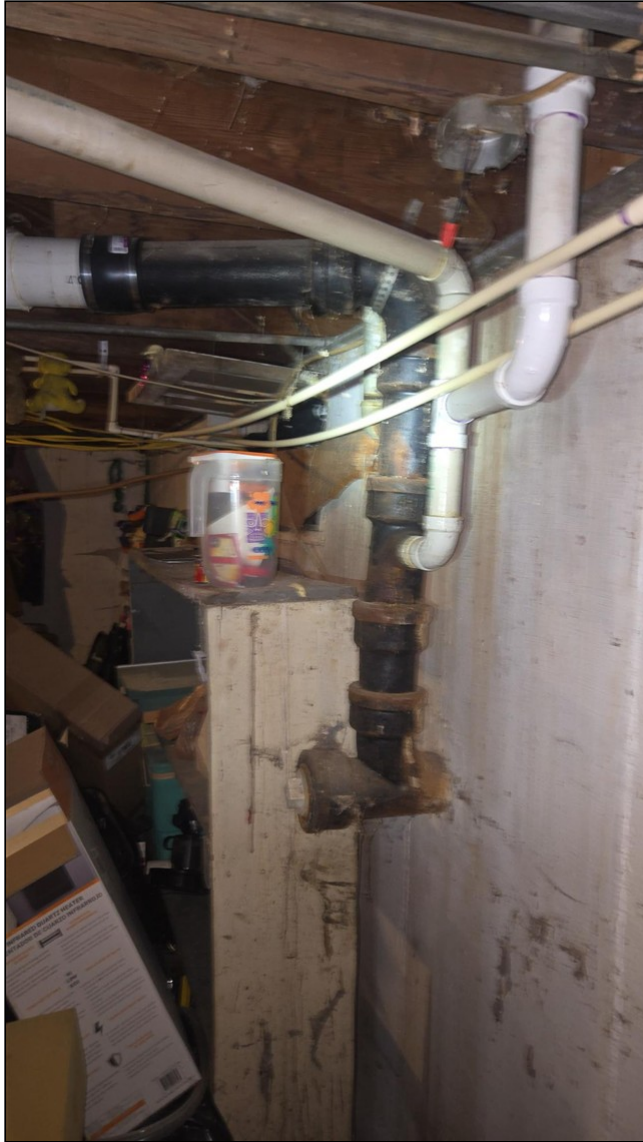
5.0 Item 3(Picture) I recommend that a sewer lateral locator service is hired to trace all sewer line and floor drains that leave the basement prior to making any septic system inspections or repairs. The cast iron plumbing is nearing the end of its useful life expectancy and may require repair or replacement soon. I recommended a sewer lateral inspection.

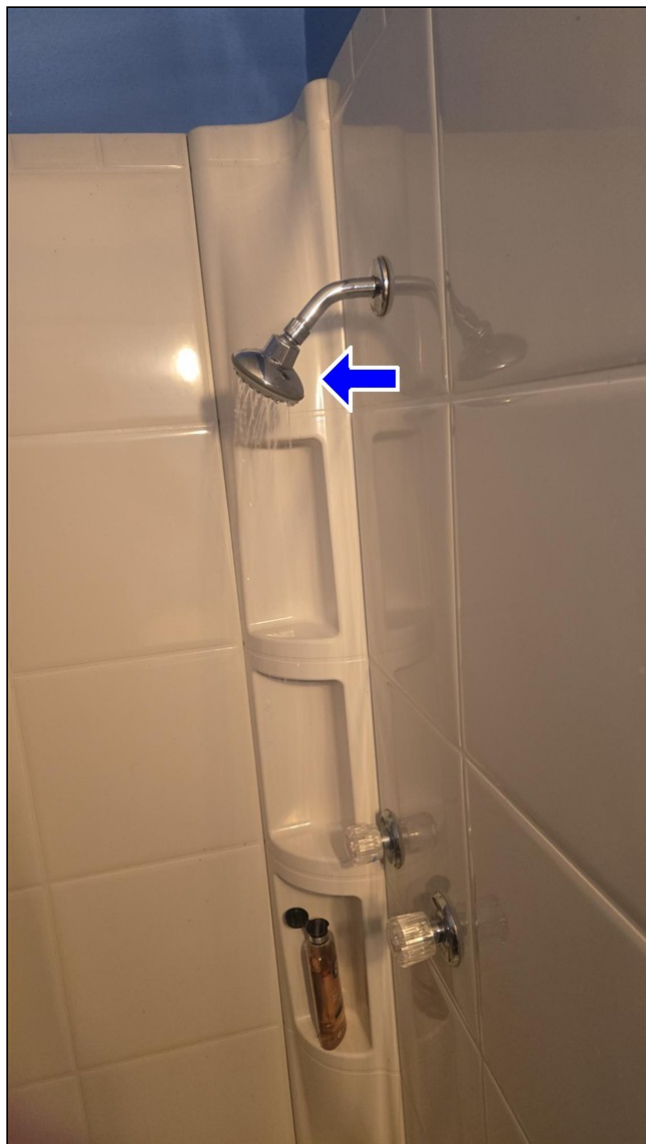
5.1 Item 1(Picture) There was low water pressure in the hall shower.

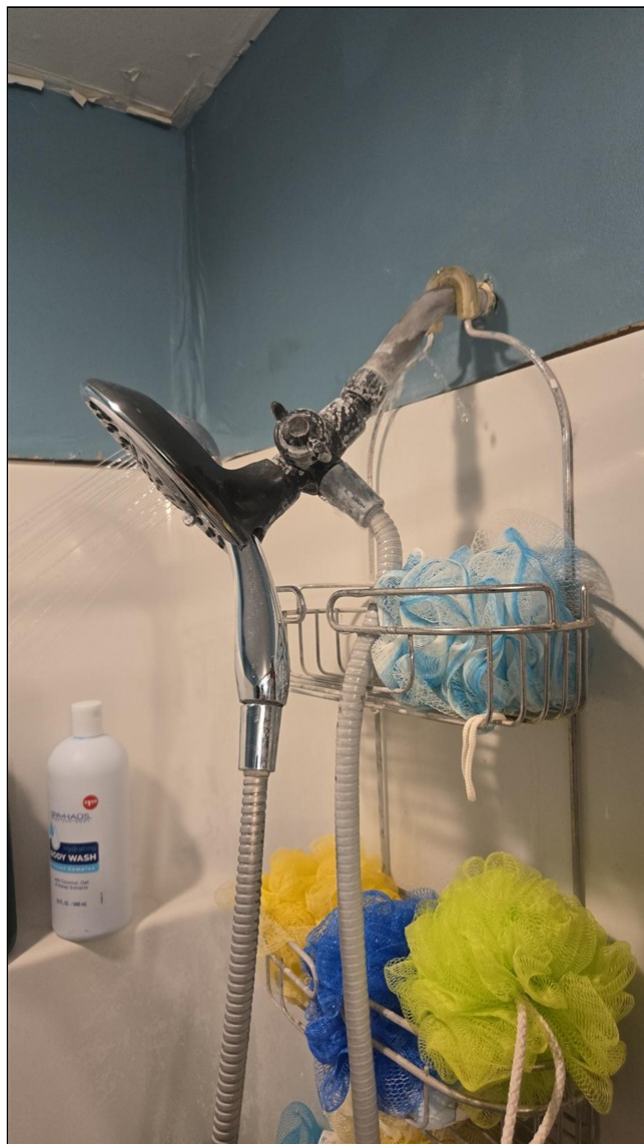
5.1 Item 2(Picture) This shower head leaked and required repairs.

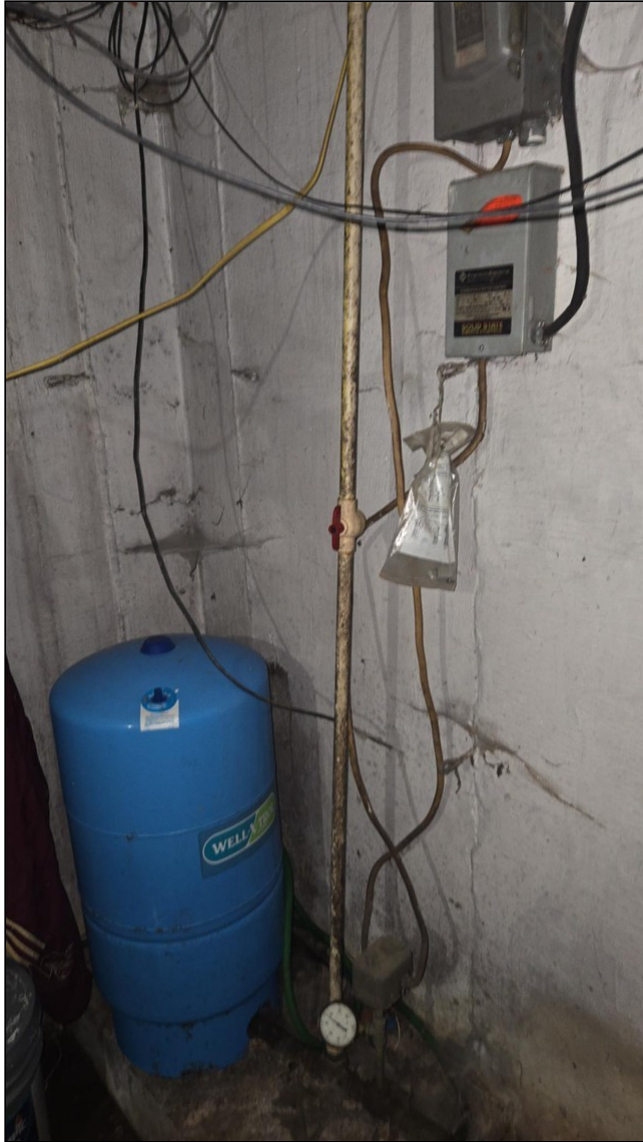
5.1 Item 3(Picture) This pressure tanks should be drained and de-scaled.

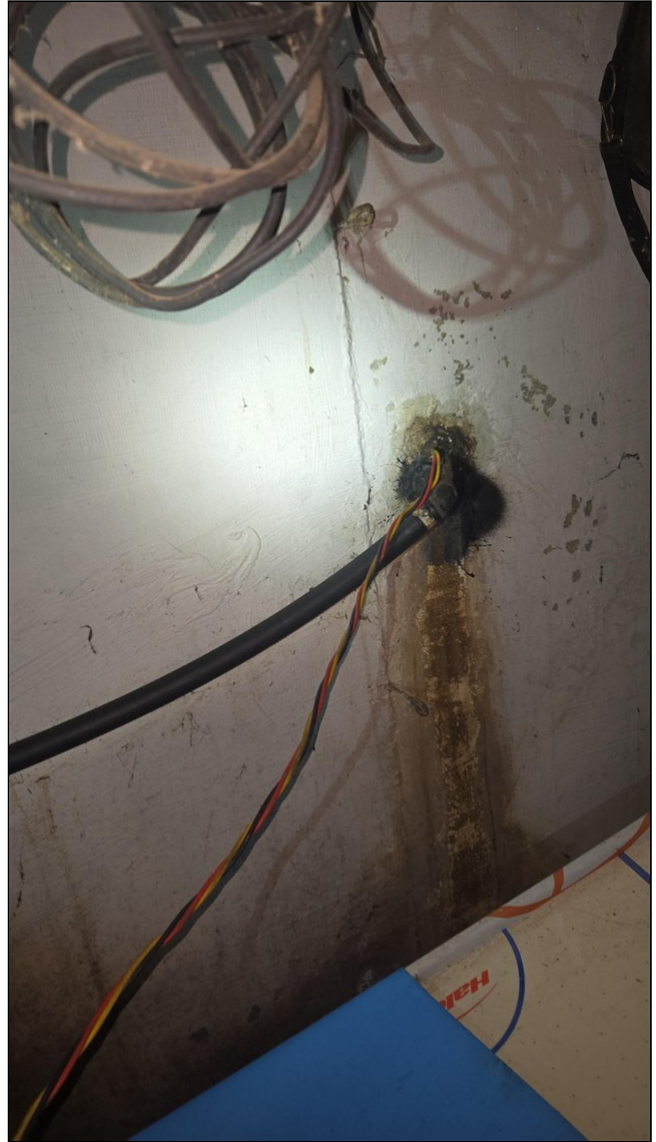
5.1 Item 4(Picture) Main line from well is plastic hdpe.

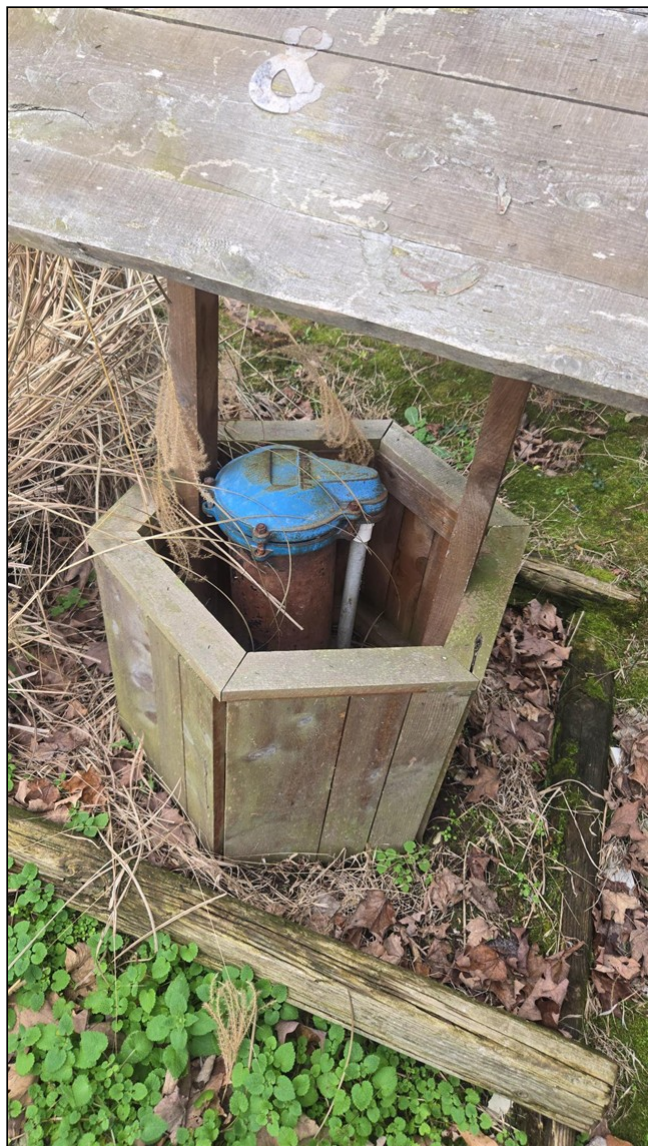
5.1 Item 5(Picture) The well should be inspected and a MO Bacteriological water sample should be taken and test results should be reviewed by the Buyer prior to closing.

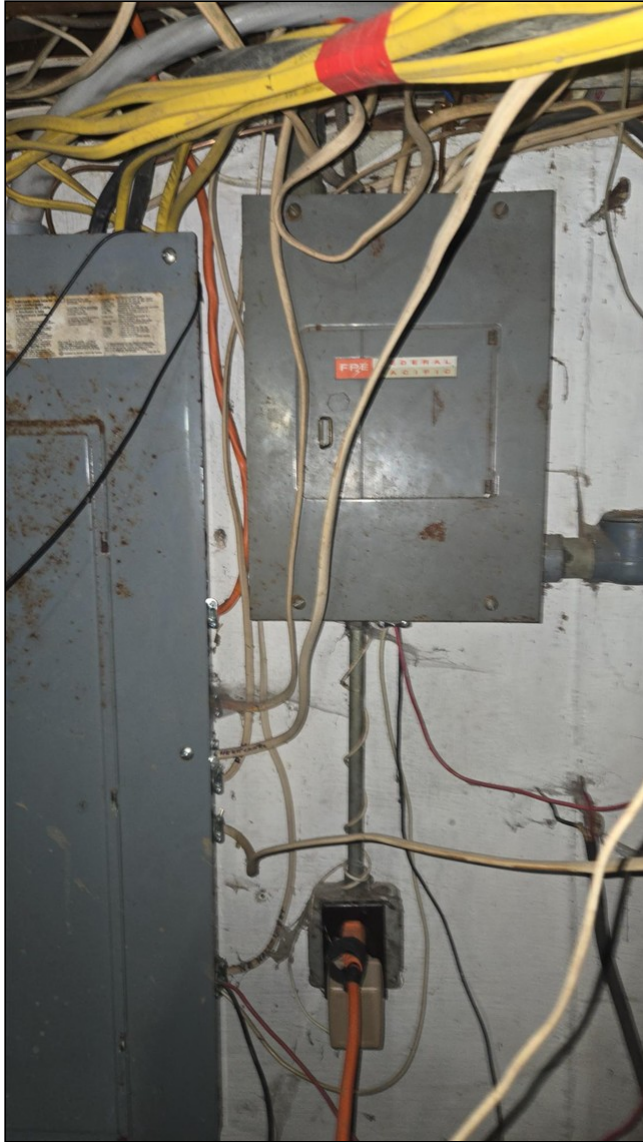
6.1 Item 1(Picture) It was unsafe for me to open the electrical panels because there were loose wires that could cause problems. I did not fully inspect the electrical system. There was loose, unprotected, or temporary wiring noticed. A qualified electrical contractor should find and fix any and all National Electrical Code deficiencies.

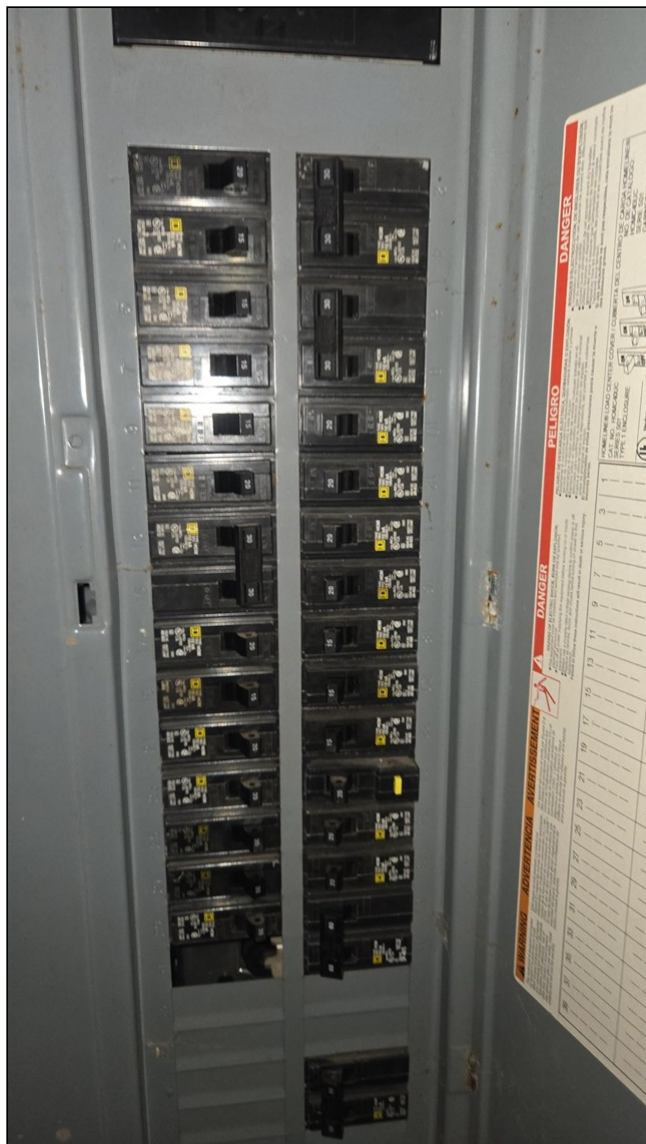
6.1 Item 5(Picture) A qualified electrical contractor should find and fix any and all National Electrical Code deficiencies.

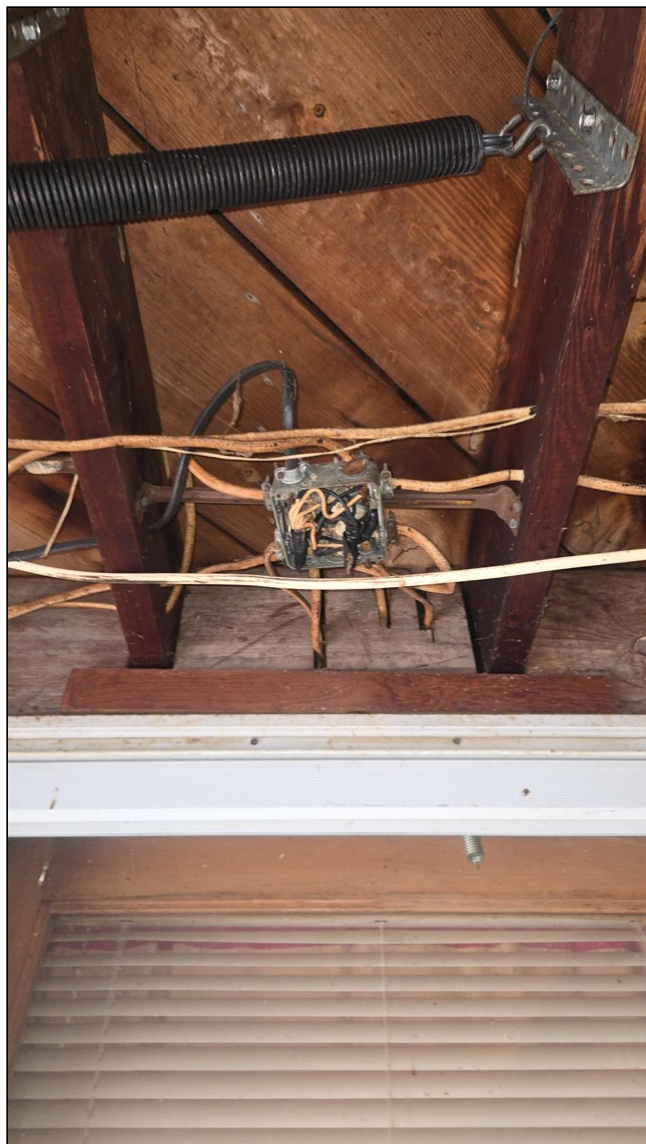
6.3 Item 1(Picture) Open and overloaded splice boxes
- A qualified electrical contractor should find and fix any and all National Electrical Code deficiencies.

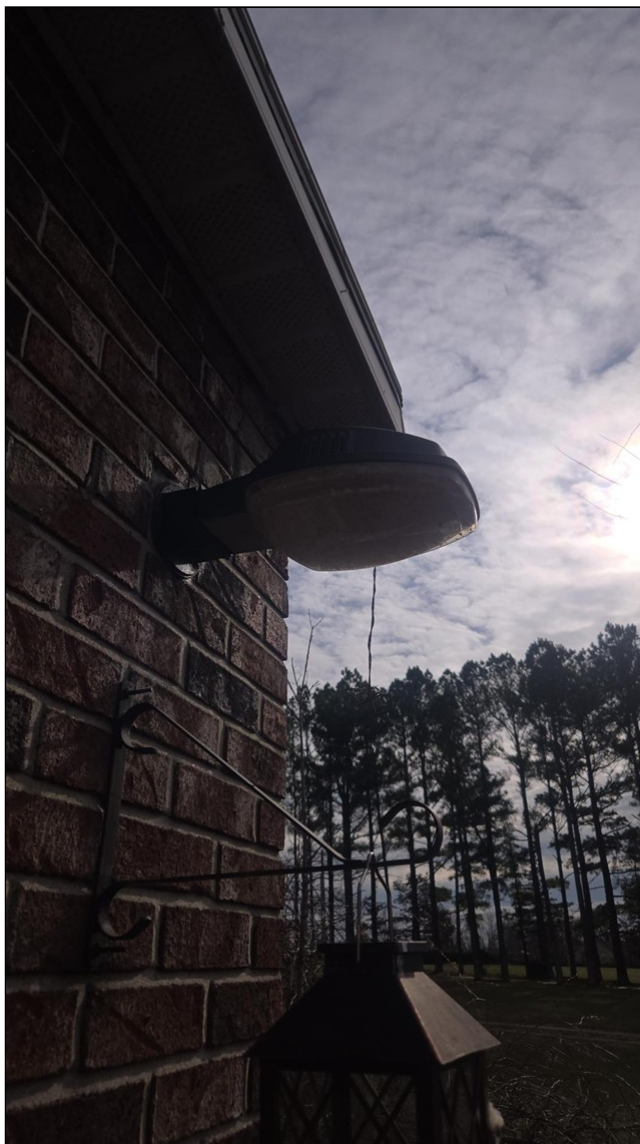
6.3 Item 2(Picture) Inoperable exterior lights - A
qualified electrical contractor should find and fix any
and all National Electrical Code deficiencies.

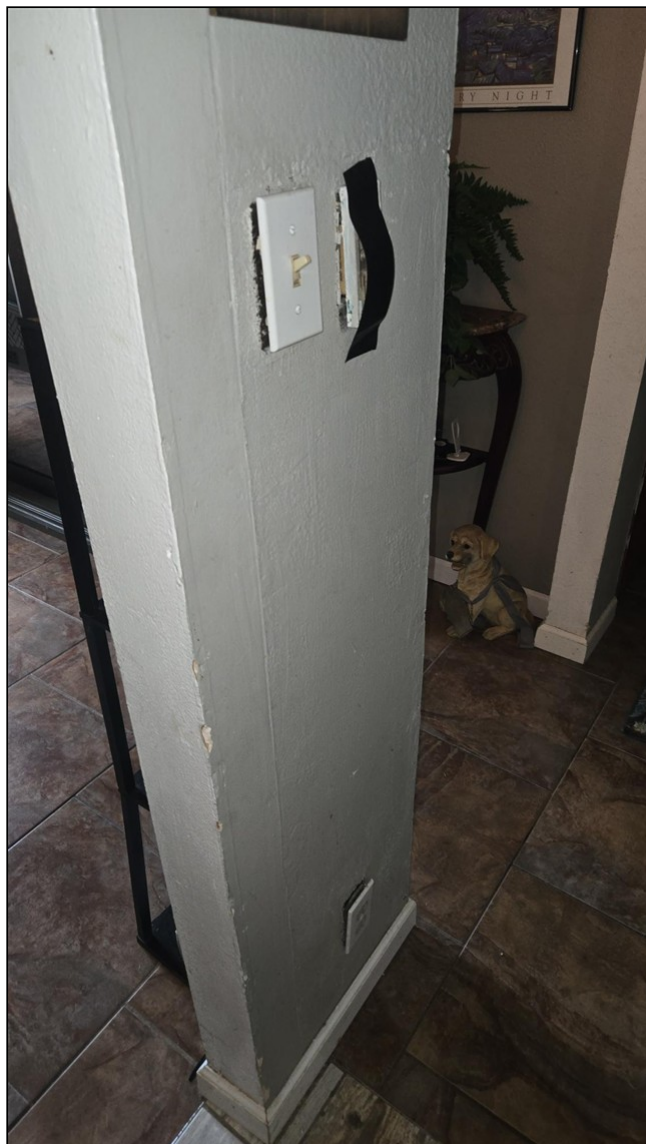
6.3 Item 3(Picture) Outlets and switches should all be replaced and properly installed. A qualified electrical contractor should find and fix any and all National Electrical Code deficiencies.

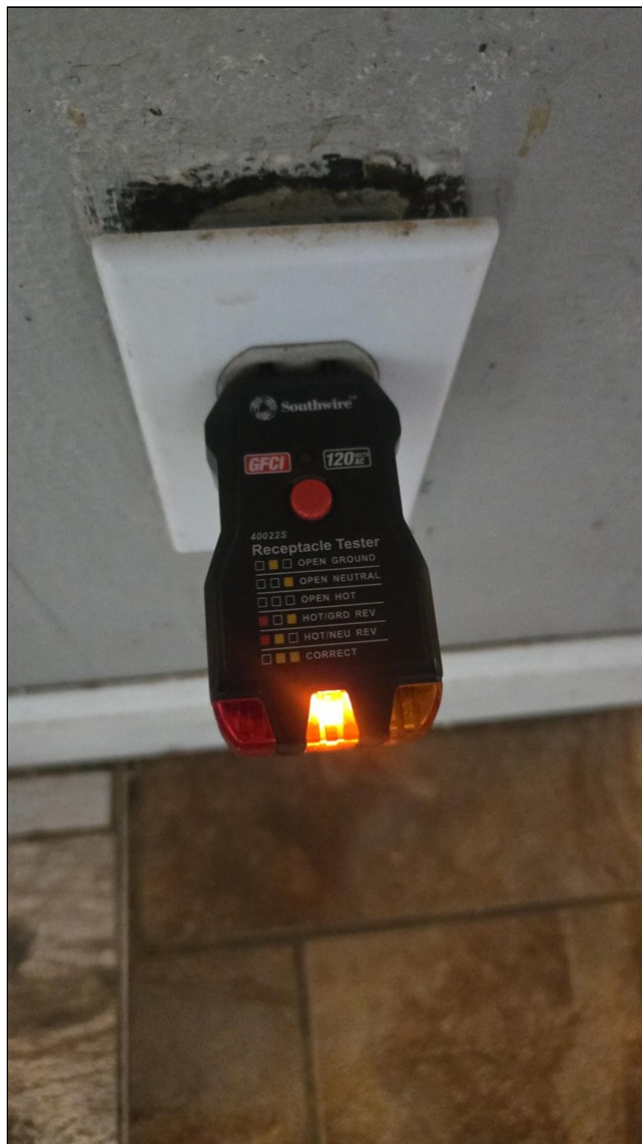
6.3 Item 4(Picture) Ungrounded outlets throughout the house. A qualified electrical contractor should find and fix any and all National Electrical Code deficiencies.

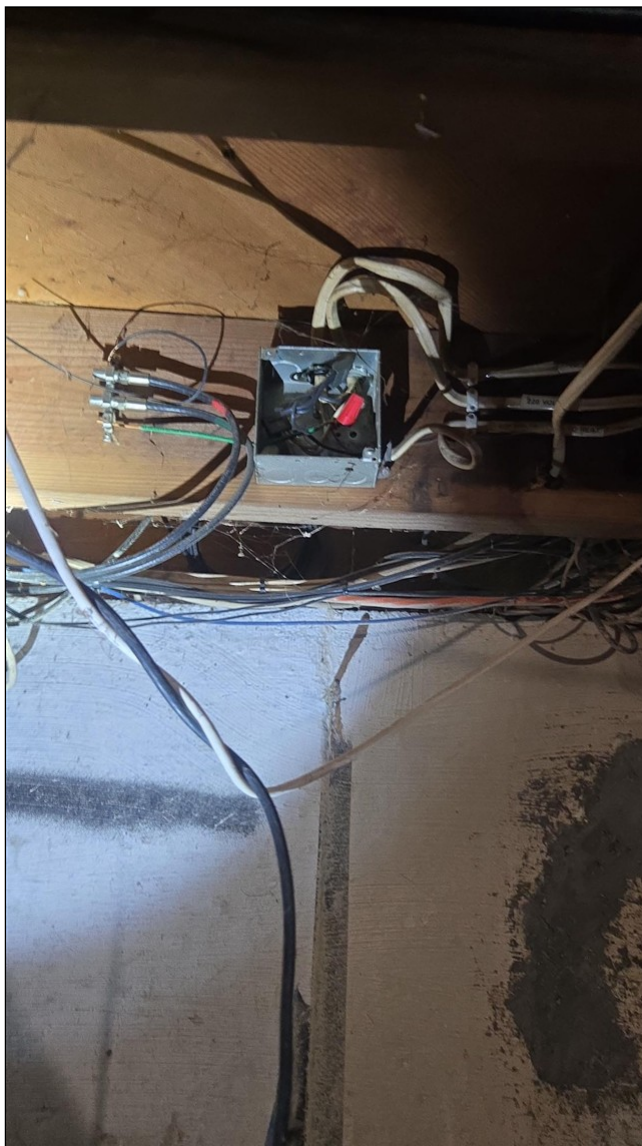
6.3 Item 6(Picture) A qualified electrical contractor should find and fix any and all National Electrical Code deficiencies.

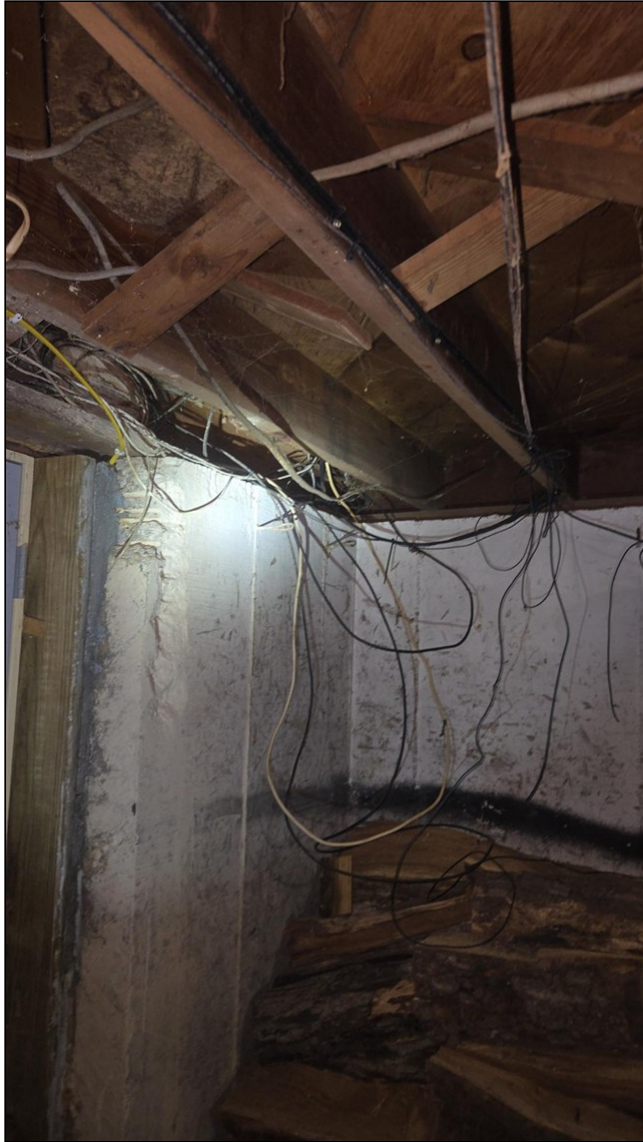
6.3 Item 7(Picture) A qualified electrical contractor should find and fix any and all National Electrical Code deficiencies. Loose wires

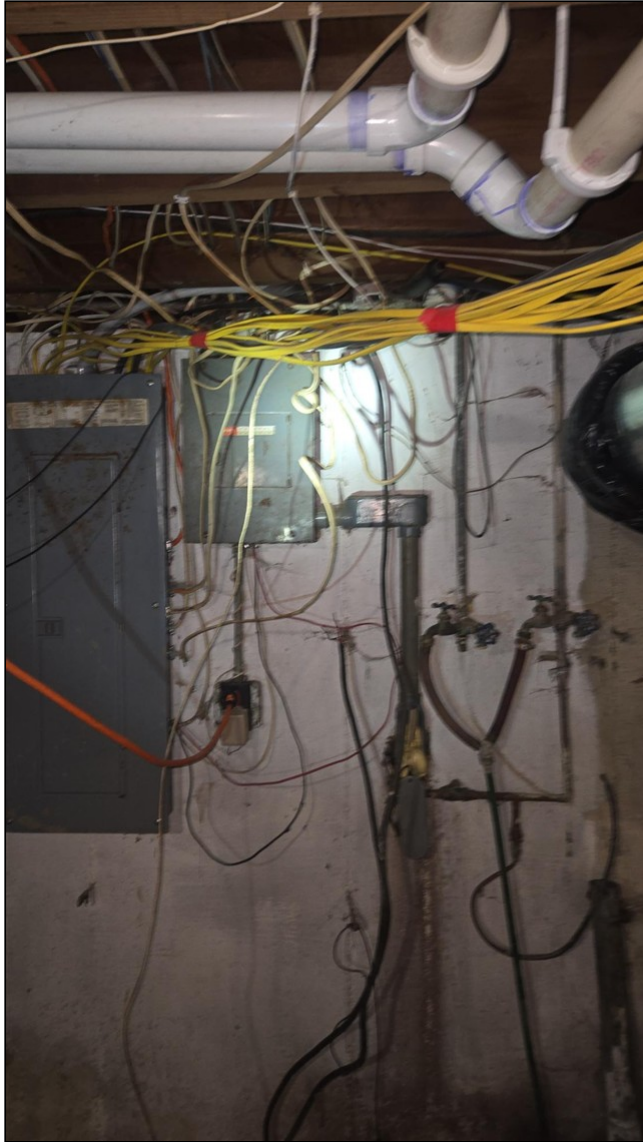
6.3 Item 9(Picture) A qualified electrical contractor should find and fix any and all National Electrical Code deficiencies.

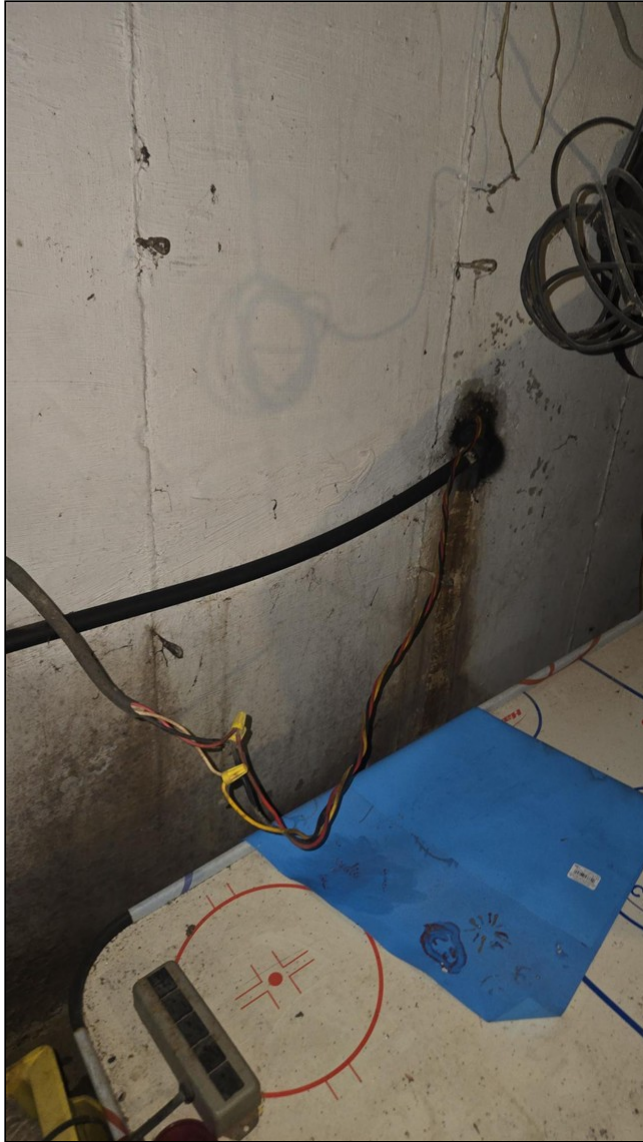
6.3 Item 11(Picture) A qualified electrical contractor should find and fix any and all National Electrical Code deficiencies.

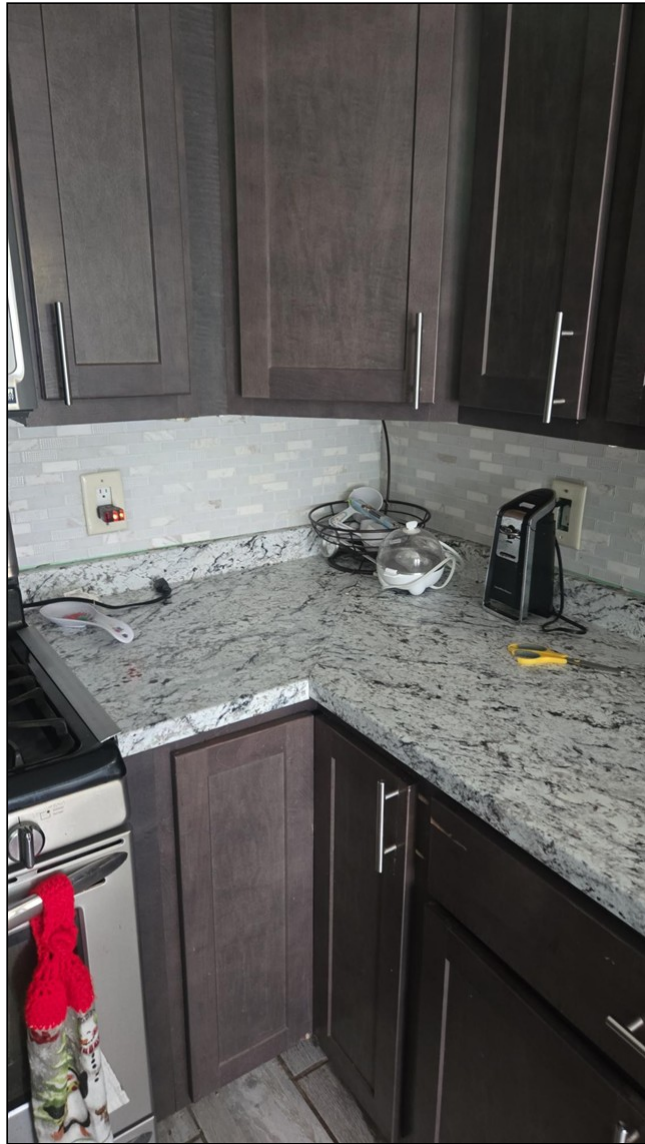
6.4 Item 1(Picture) Not GFCI protected. GFCI outlets should be located: at least one on the front exterior of the house, at least one on the rear exterior of the house, all exterior outlets, all outbuilding outlets, all unfinished spaces, all outlets above the countertop in the kitchen, all bathroom outlets (at least one above the sink/vanity), and all laundry room outlets...This home did not have all of the GFCI's in the correct places. A qualified electrical contractor should find and fix any and all NEC deficiencies.

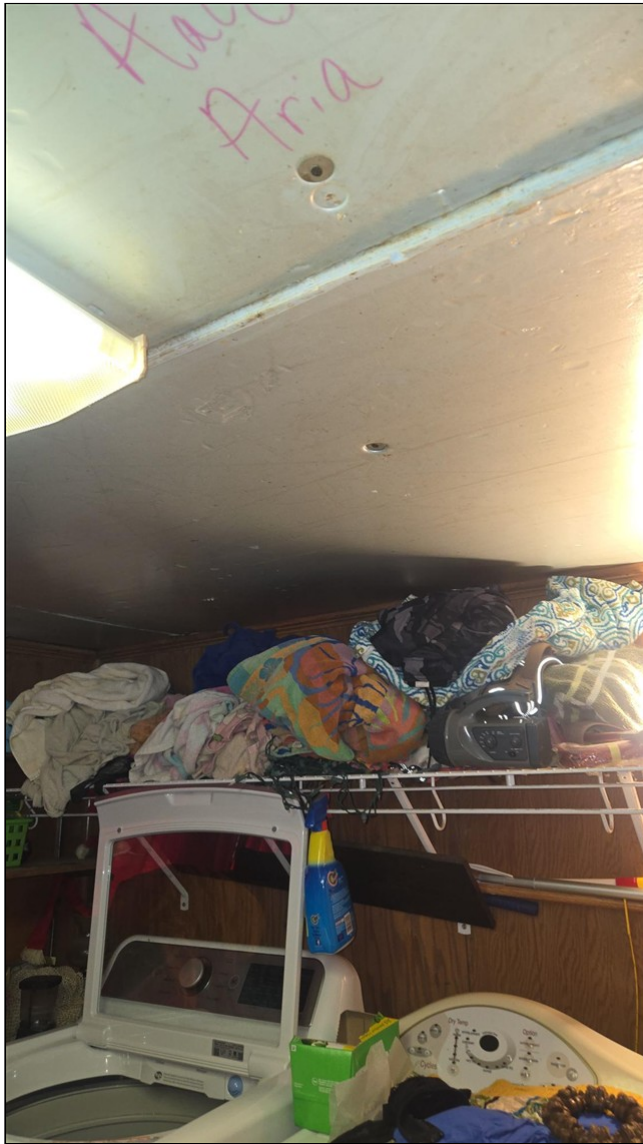
7.0 Item 1(Picture) There was not a finished ceiling in the laundry room. This ceiling should be removed and the wood rafters should be inspected in this area prior to finishing this ceiling. There may be hidden water damage in this area.

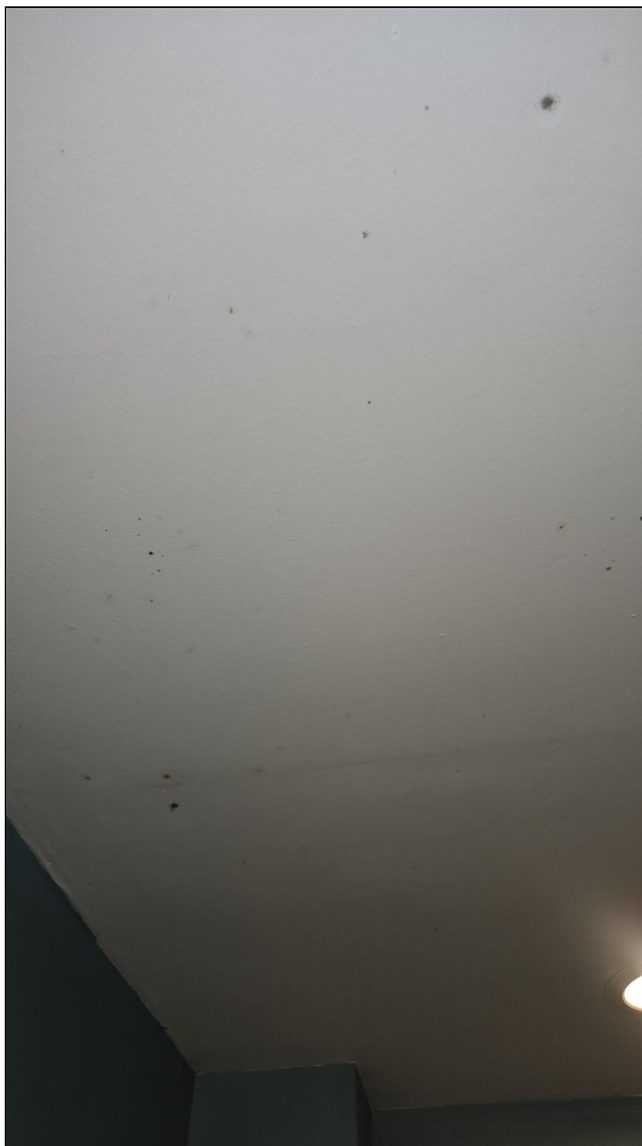
7.0 Item 4(Picture) MoldThere were some scuffs, scrapes, cracks, and inconsistent texture noticed throughout the house.

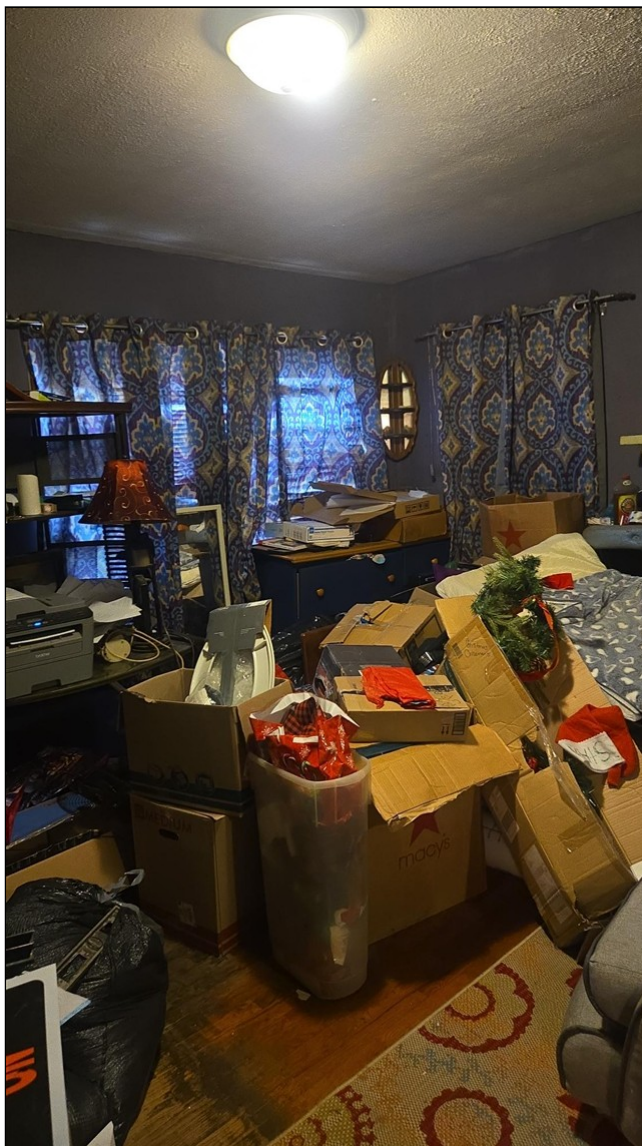
7.1 Item 2(Picture) The occupant and occupants belongings limited the inspection.

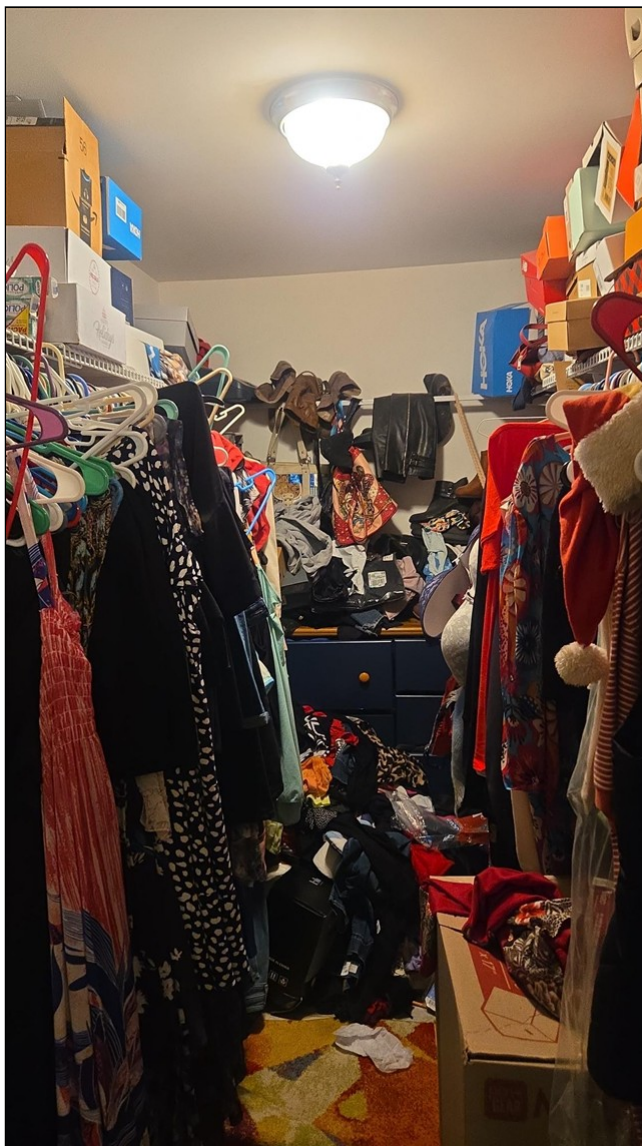
7.1 Item 4(Picture) The occupant and occupants belongings limited the inspection.

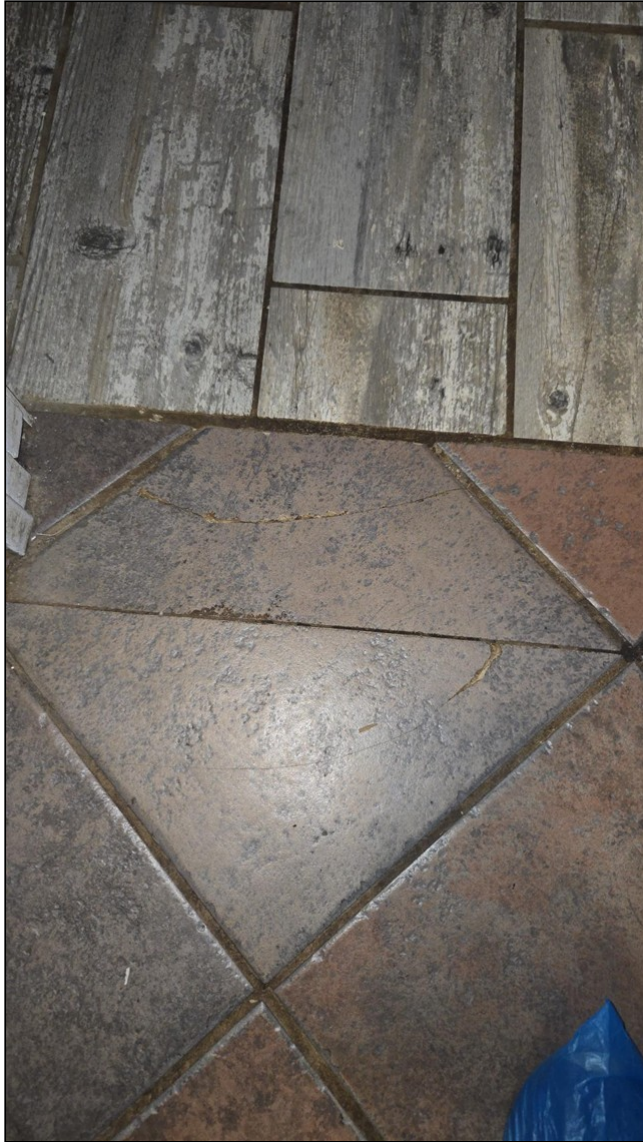
7.2 Item 1(Picture) There was cracked tile and grout throughout the house. Some of the cracked tile and grout appeared to be from structural movement and you should expect to make structural repairs to the subflooring and floor joists in some, but not all areas.

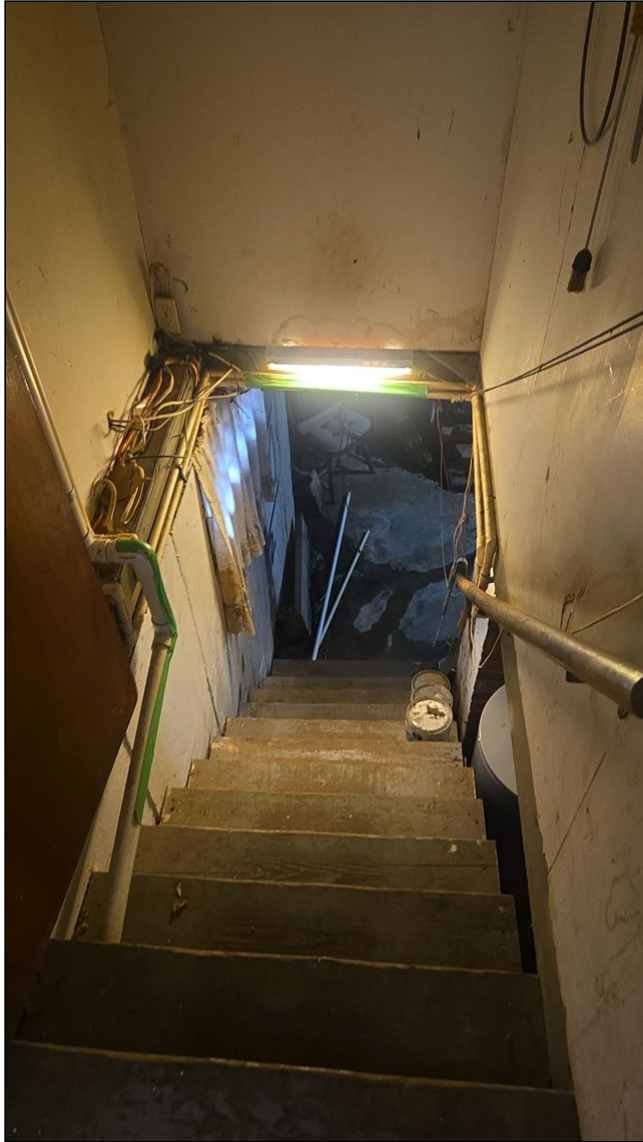
7.3 Item 1(Picture) The stairs were too steep. Stairs should be no steeper than 7" riser on 11" tread depth. The stairs were leaning/unlevel. A qualified contractor should repair the stairs to code requirements. There was low overhead clearance. The overhead clearance over the stairwell should be 6'8" or more and was not. The stairwell should be rebuilt. There were open risers. Open risers can be a safety hazard for small children whom might stick their heads in the riser gap. These should be closed with a board to prevent injury. A qualified contractor should complete all work.
