Inspection Report

4700 Turley Mill Rd, Farmington, MO 63640, USA

A-Team Consulting and Contracting

Date: 1/2/2025	Time:	Report ID: 2025010202
Property: Address	Customer: NAME	Real Estate Professional:

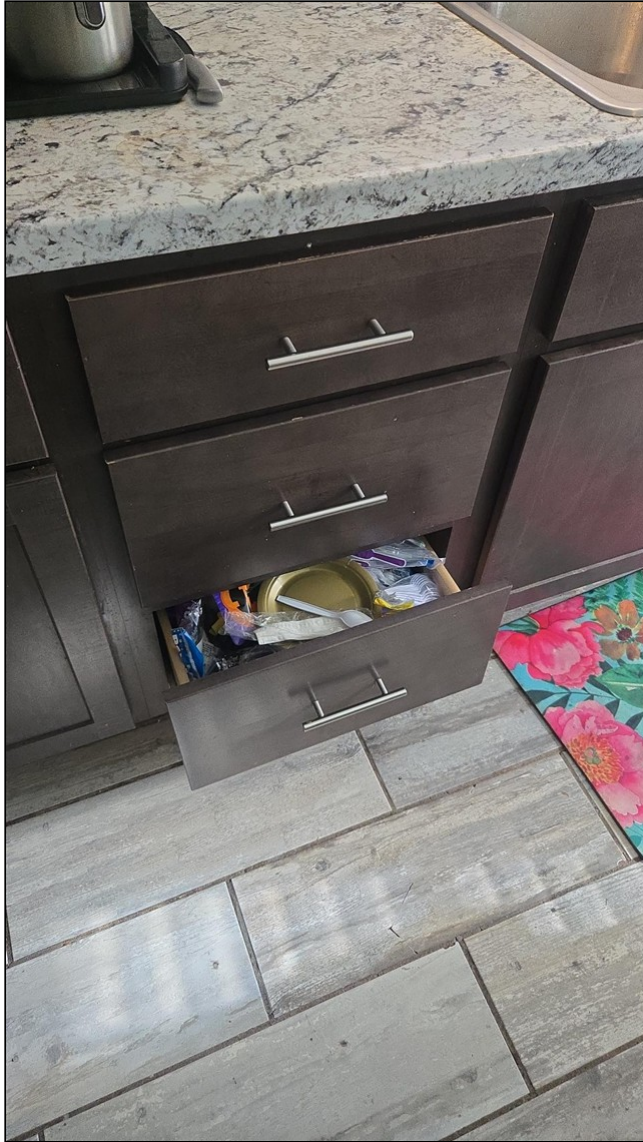
7.4 Item 1(Picture) There was a drawer in the kitchen that required repairs.

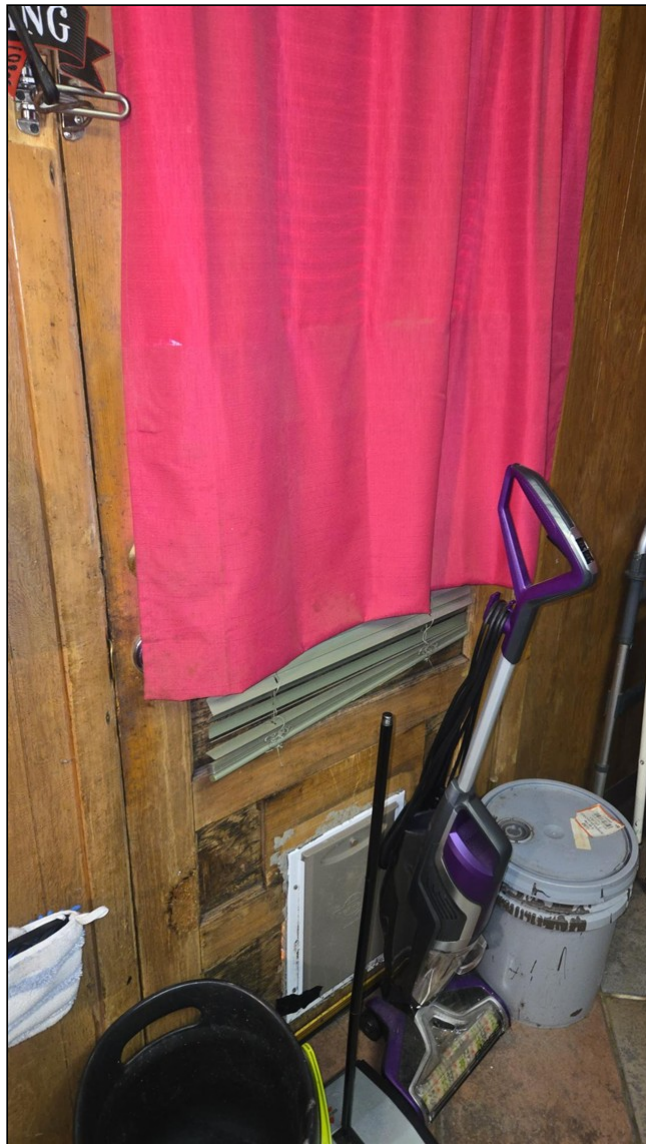
7.5 Item 1(Picture) There were some damaged doors that should be repaired or replaced. Some doorways were blocked and the door could not be fully inspected.

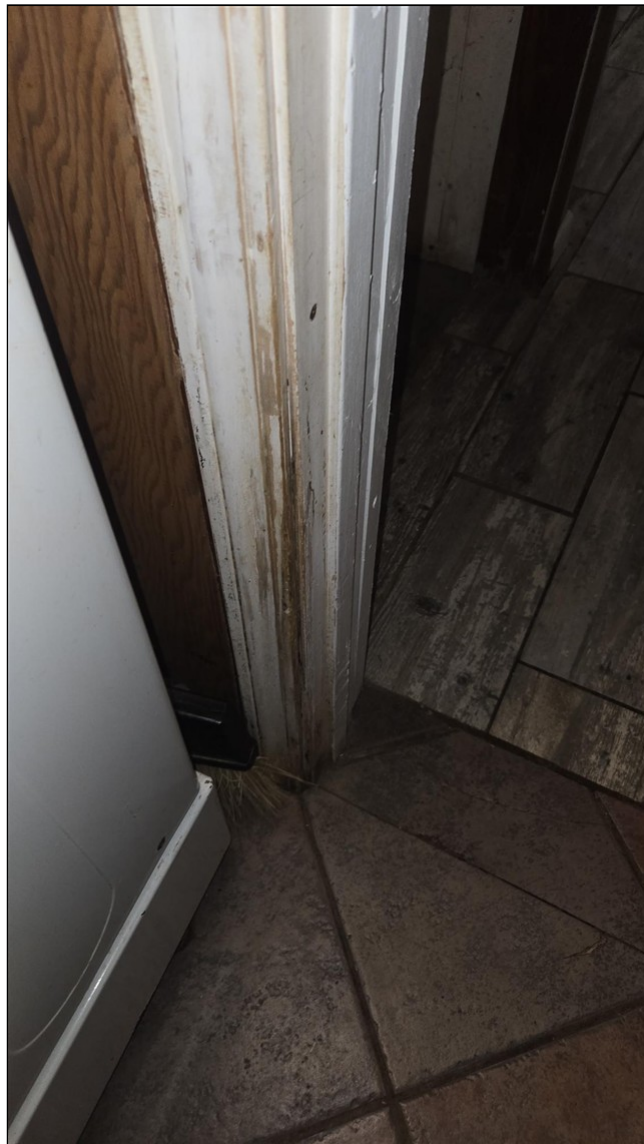
7.5 Item 2(Picture) There were some damaged doors that should be repaired or replaced.

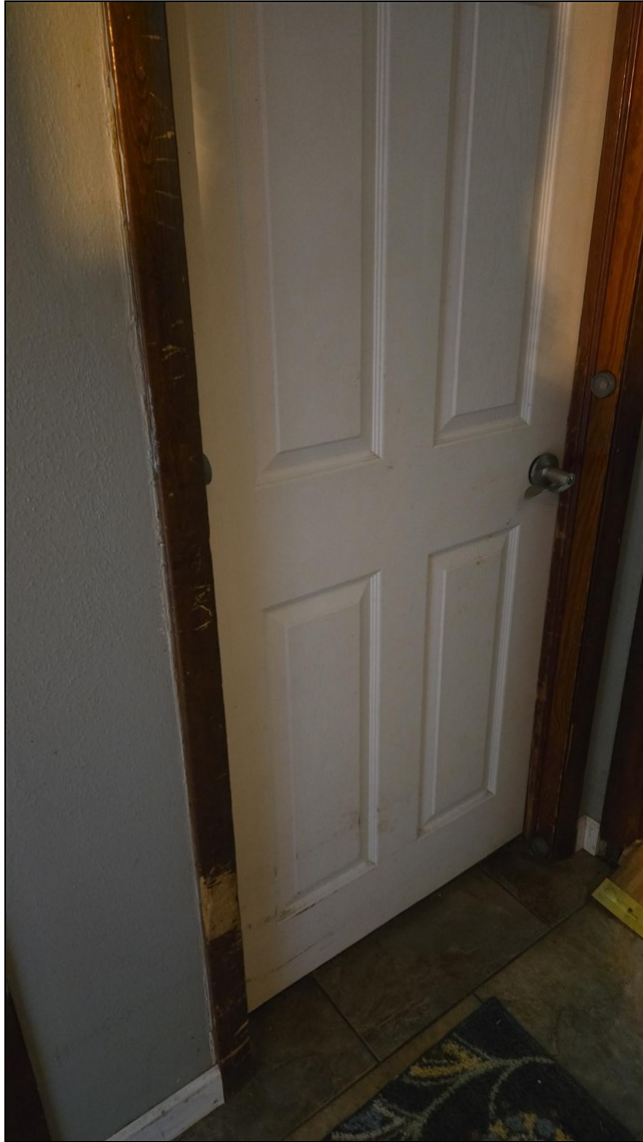
7.5 Item 3(Picture) There were some damaged doors that should be repaired or replaced.

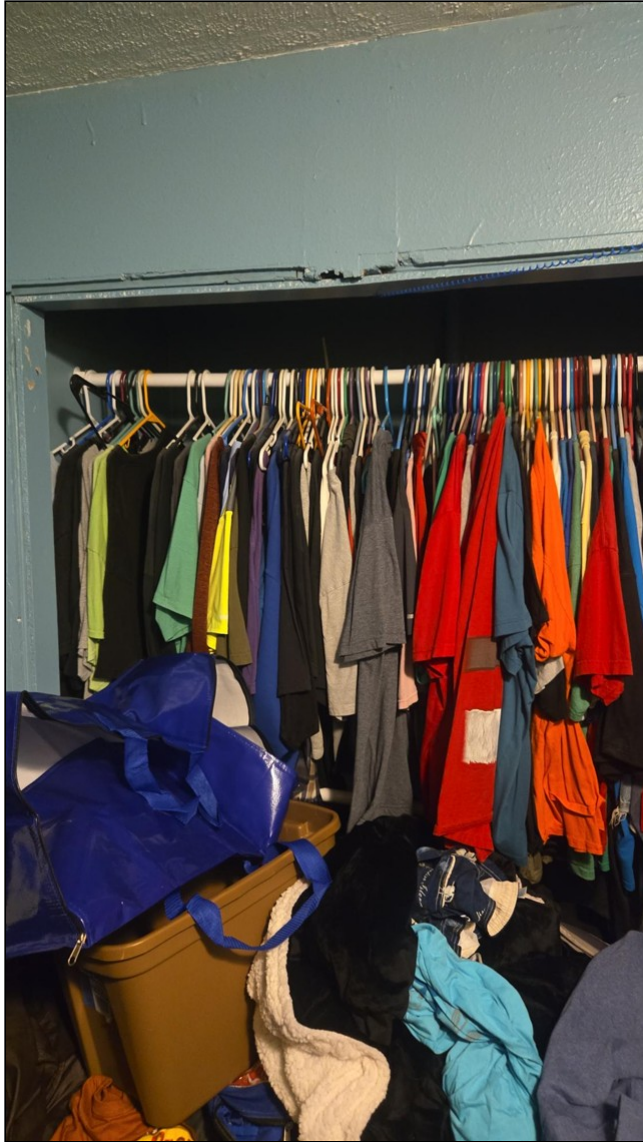
7.5 Item 5(Picture) Missing closet door.

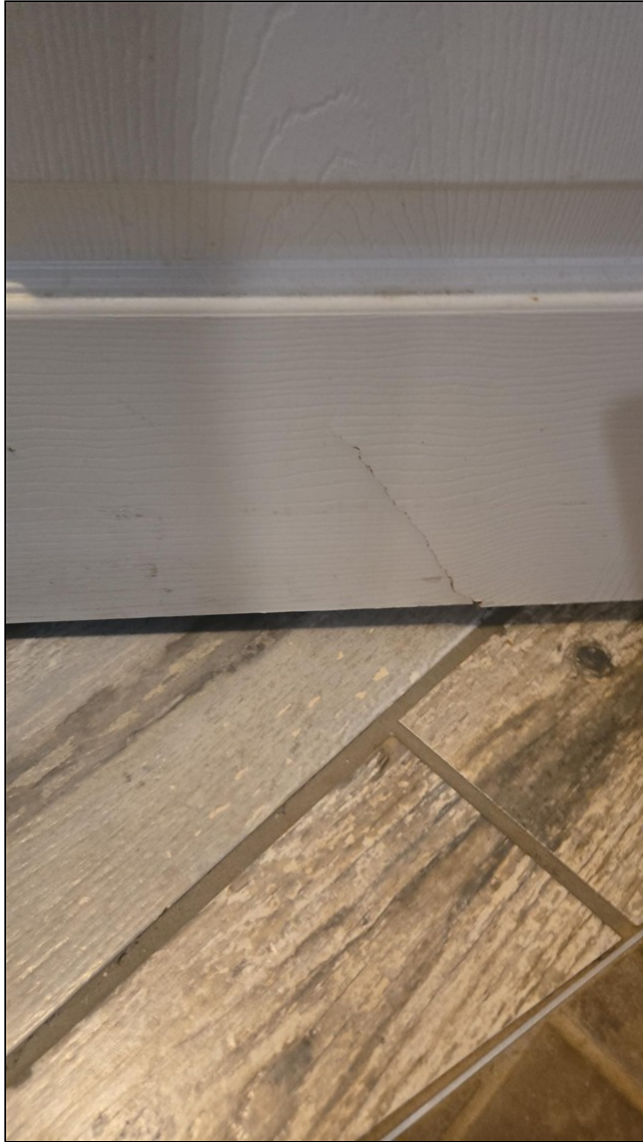
7.5 Item 7(Picture) Cracked door.

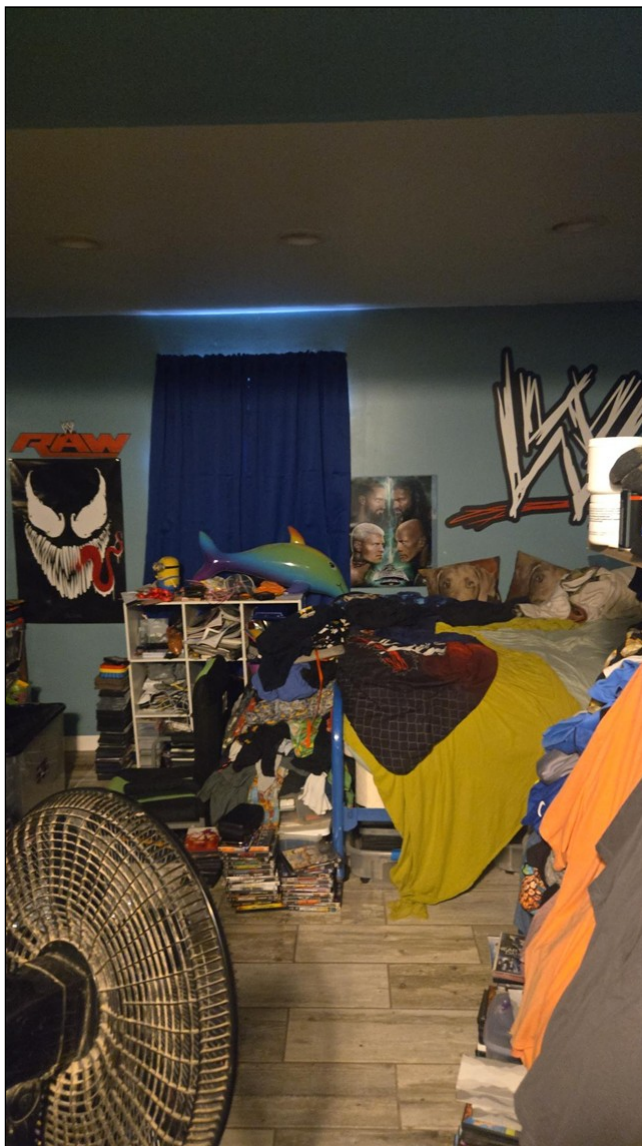
7.6 Item 2(Picture) Many windows were inaccessible and were not inspected.

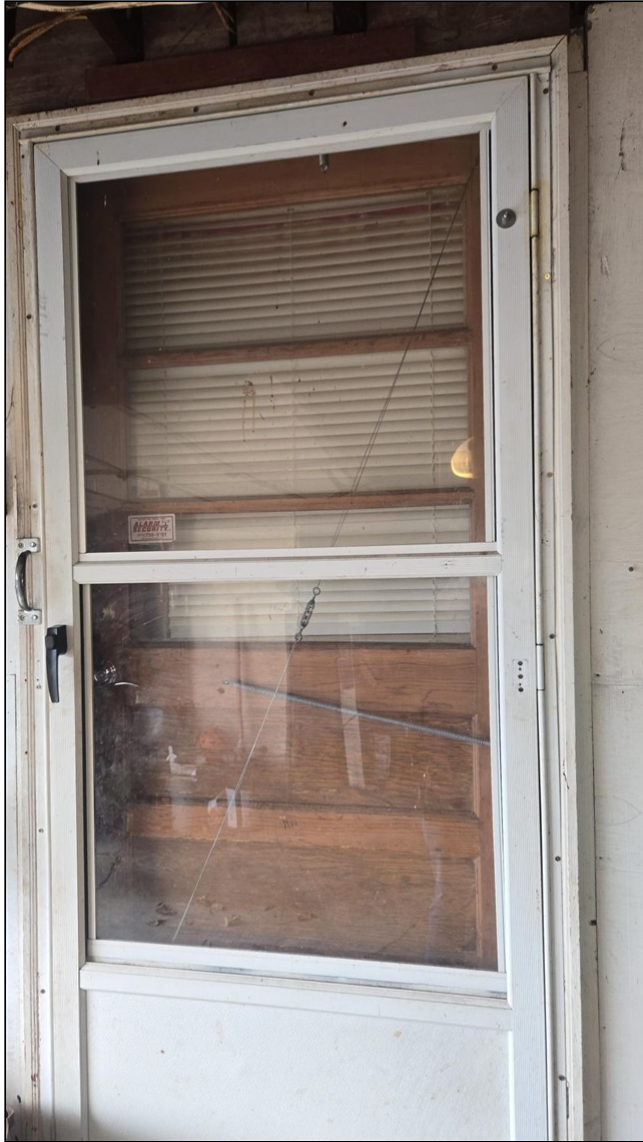
8.4 Item 1(Picture) The occupant door to the house from the garage should be a fire resistant door. "Other openings between the garage and the residence shall be equipped with solid wood doors not less than 1-3/8" (35 mm) in thickness, solid- or honeycomb-core steel doors not less than 1-3/8" (35 mm) thick, or 20-minute fire-rated doors." The door should be replaced with a fire resistant door by a qualified contractor.

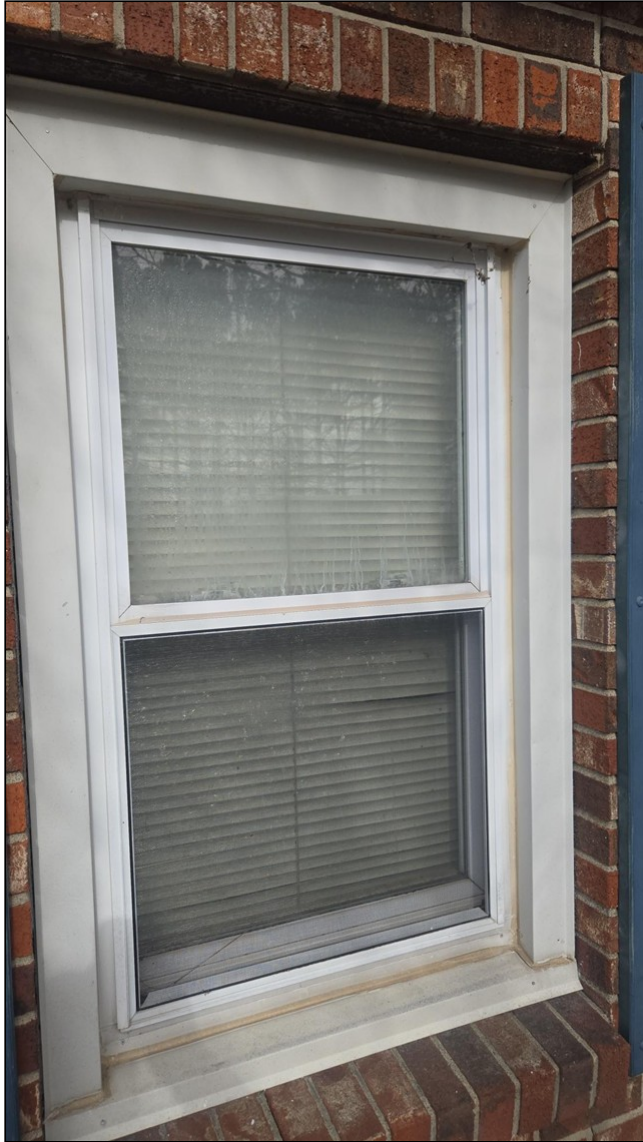
8.6 Item 1(Picture) Broken thermal seals present as sometimes milky residue between the panes of glass and or condensation in between the thermal panes. Broken thermal seals allow moisture vapor to enter the window between the thermal panes and make the window less efficient from a thermal energy perspective. The windows should be cleaned; any and all broken thermal seals should be found and fixed by a qualified contractor.
